Profile/Photo Observation Report

Street:	E 38th Ave	Flow Control:	Not Controlled
City:	Hobart, IN	Year Renewed:	
Location:	Other	Tape/Media #:	
Purpose:	Not Known	Dia/Height:	12"
Use:	Sanitary	Material:	PVC
Drain Area:	NA	Lining:	
Category:	NA		
Comment:

Location Details:		Direction of Survey:	Upstream
US MH:	M-103-032	DS MH:	M-103-031
		Total Length Surveyed (ft):	3.9

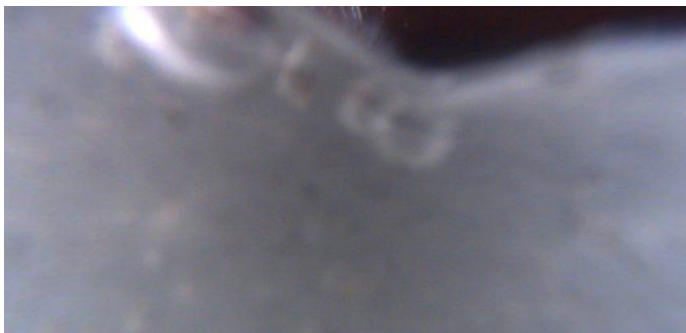
Code: **AMH**
Description: **Manhole**

Distance (ft): **.0**
Structural Grade: **0**
O&M Grade: **0**
Clock Start/From:
Clock To:
1st Value:
2nd Value:
Value Percent:
Continuous Index:
Within 8" of Joint: **NO**
Remarks: **M-103-031**

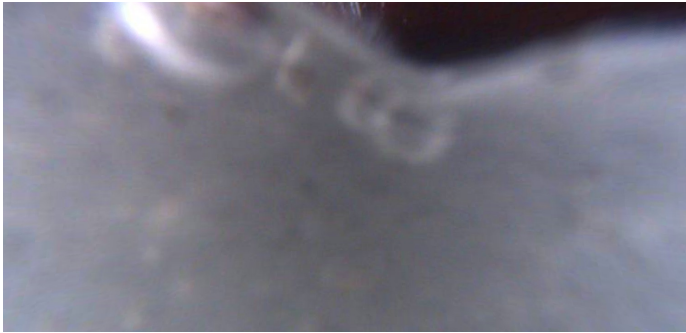
Code:	MWL
Description:	Water Level

Distance (ft):	.0
Structural Grade:	0
O&M Grade:	0
Clock Start/From:	
Clock To:	
1st Value:	
2nd Value:	
Value Percent:	90.000
Continuous Index:	
Within 8" of Joint:	NO
Remarks:

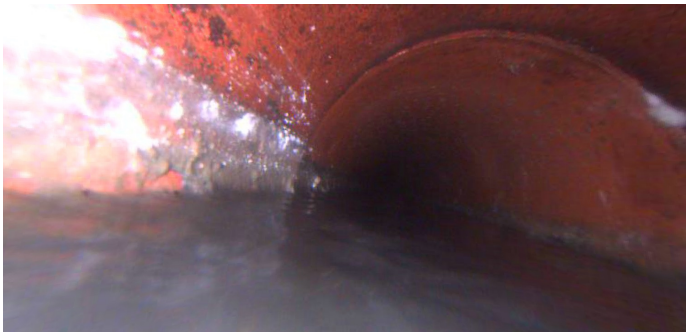
Code:	MSA
Description:	Abandoned Survey

Distance (ft):	3.9
Structural Grade:	0
O&M Grade:	0
Clock Start/From:	
Clock To:	
1st Value:	
2nd Value:	
Value Percent:	
Continuous Index:	
Within 8" of Joint:	NO
Remarks:	debris under water
