## Profile/Photo Observation Report

Street:	<b>ALLEY BETWEEN W 37TH AVE &amp; W 3</b>	Flow Control:	<b>Not Controlled</b>
City:	<b>Hobart, IN</b>	Year Renewed:	
Location:	<b>Other</b>	Tape/Media #:	
Purpose:	<b>Not Known</b>	Dia/Height:	<b>12"</b>
Use:	<b>Sanitary</b>	Material:	<b>VCP</b>
Drain Area:	<b>NA</b>	Lining:	
Category:	<b>NA</b>		
Comment:

Location Details:		Direction of Survey:	<b>Upstream</b>
US MH:	<b>M-103-032</b>	DS MH:	<b>M-103-033</b>
		Total Length Surveyed (ft):	<b>240.0</b>

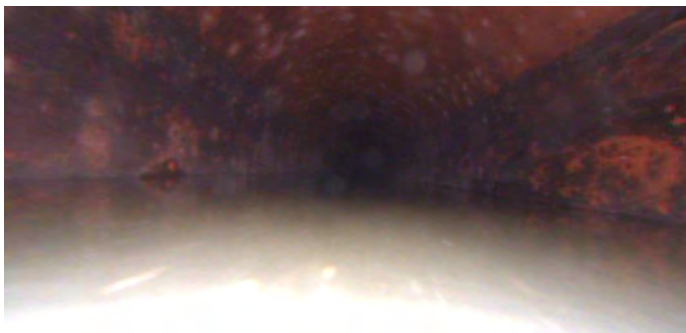
Code: **AMH**  
Description: **Manhole**

Distance (ft): **.0**  
Structural Grade: **0**  
O&M Grade: **0**  
Clock Start/From:  
Clock To:  
1st Value:  
2nd Value:  
Value Percent:  
Continuous Index:  
Within 8" of Joint: **NO**  
Remarks: **M-103-033**

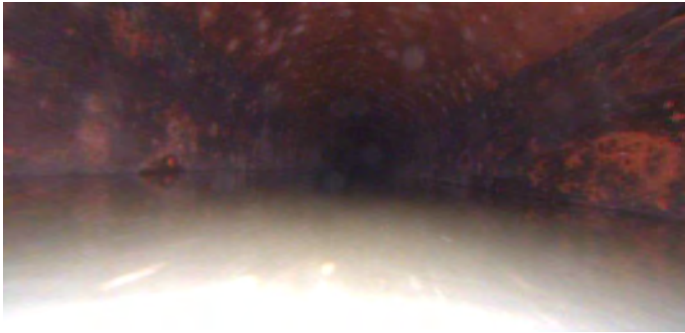
Code:	<b>MWL</b>
Description:	<b>Water Level</b>

Distance (ft):	<b>.0</b>
Structural Grade:	<b>0</b>
O&M Grade:	<b>0</b>
Clock Start/From:	
Clock To:	
1st Value:	
2nd Value:	
Value Percent:	<b>15.000</b>
Continuous Index:	
Within 8" of Joint:	<b>NO</b>
Remarks:

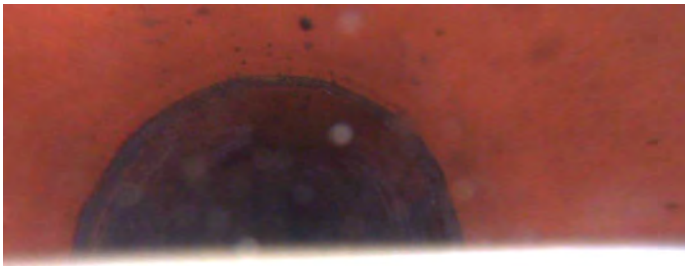
Code:	<b>IS</b>
Description:	<b>Infil Stain</b>

Distance (ft):	<b>13.7</b>
Structural Grade:	<b>0</b>
O&M Grade:	<b>0</b>
Clock Start/From:	<b>7</b>
Clock To:	<b>5</b>
1st Value:	
2nd Value:	
Value Percent:	
Continuous Index:	
Within 8" of Joint:	<b>YES</b>
Remarks:

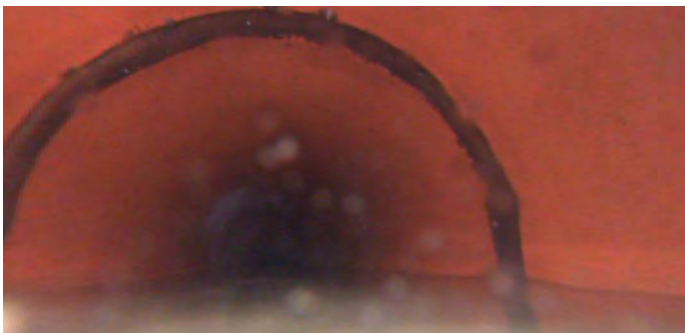
Code: **IS**  
Description: **Infil Stain**

Distance (ft): **38.7**  
Structural Grade: **0**  
O&M Grade: **0**  
Clock Start/From: **7**  
Clock To: **5**  
1st Value:  
2nd Value:  
Value Percent:  
Continuous Index: **S02**  
Within 8" of Joint: **YES**  
Remarks: **WANDER**

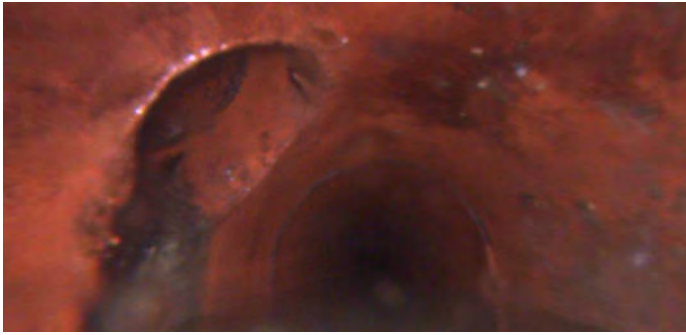
Code: **TF**  
Description: **Tap Factory**

Distance (ft): **50.0**  
Structural Grade: **0**  
O&M Grade: **0**  
Clock Start/From: **10**  
Clock To:  
1st Value: **4.000**  
2nd Value:  
Value Percent:  
Continuous Index:  
Within 8" of Joint:  
Remarks:

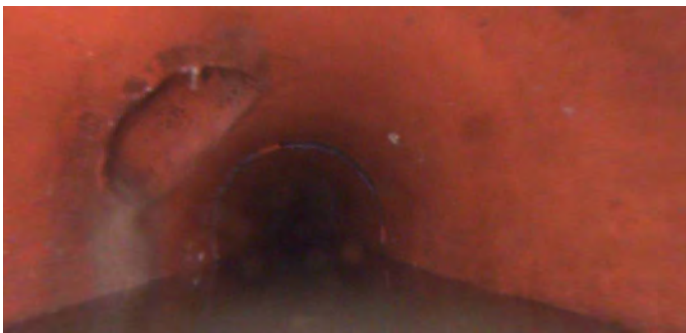
Code: **TF**  
Description: **Tap Factory**

Distance (ft): **96.9**  
Structural Grade: **0**  
O&M Grade: **0**  
Clock Start/From: **10**  
Clock To:  
1st Value: **4.000**  
2nd Value:  
Value Percent:  
Continuous Index:  
Within 8" of Joint:  
Remarks:

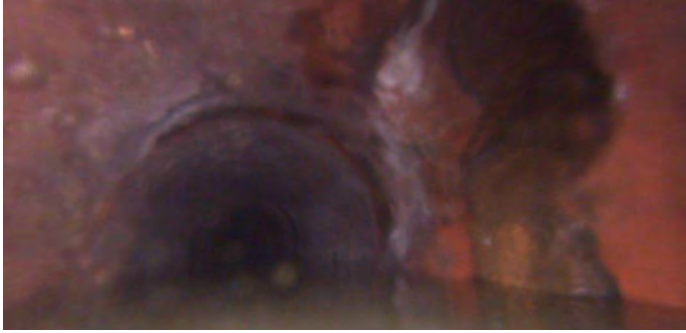
Code: **TF**  
Description: **Tap Factory**

Distance (ft): **119.5**  
Structural Grade: **0**  
O&M Grade: **0**  
Clock Start/From: **3**  
Clock To:  
1st Value: **4.000**  
2nd Value:  
Value Percent:  
Continuous Index:  
Within 8" of Joint:  
Remarks:

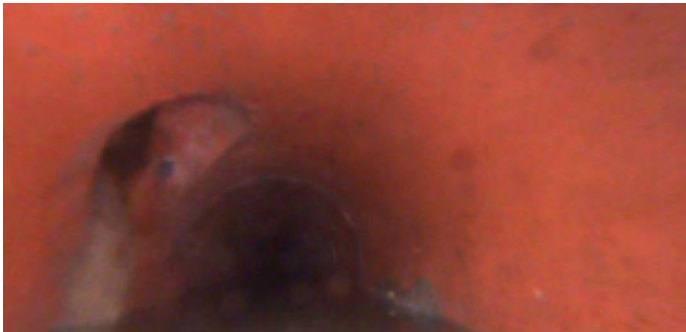
Code: **TF**  
Description: **Tap Factory**

Distance (ft): **150.9**  
Structural Grade: **0**  
O&M Grade: **0**  
Clock Start/From: **10**  
Clock To:  
1st Value: **4.000**  
2nd Value:  
Value Percent:  
Continuous Index:  
Within 8" of Joint:  
Remarks:

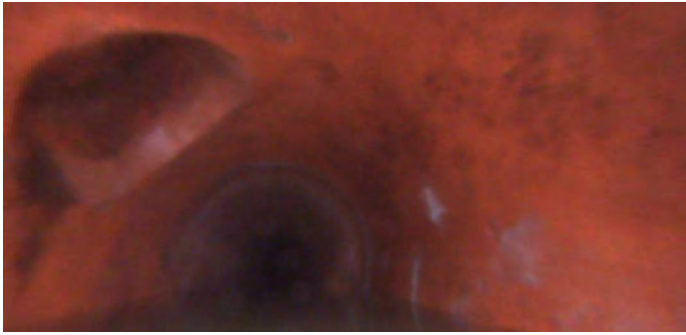
Code: **TF**  
Description: **Tap Factory**

Distance (ft): **197.8**  
Structural Grade: **0**  
O&M Grade: **0**  
Clock Start/From: **10**  
Clock To:  
1st Value: **4.000**  
2nd Value:  
Value Percent:  
Continuous Index:  
Within 8" of Joint:  
Remarks:

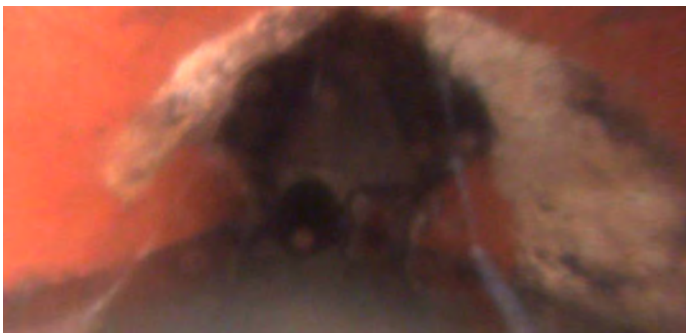
Code: **DAE**  
Description: **Deposits Attached Encrustation**

Distance (ft): **237.5**  
Structural Grade: **0**  
O&M Grade: **2**  
Clock Start/From: **8**  
Clock To: **4**  
1st Value:  
2nd Value:  
Value Percent: **10.000**  
Continuous Index:  
Within 8" of Joint: **NO**  
Remarks:
