Profile/Photo Observation Report

Date:	03/23/2018	Weather:		Coding:	PACP 6.0
Pipe Length (ft):	245.4	Owner:	NA	Pre Clean:	Not Known
P.O.#:		Surveyor:	Justin Gonzales	PSR:	P-103-032-033
Customer:		Clean Date:	01/01/1900	Shape:	C

Street:	E 38th Ave	Flow Control:	Not Controlled
City:	Hobart, IN	Year Renewed:	
Location:	Other	Tape/Media #:	
Purpose:	Not Known	Dia/Height:	12"
Use:	Sanitary	Material:	VCP
Drain Area:	NA	Lining:	
Category:	NA		
Comment:

Location Details:		Direction of Survey:	Upstream
US MH:	M-103-032	DS MH:	M-103-033
		Total Length Surveyed (ft):	240.0

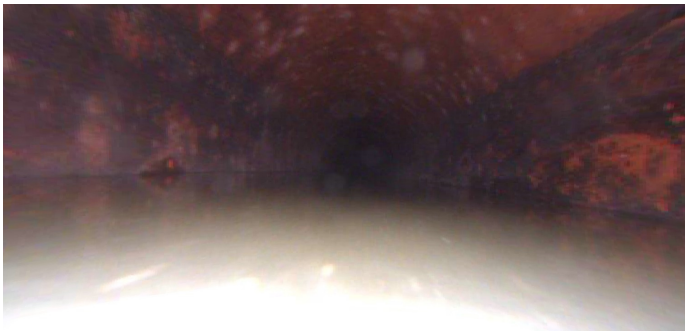
Code: **AMH**
Description: **Manhole**

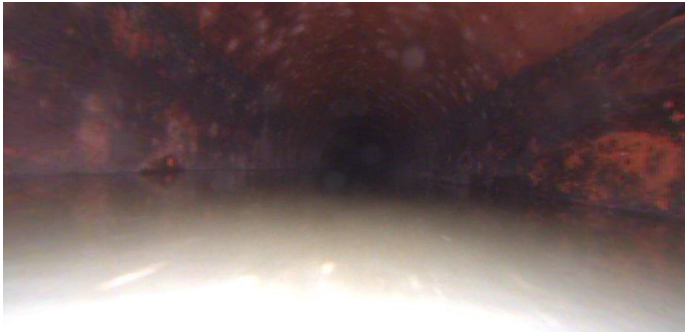
Code:	MWL
Description:	Water Level

Distance (ft):	.0
Structural Grade:	0
O&M Grade:	0
Clock Start/From:	
Clock To:	
1st Value:	
2nd Value:	
Value Percent:	15.000
Continuous Index:	
Within 8" of Joint:	NO
Remarks:

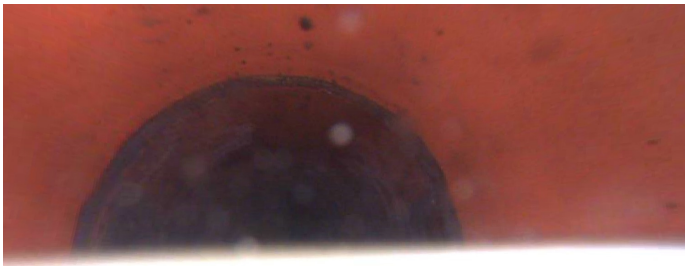
Code:	IS
Description:	Infil Stain

Distance (ft):	13.7
Structural Grade:	0
O&M Grade:	0
Clock Start/From:	7
Clock To:	5
1st Value:	
2nd Value:	
Value Percent:	
Continuous Index:	
Within 8" of Joint:	YES
Remarks:

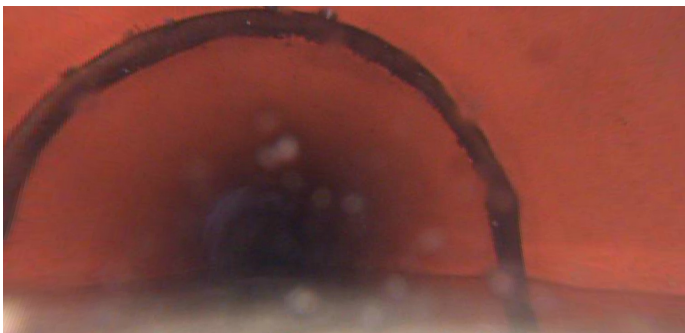
Code: **IS**
Description: **Infil Stain**

Distance (ft): **38.7**
Structural Grade: **0**
O&M Grade: **0**
Clock Start/From: **7**
Clock To: **5**
1st Value:
2nd Value:
Value Percent:
Continuous Index: **S02**
Within 8" of Joint: **YES**
Remarks: **WANDER**

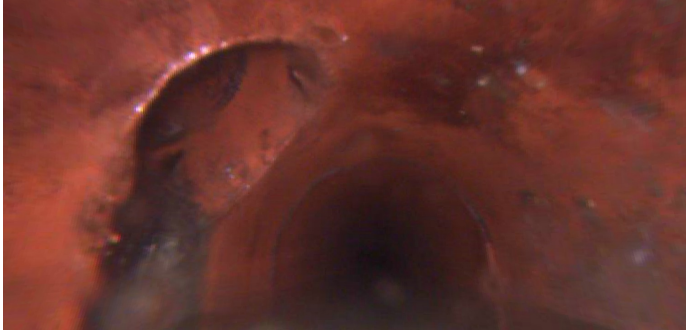
Code: **TF**
Description: **Tap Factory**

Distance (ft): **50.0**
Structural Grade: **0**
O&M Grade: **0**
Clock Start/From: **10**
Clock To:
1st Value: **4.000**
2nd Value:
Value Percent:
Continuous Index:
Within 8" of Joint:
Remarks:

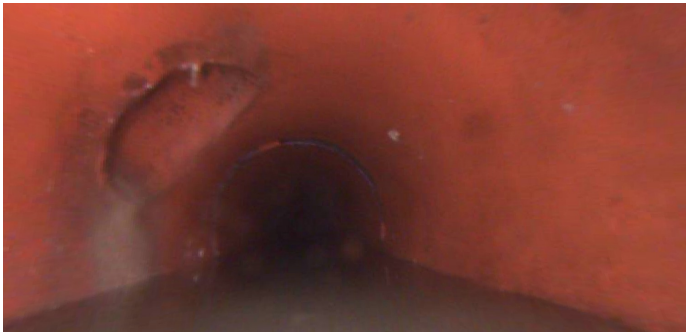
Code: **TF**
Description: **Tap Factory**

Distance (ft): **96.9**
Structural Grade: **0**
O&M Grade: **0**
Clock Start/From: **10**
Clock To:
1st Value: **4.000**
2nd Value:
Value Percent:
Continuous Index:
Within 8" of Joint:
Remarks:

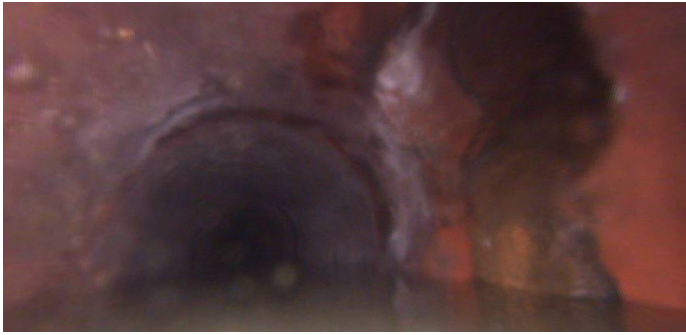
Code: **TF**
Description: **Tap Factory**

Distance (ft): **119.5**
Structural Grade: **0**
O&M Grade: **0**
Clock Start/From: **3**
Clock To:
1st Value: **4.000**
2nd Value:
Value Percent:
Continuous Index:
Within 8" of Joint:
Remarks:

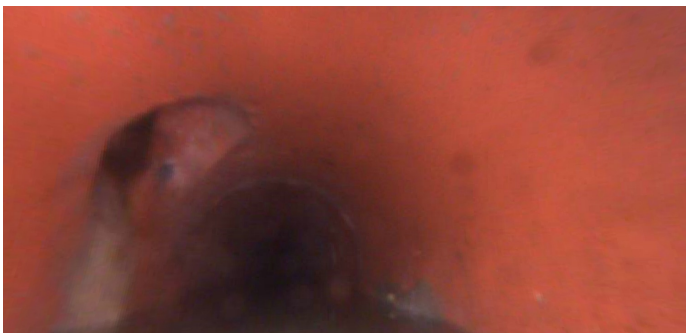
Code: **TF**
Description: **Tap Factory**

Distance (ft): **150.9**
Structural Grade: **0**
O&M Grade: **0**
Clock Start/From: **10**
Clock To:
1st Value: **4.000**
2nd Value:
Value Percent:
Continuous Index:
Within 8" of Joint:
Remarks:

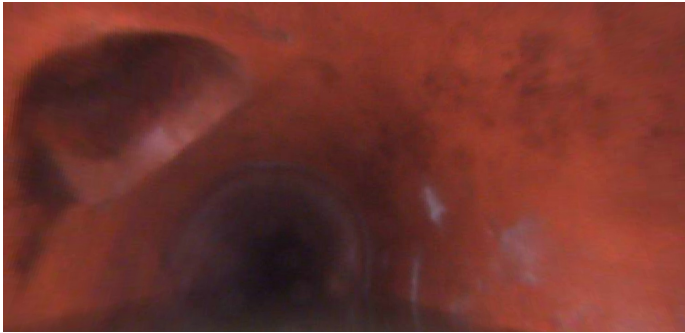
Code: **TF**
Description: **Tap Factory**

Distance (ft): **197.8**
Structural Grade: **0**
O&M Grade: **0**
Clock Start/From: **10**
Clock To:
1st Value: **4.000**
2nd Value:
Value Percent:
Continuous Index:
Within 8" of Joint:
Remarks:

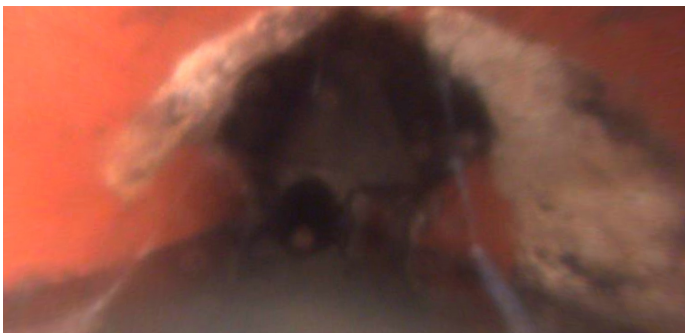
Code: **DAE**
Description: **Deposits Attached Encrustation**

Distance (ft): **237.5**
Structural Grade: **0**
O&M Grade: **2**
Clock Start/From: **8**
Clock To: **4**
1st Value:
2nd Value:
Value Percent: **10.000**
Continuous Index:
Within 8" of Joint: **NO**
Remarks:

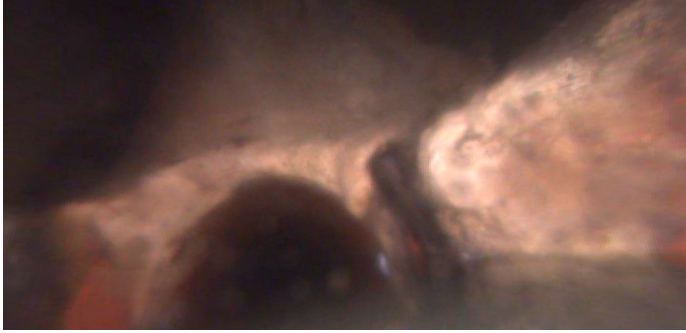
Code: **AMH**
Description: **Manhole**

Distance (ft): **240.0**
Structural Grade: **0**
O&M Grade: **0**
Clock Start/From:
Clock To:
1st Value:
2nd Value:
Value Percent:
Continuous Index:
Within 8" of Joint: **NO**
Remarks: **M-103-032**

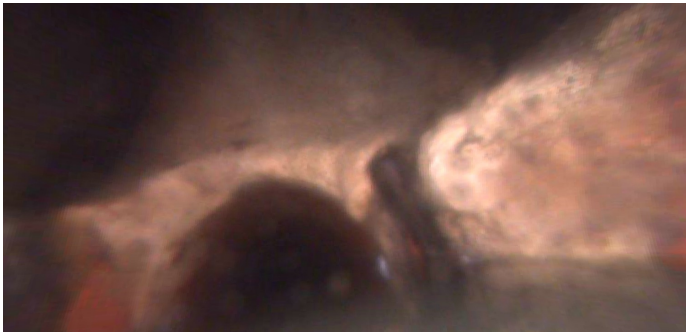
Code: **IS**
Description: **Infil Stain**

Distance (ft): **240.0**
Structural Grade: **0**
O&M Grade: **0**
Clock Start/From: **7**
Clock To: **5**
1st Value:
2nd Value:
Value Percent:
Continuous Index: **F02**
Within 8" of Joint: **YES**
Remarks: **WANDER**
