## Profile/Photo Observation Report

Street:	<b>Maple Street</b>	Flow Control:	
City:	<b>Hobart, IN</b>	Year Renewed:	
Location:	<b>Light Highway</b>	Tape/Media #:	<b>826</b>
Purpose:	<b>Routine Assessment</b>	Dia/Height:	<b>8"</b>
Use:	<b>Sanitary</b>	Material:	<b>PVC</b>
Drain Area:		Lining:

US MH: **M-103-102** DS MH: **M-103-101** Total Length Surveyed (ft): **.1**

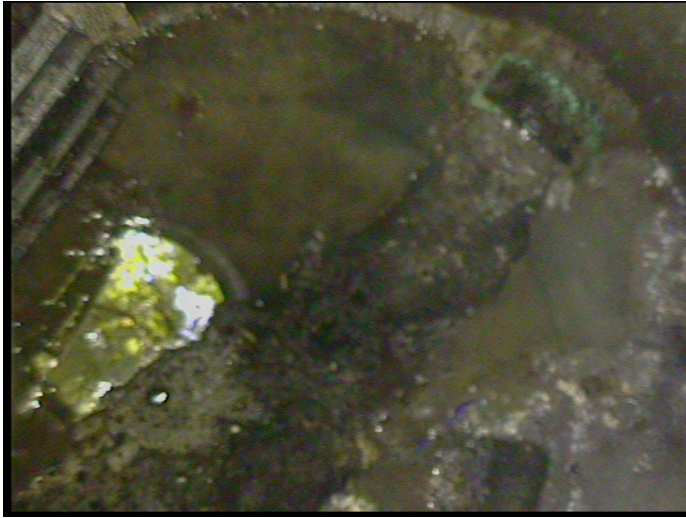
Code: **MWL**  
Description: **Water Level**

Distance (ft): **.0**  
Structural Grade: **0**  
O&M Grade: **0**  
Clock Start/From:  
Clock To:  
1st Value:  
2nd Value:  
Value Percent: **5.000**  
Continuous Index:  
Within 8" of Joint: **NO**  
Remarks:

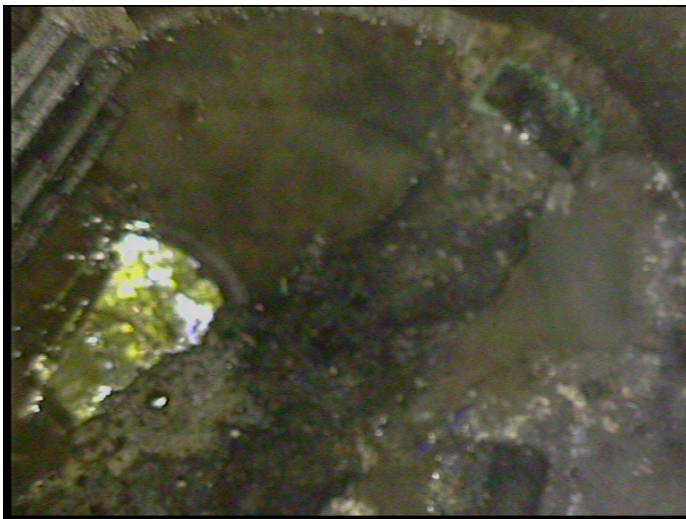
Code: **DSF**  
Description: **Deposits Settled Fine**

Distance (ft): **.0**  
Structural Grade: **0**  
O&M Grade: **5**  
Clock Start/From: **6**  
Clock To: **6**  
1st Value:  
2nd Value:  
Value Percent: **90.000**  
Continuous Index:  
Within 8" of Joint: **NO**  
Remarks:

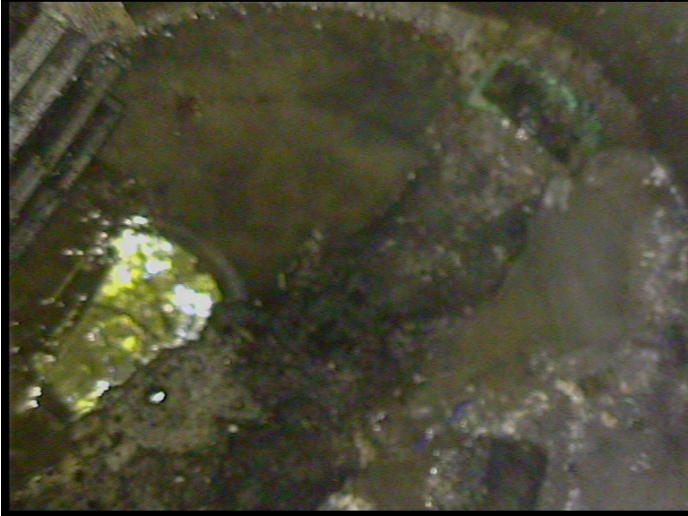
Code:	MSA
Description:	Abandoned Survey
Distance (ft):	.0
Structural Grade:	0
O&M Grade:	0
Clock Start/From:	
Clock To:	
1st Value:	
2nd Value:	
Value Percent:	
Continuous Index:	
Within 8" of Joint:	NO
Remarks:	heavy debris
