Profile/Photo Observation Report

Date:	10/16/2021	Weather:		Coding:	PACP 6.0
Pipe Length (ft):		Owner:	Hobart, IN	Pre Clean:	Not Known
P.O.#:	827_1	Surveyor:	M. Pielacha	PSR:	P-103-101-102
Customer:	Hobart, IN	Clean Date:		Shape:	C

Street:	Maple Street	Flow Control:	Not Controlled
City:	Hobart, IN	Year Renewed:	
Location:	Light Highway	Tape/Media #:	827
Purpose:	Routine Assessment	Dia/Height:	8"
Use:	Sanitary	Material:	PVC
Drain Area:		Lining:	
Category:	NA		
Comment:			
Location Details:		Direction of Survey:	Downstream
US MH:	M-103-102	DS MH:	M-103-101
		Total Length Surveyed (ft):	.1

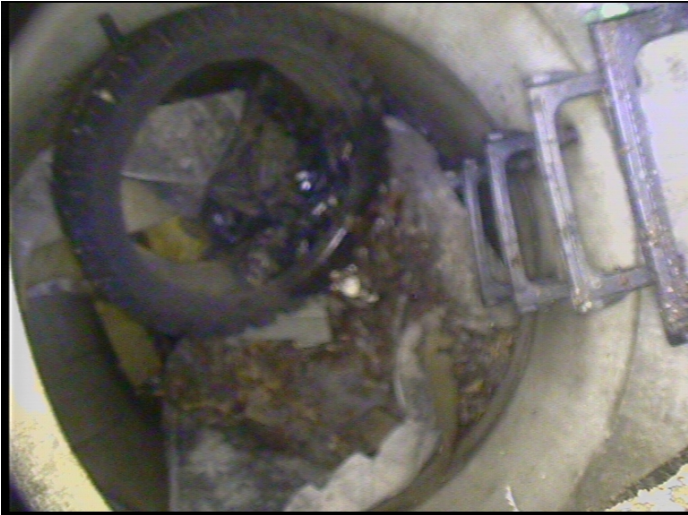
AMH

Manhole

M-103-102

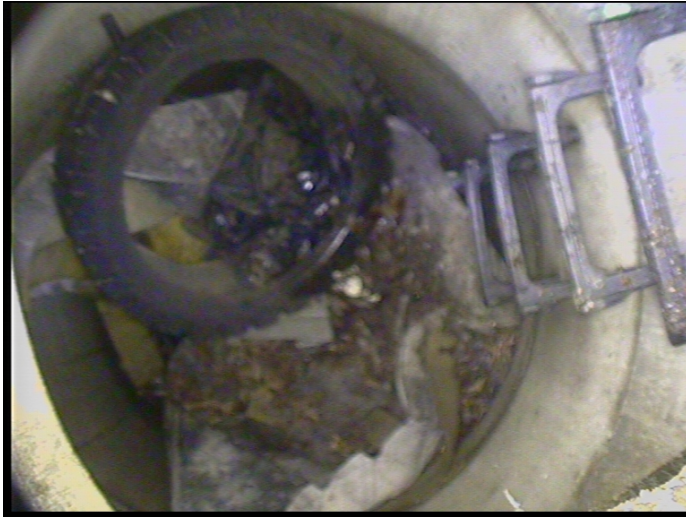
Code: **MWL**
Description: **Water Level**

Distance (ft): **.0**
Structural Grade: **0**
O&M Grade: **0**
Clock Start/From:
Clock To:
1st Value:
2nd Value:
Value Percent: **0.000**
Continuous Index:
Within 8" of Joint: **NO**
Remarks:

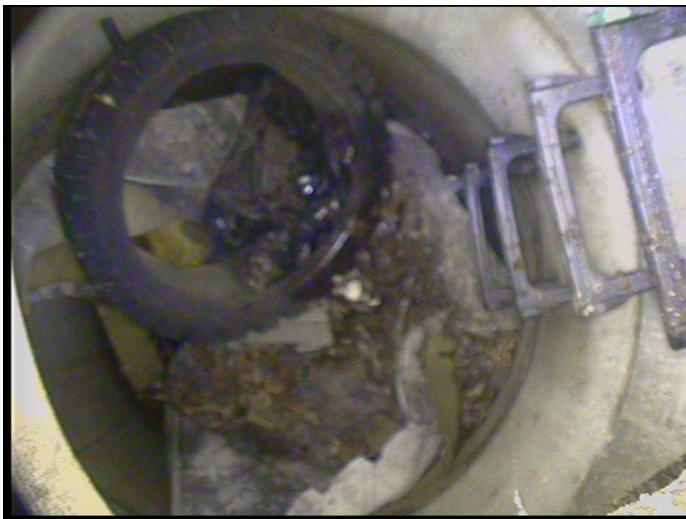
Code: **OBZ**
Description: **Obstacle Other**

Distance (ft): **.0**
Structural Grade: **0**
O&M Grade: **5**
Clock Start/From: **6**
Clock To: **6**
1st Value:
2nd Value:
Value Percent: **100.000**
Continuous Index:
Within 8" of Joint: **NO**
Remarks: **Debris**

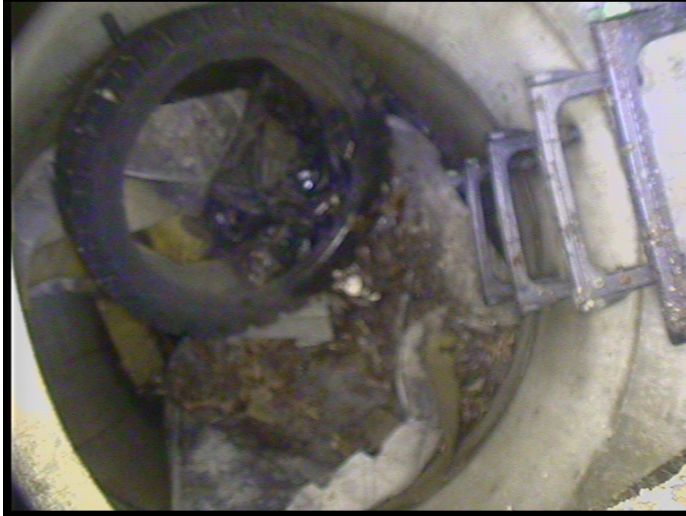
Code:	MSA
Description:	Abandoned Survey
Distance (ft):	.0
Structural Grade:	0
O&M Grade:	0
Clock Start/From:	
Clock To:	
1st Value:	
2nd Value:	
Value Percent:	
Continuous Index:	
Within 8" of Joint:	NO
Remarks:	heavy debris
