Profile/Photo Observation Report

| P.O.#: | 824_1 | Surveyor: | M. Pielacha | PSR: | P-103-104-103 |

| Street: | Maple Street | Flow Control: | |

US MH: **M-103-103** DS MH: **M-103-104** Total Length Surveyed (ft): **154.1**

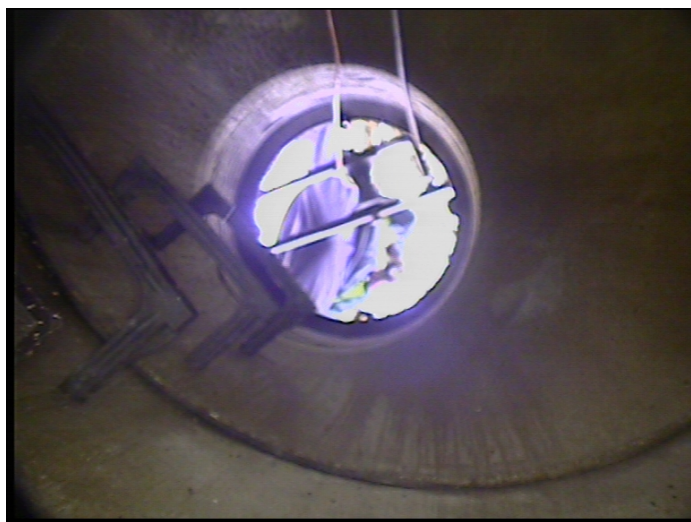
Code: **AMH**
Description: **Manhole**

Distance (ft): **.0**
Structural Grade: **0**
O&M Grade: **0**
Clock Start/From:
Clock To:
1st Value:
2nd Value:
Value Percent:
Continuous Index:
Within 8" of Joint: **NO**
Remarks: **M-103-104**

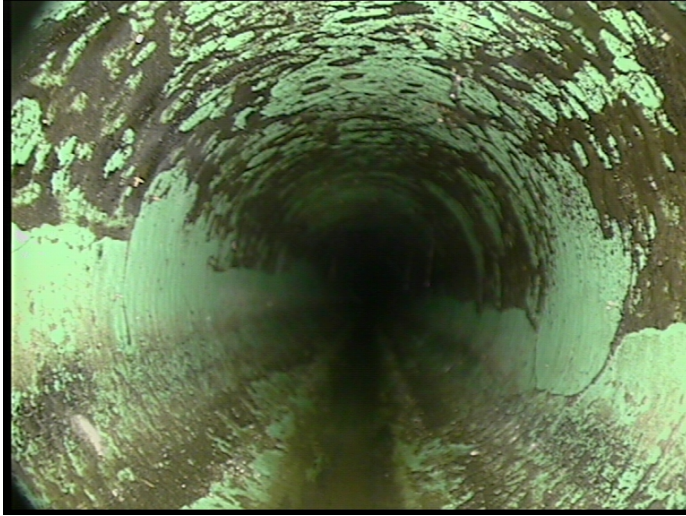
| Description: | Water Level |
| Value Percent: | 5.000 |

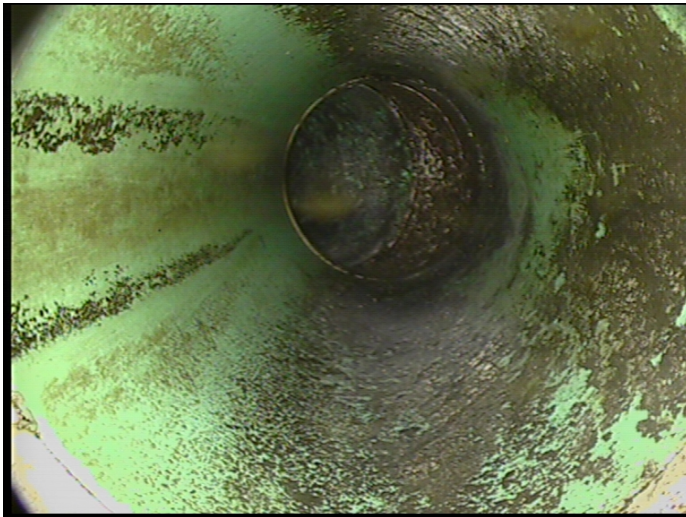
| Description: | Tap Factory |
| Distance (ft): | 108.1 |
| Clock Start/From: | 10 |
| 1st Value: | 4.000 |

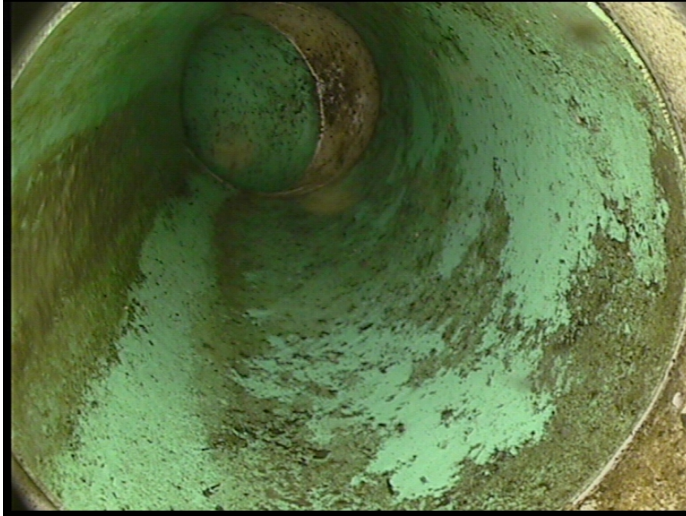
| Description: | Tap Factory |
| Distance (ft): | 145.5 |
| Clock Start/From: | 10 |
| 1st Value: | 4.000 |

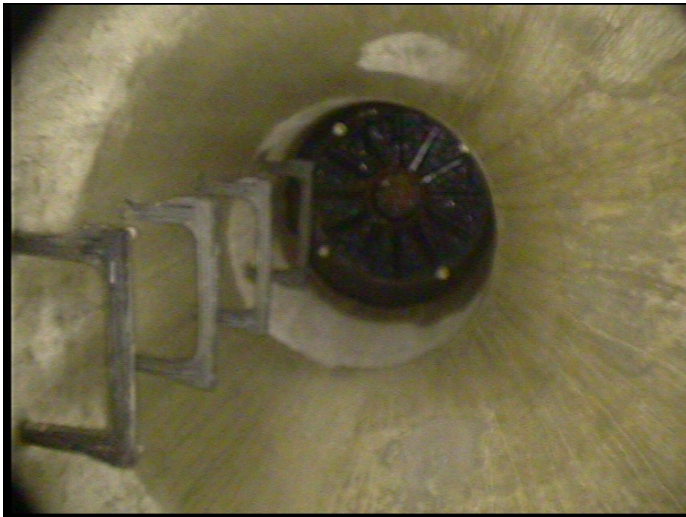
| Description: | Manhole |
| Distance (ft): | 154.1 |
| Remarks: | M-103-103 |
