## Profile/Photo Observation Report

Street:	<b>East 39th Avenue</b>	Flow Control:	
City:	<b>Hobart, IN</b>	Year Renewed:	
Location:	<b>Light Highway</b>	Tape/Media #:	<b>822</b>
Purpose:	<b>Routine Assessment</b>	Dia/Height:	<b>8"</b>
Use:	<b>Sanitary</b>	Material:	<b>PVC</b>
Drain Area:		Lining:	
Category:	<b>NA</b>		
Comment:

Location Details:		Direction of Survey:	<b>Downstream</b>
US MH:	<b>M-103-105</b>	DS MH:	<b>M-103-106</b>
		Total Length Surveyed (ft):	<b>106.8</b>

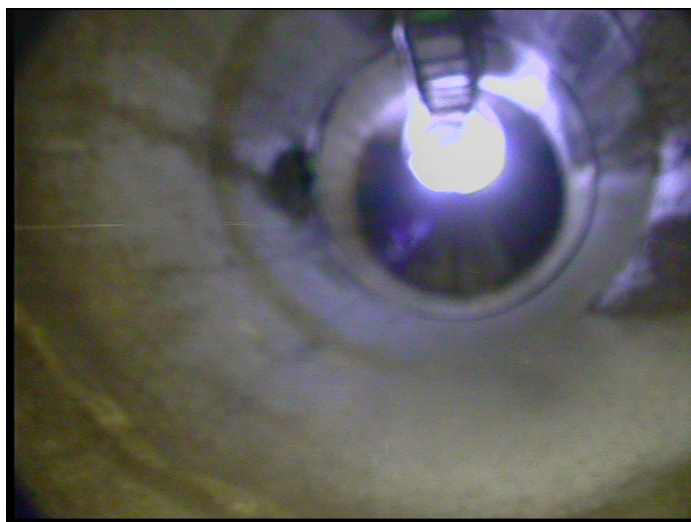
Code: **AMH**  
Description: **Manhole**

Distance (ft): **.0**  
Structural Grade: **0**  
O&M Grade: **0**  
Clock Start/From:  
Clock To:  
1st Value:  
2nd Value:  
Value Percent:  
Continuous Index:  
Within 8" of Joint: **NO**  
Remarks: **M-103-105**

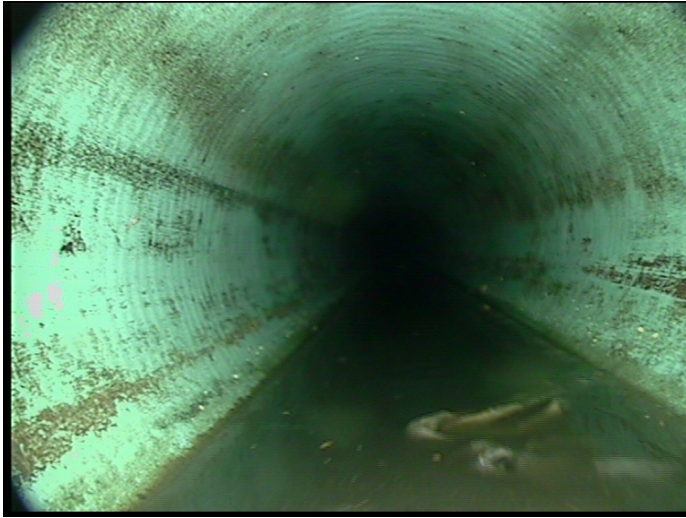
Code:	<b>MWL</b>
Description:	<b>Water Level</b>
Distance (ft):	<b>.0</b>
Structural Grade:	<b>0</b>
O&M Grade:	<b>0</b>
Clock Start/From:	
Clock To:	
1st Value:	
2nd Value:	
Value Percent:	<b>5.000</b>
Continuous Index:	
Within 8" of Joint:	<b>NO</b>
Remarks:

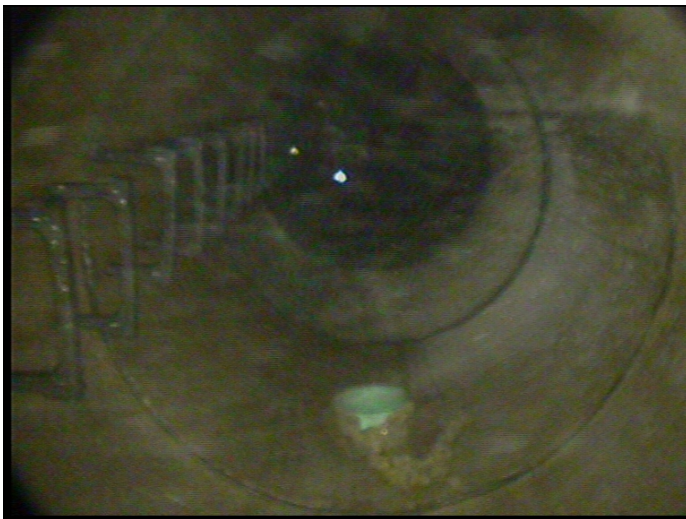
Code:	<b>AMH</b>
Description:	<b>Manhole</b>
Distance (ft):	<b>106.8</b>
Structural Grade:	<b>0</b>
O&M Grade:	<b>0</b>
Clock Start/From:	
Clock To:	
1st Value:	
2nd Value:	
Value Percent:	
Continuous Index:	
Within 8" of Joint:	<b>NO</b>
Remarks:	<b>M-103-106</b>
