Profile/Photo Observation Report

Date:	10/16/2021	Weather:		Coding:	PACP 6.0
Pipe Length (ft):		Owner:	Hobart, IN	Pre Clean:	Not Known
P.O.#:	819_1	Surveyor:	M. Pielacha	PSR:	P-103-113-108
Customer:	Hobart, IN	Clean Date:		Shape:	C

Street:	Swift Street	Flow Control:	
City:	Hobart, IN	Year Renewed:	
Location:	Light Highway	Tape/Media #:	819
Purpose:	Routine Assessment	Dia/Height:	8"
Use:	Sanitary	Material:	PVC
Drain Area:		Lining:	
Category:	NA		
Comment:

Location Details:		Direction of Survey:	Downstream
US MH:	M-103-108	DS MH:	M-103-113
		Total Length Surveyed (ft):	61.9

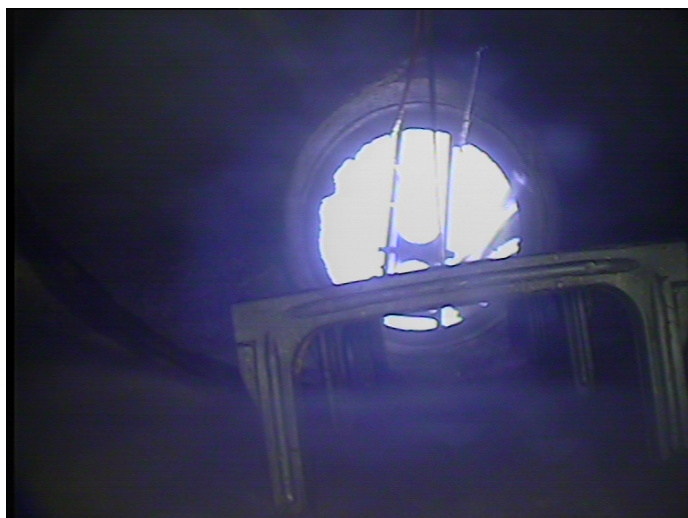
Code: **AMH**
Description: **Manhole**

Distance (ft): **.0**
Structural Grade: **0**
O&M Grade: **0**
Clock Start/From:
Clock To:
1st Value:
2nd Value:
Value Percent:
Continuous Index:
Within 8" of Joint: **NO**
Remarks: **M-103-108**

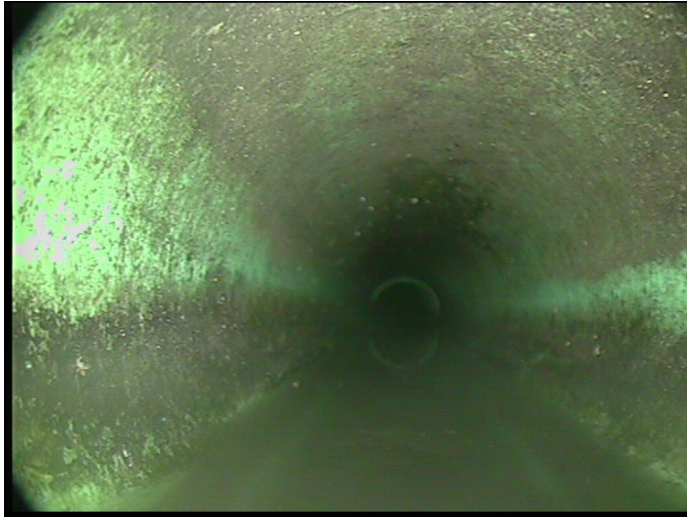
Code: **MWL**
Description: **Water Level**

Distance (ft): **.0**
Structural Grade: **0**
O&M Grade: **0**
Clock Start/From:
Clock To:
1st Value:
2nd Value:
Value Percent: **5.000**
Continuous Index:
Within 8" of Joint: **NO**
Remarks:

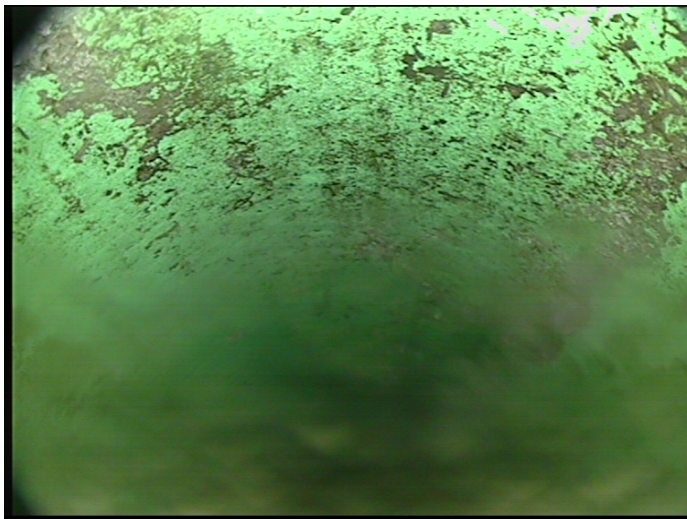
Code: **MWL**
Description: **Water Level**

Distance (ft): **28.6**
Structural Grade: **0**
O&M Grade: **0**
Clock Start/From:
Clock To:
1st Value:
2nd Value:
Value Percent: **40.000**
Continuous Index:
Within 8" of Joint: **NO**
Remarks:

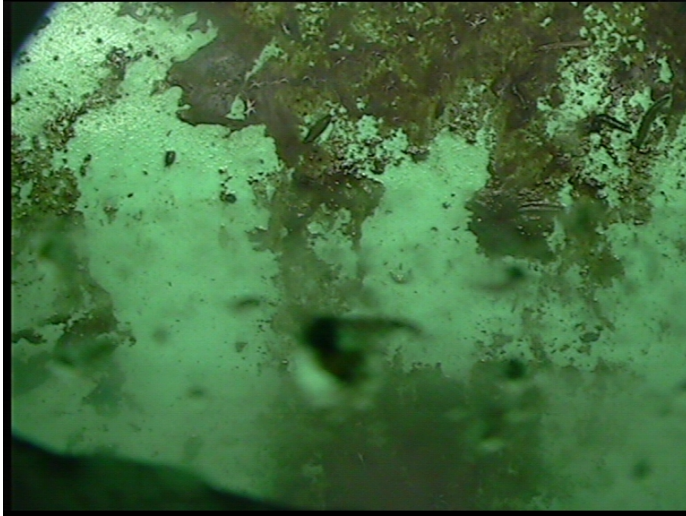
Code: **MWL**
Description: **Water Level**

Distance (ft): **47.2**
Structural Grade: **0**
O&M Grade: **0**
Clock Start/From:
Clock To:
1st Value:
2nd Value:
Value Percent: **70.000**
Continuous Index:
Within 8" of Joint: **NO**
Remarks:

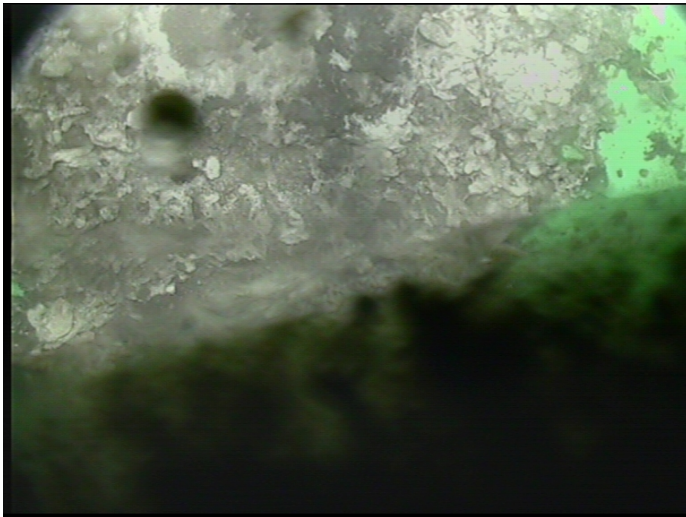
Code: **DSF**
Description: **Deposits Settled Fine**

Distance (ft): **60.4**
Structural Grade: **0**
O&M Grade: **3**
Clock Start/From: **4**
Clock To: **8**
1st Value:
2nd Value:
Value Percent: **20.000**
Continuous Index:
Within 8" of Joint: **NO**
Remarks:

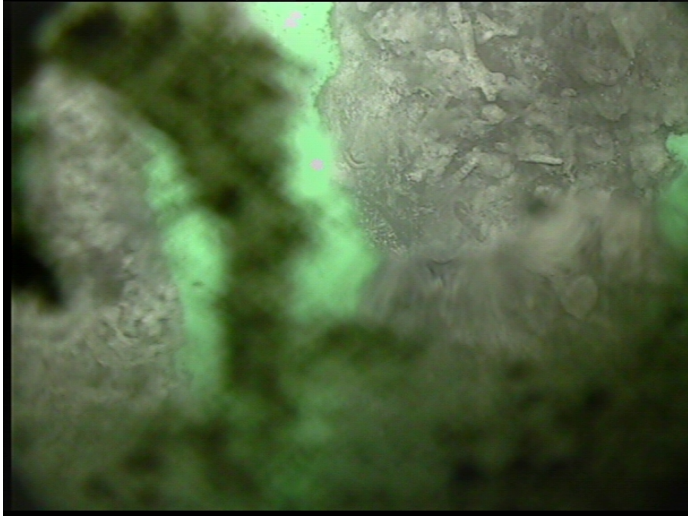
Code:	MSA
Description:	Abandoned Survey
Distance (ft):	61.9
Structural Grade:	0
O&M Grade:	0
Clock Start/From:	
Clock To:	
1st Value:	
2nd Value:	
Value Percent:	
Continuous Index:	
Within 8" of Joint:	NO
Remarks:	sediment
