## Profile/Photo Observation Report

Date:	<b>10/16/2021</b>	Weather:		Coding:	<b>PACP 6.0</b>
Pipe Length (ft):		Owner:	<b>Hobart, IN</b>	Pre Clean:	<b>Not Known</b>
P.O.#:	<b>818_1</b>	Surveyor:	<b>M. Pielacha</b>	PSR:	<b>P-103-112-113</b>
Customer:	<b>Hobart, IN</b>	Clean Date:		Shape:	<b>C</b>

Street:	<b>Swift Street</b>	Flow Control:	
City:	<b>Hobart, IN</b>	Year Renewed:	
Location:	<b>Light Highway</b>	Tape/Media #:	<b>818</b>
Purpose:	<b>Routine Assessment</b>	Dia/Height:	<b>8"</b>
Use:	<b>Sanitary</b>	Material:	<b>PVC</b>
Drain Area:		Lining:	
Category:	<b>NA</b>		
Comment:

Location Details:		Direction of Survey:	<b>Upstream</b>
US MH:	<b>M-103-113</b>	DS MH:	<b>M-103-112</b>
		Total Length Surveyed (ft):	<b>297.4</b>

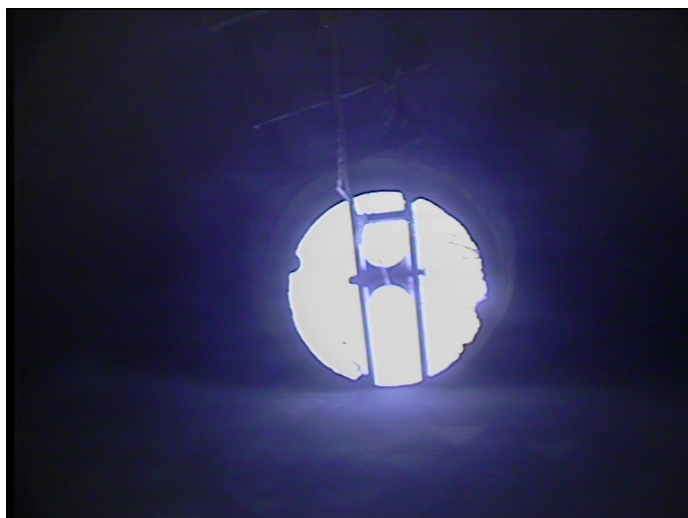
Code: **AMH**  
Description: **Manhole**

Distance (ft): **.0**  
Structural Grade: **0**  
O&M Grade: **0**  
Clock Start/From:  
Clock To:  
1st Value:  
2nd Value:  
Value Percent:  
Continuous Index:  
Within 8" of Joint: **NO**  
Remarks: **M-103-112**

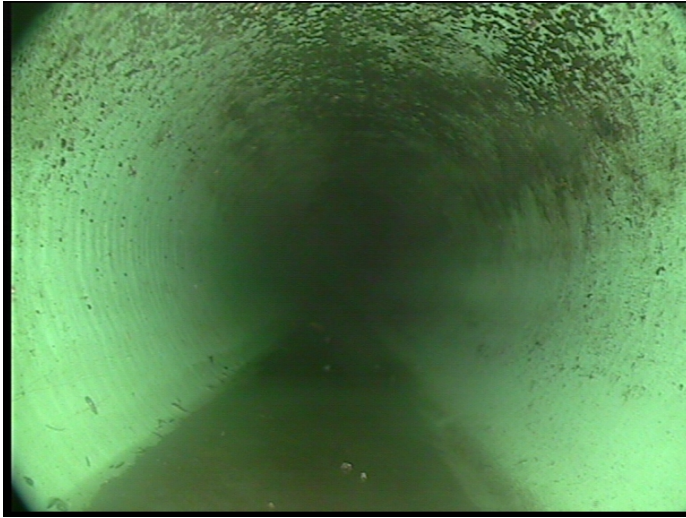
Code:	<b>MWL</b>
Description:	<b>Water Level</b>
Distance (ft):	<b>.0</b>
Structural Grade:	<b>0</b>
O&M Grade:	<b>0</b>
Clock Start/From:	
Clock To:	
1st Value:	
2nd Value:	
Value Percent:	<b>5.000</b>
Continuous Index:	
Within 8" of Joint:	<b>NO</b>
Remarks:

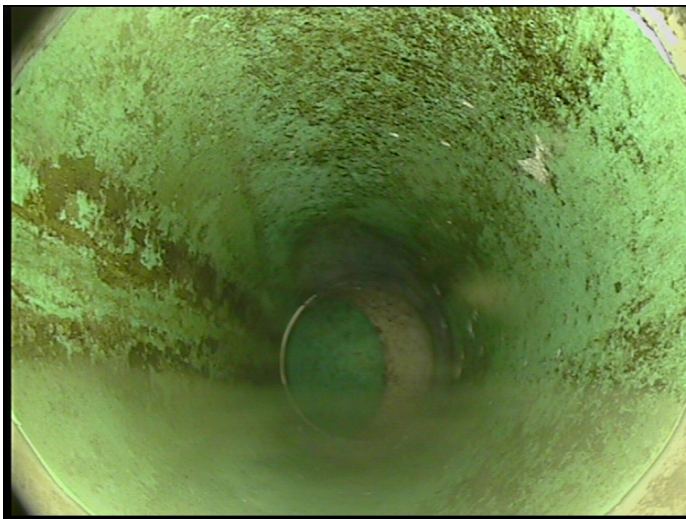
Code:	<b>TF</b>
Description:	<b>Tap Factory</b>
Distance (ft):	<b>74.6</b>
Structural Grade:	<b>0</b>
O&M Grade:	<b>0</b>
Clock Start/From:	<b>10</b>
Clock To:	
1st Value:	<b>4.000</b>
2nd Value:	
Value Percent:	
Continuous Index:	
Within 8" of Joint:	<b>NO</b>
Remarks:

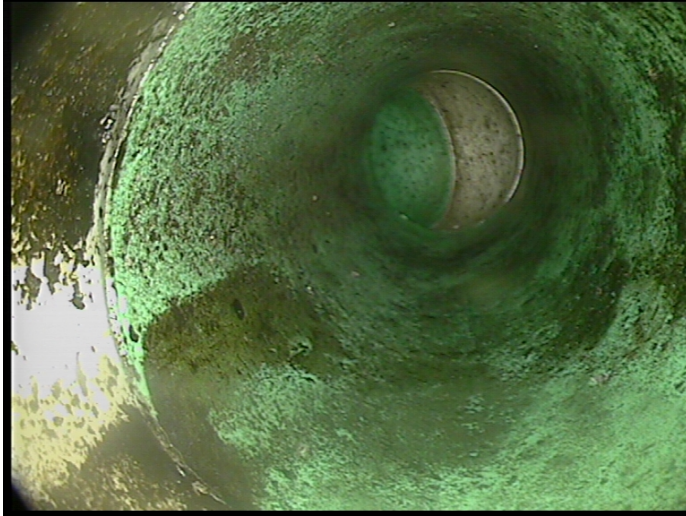
Code: **TF**  
Description: **Tap Factory**

Distance (ft): **186.1**  
Structural Grade: **0**  
O&M Grade: **0**  
Clock Start/From: **10**  
Clock To:  
1st Value: **4.000**  
2nd Value:  
Value Percent:  
Continuous Index:  
Within 8" of Joint: **NO**  
Remarks:

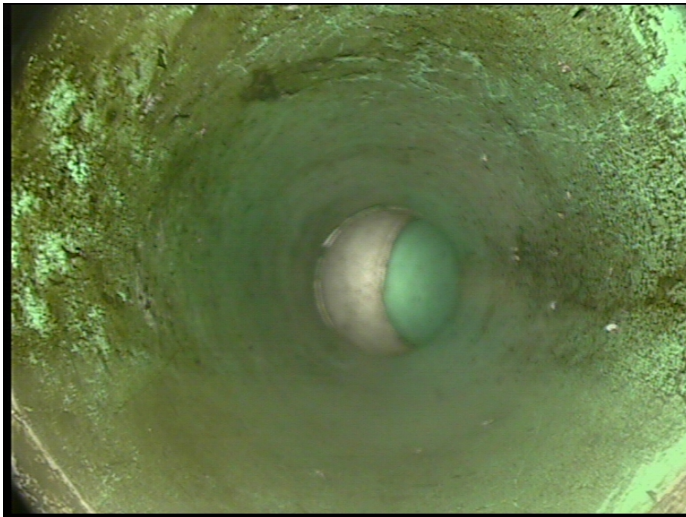
Code: **TF**  
Description: **Tap Factory**

Distance (ft): **211.4**  
Structural Grade: **0**  
O&M Grade: **0**  
Clock Start/From: **2**  
Clock To:  
1st Value: **4.000**  
2nd Value:  
Value Percent:  
Continuous Index:  
Within 8" of Joint: **NO**  
Remarks:

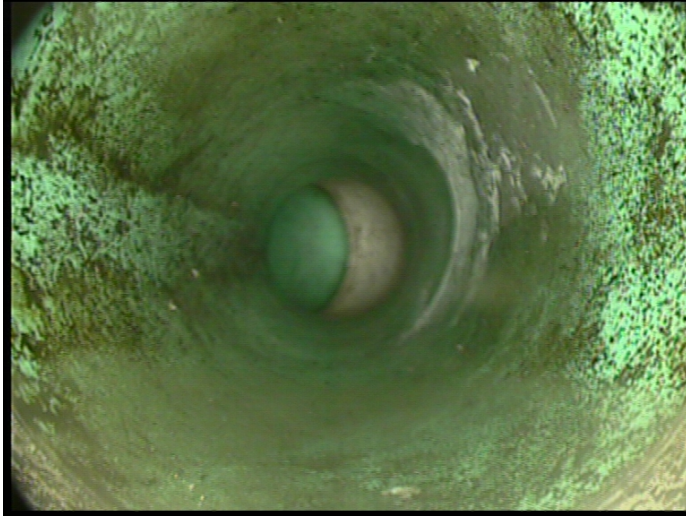
Code: **TF**  
Description: **Tap Factory**

Distance (ft): **249.3**  
Structural Grade: **0**  
O&M Grade: **0**  
Clock Start/From: **10**  
Clock To:  
1st Value: **4.000**  
2nd Value:  
Value Percent:  
Continuous Index:  
Within 8" of Joint: **NO**  
Remarks:

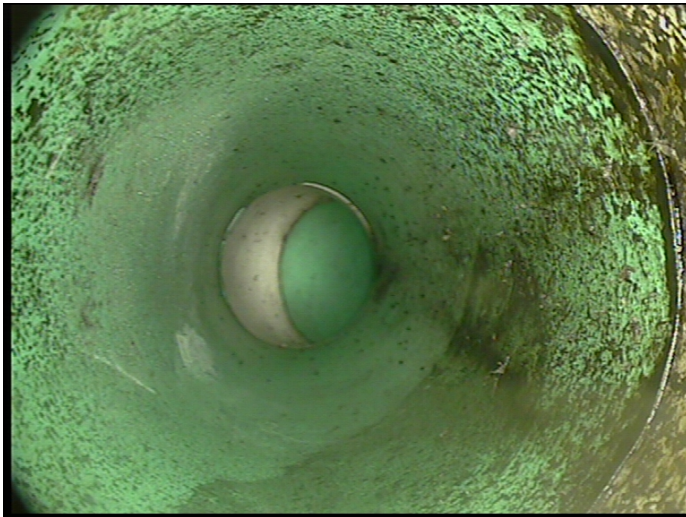
Code: **TF**  
Description: **Tap Factory**

Distance (ft): **274.6**  
Structural Grade: **0**  
O&M Grade: **0**  
Clock Start/From: **2**  
Clock To:  
1st Value: **4.000**  
2nd Value:  
Value Percent:  
Continuous Index:  
Within 8" of Joint: **NO**  
Remarks:

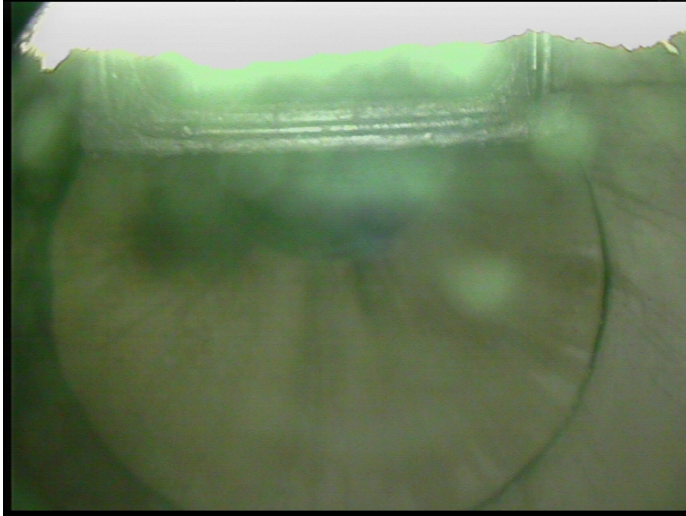
Code:	<b>AMH</b>
Description:	<b>Manhole</b>
Distance (ft):	<b>297.4</b>
Structural Grade:	<b>0</b>
O&M Grade:	<b>0</b>
Clock Start/From:	
Clock To:	
1st Value:	
2nd Value:	
Value Percent:	
Continuous Index:	
Within 8" of Joint:	<b>NO</b>
Remarks:	<b>M-103-113</b>
