Profile/Photo Observation Report

Street:	West 39th Avenue	Flow Control:	
City:	Hobart, IN	Year Renewed:	
Location:	Light Highway	Tape/Media #:	817
Purpose:	Routine Assessment	Dia/Height:	8"
Use:	Sanitary	Material:	PVC
Drain Area:		Lining:	
Category:	NA		
Comment:

Location Details:		Direction of Survey:	Upstream
US MH:	M-103-113	DS MH:	M-103-114
		Total Length Surveyed (ft):	52.5

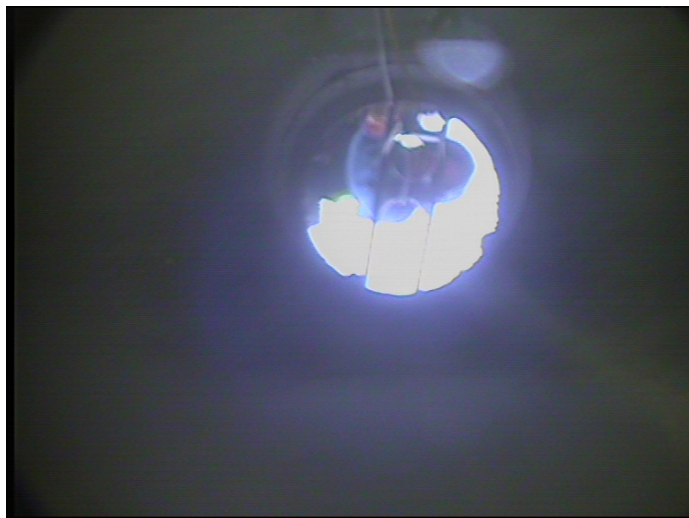
Code: **AMH**
Description: **Manhole**

Distance (ft): **.0**
Structural Grade: **0**
O&M Grade: **0**
Clock Start/From:
Clock To:
1st Value:
2nd Value:
Value Percent:
Continuous Index:
Within 8" of Joint: **NO**
Remarks: **M-103-114**

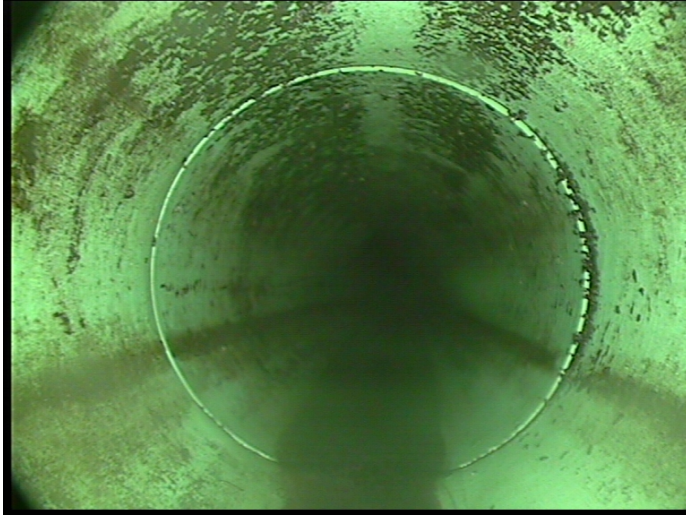
Code: **MWL**
Description: **Water Level**

Distance (ft): **.0**
Structural Grade: **0**
O&M Grade: **0**
Clock Start/From:
Clock To:
1st Value:
2nd Value:
Value Percent: **5.000**
Continuous Index:
Within 8" of Joint: **NO**
Remarks:

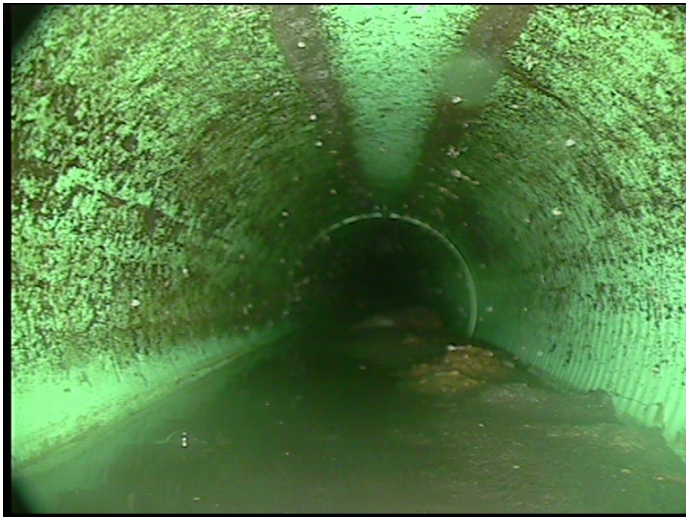
Code: **DSF**
Description: **Deposits Settled Fine**

Distance (ft): **38.2**
Structural Grade: **0**
O&M Grade: **3**
Clock Start/From: **4**
Clock To: **8**
1st Value:
2nd Value:
Value Percent: **15.000**
Continuous Index: **S01**
Within 8" of Joint: **YES**
Remarks:

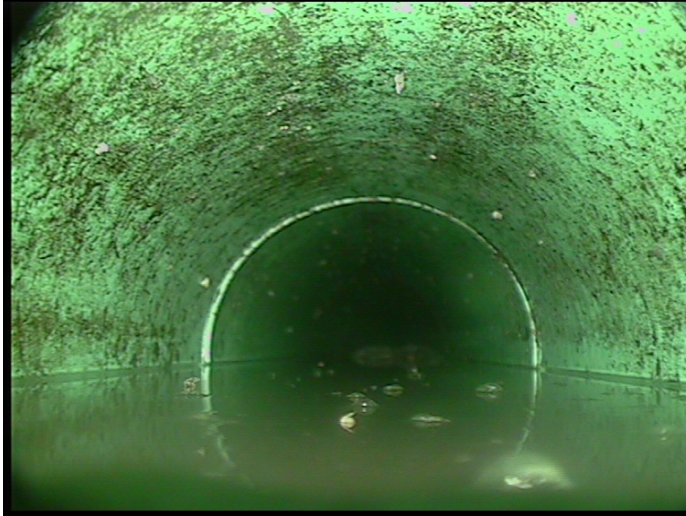
Code: **DSF**
Description: **Deposits Settled Fine**

Distance (ft): **52.1**
Structural Grade: **0**
O&M Grade: **4**
Clock Start/From: **4**
Clock To: **8**
1st Value:
2nd Value:
Value Percent: **25.000**
Continuous Index: **F01**
Within 8" of Joint: **NO**
Remarks:

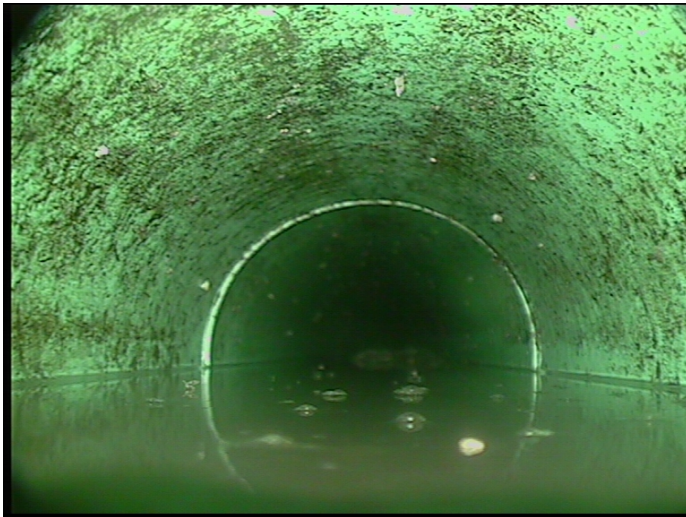
Code: **MSA**
Description: **Abandoned Survey**

Distance (ft): **52.1**
Structural Grade: **0**
O&M Grade: **0**
Clock Start/From:
Clock To:
1st Value:
2nd Value:
Value Percent:
Continuous Index:
Within 8" of Joint: **NO**
Remarks: **deeps sediment**
