## Profile/Photo Observation Report

Street:	<b>MAPLE ST</b>	Flow Control:	<b>Not Controlled</b>
City:	<b>Hobart, IN</b>	Year Renewed:	
Location:	<b>Other</b>	Tape/Media #:	
Purpose:	<b>Not Known</b>	Dia/Height:	<b>8"</b>
Use:	<b>Sanitary</b>	Material:	<b>PVC</b>
Drain Area:	<b>NA</b>	Lining:	
Category:	<b>NA</b>		
Comment:

Location Details:		Direction of Survey:	<b>Upstream</b>
US MH:	<b>M-103-115</b>	DS MH:	<b>M-103-105</b>
		Total Length Surveyed (ft):	<b>45.6</b>

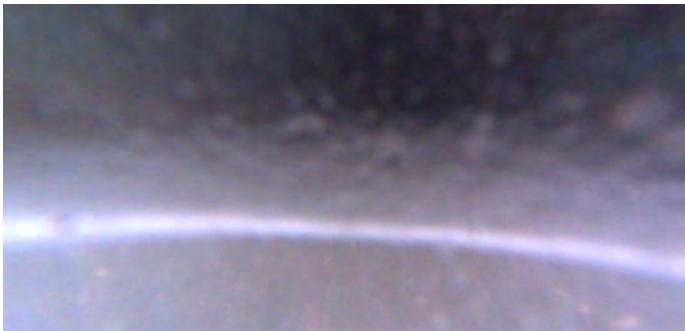
Code: **AMH**  
Description: **Manhole**

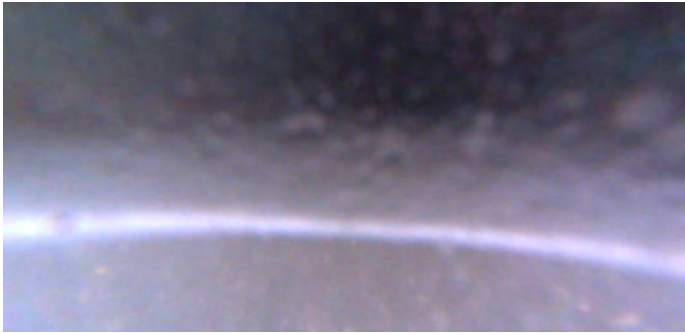
Code:	<b>MWL</b>
Description:	<b>Water Level</b>

Distance (ft):	<b>.0</b>
Structural Grade:	<b>0</b>
O&M Grade:	<b>0</b>
Clock Start/From:	
Clock To:	
1st Value:	
2nd Value:	
Value Percent:	<b>5.000</b>
Continuous Index:	
Within 8" of Joint:	<b>NO</b>
Remarks:

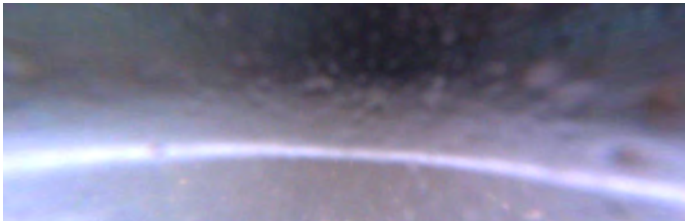
Code:	<b>MWLS</b>
Description:	<b>Water Level Sag</b>

Distance (ft):	<b>.0</b>
Structural Grade:	<b>2</b>
O&M Grade:	<b>3</b>
Clock Start/From:	
Clock To:	
1st Value:	
2nd Value:	
Value Percent:	<b>5.000</b>
Continuous Index:	<b>S01</b>
Within 8" of Joint:	<b>NO</b>
Remarks:

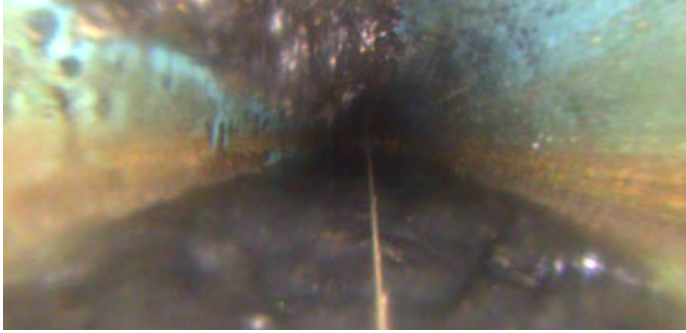
Code: **DAZ**  
Description: **Deposits Attached Other**

Distance (ft): **2.8**  
Structural Grade: **0**  
O&M Grade: **2**  
Clock Start/From: **8**  
Clock To: **4**  
1st Value:  
2nd Value:  
Value Percent: **10.000**  
Continuous Index: **S02**  
Within 8" of Joint: **NO**  
Remarks:

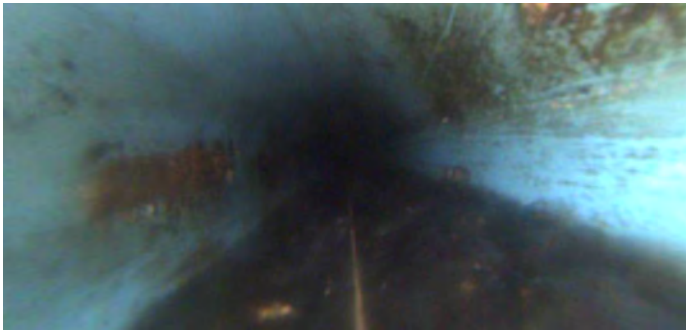
Code: **DAZ**  
Description: **Deposits Attached Other**

Distance (ft): **42.8**  
Structural Grade: **0**  
O&M Grade: **2**  
Clock Start/From: **8**  
Clock To: **4**  
1st Value:  
2nd Value:  
Value Percent: **10.000**  
Continuous Index: **F02**  
Within 8" of Joint: **NO**  
Remarks:
