## Profile/Photo Observation Report

Street:	<b>E 38th Ave</b>	Flow Control:	<b>Not Controlled</b>
City:	<b>Hobart, IN</b>	Year Renewed:	
Location:	<b>Other</b>	Tape/Media #:	
Purpose:	<b>Not Known</b>	Dia/Height:	<b>8"</b>
Use:	<b>Sanitary</b>	Material:	<b>PVC</b>
Drain Area:	<b>NA</b>	Lining:	
Category:	<b>NA</b>		
Comment:

Location Details:		Direction of Survey:	<b>Upstream</b>
US MH:	<b>M-103-115</b>	DS MH:	<b>M-103-105</b>
		Total Length Surveyed (ft):	<b>45.6</b>

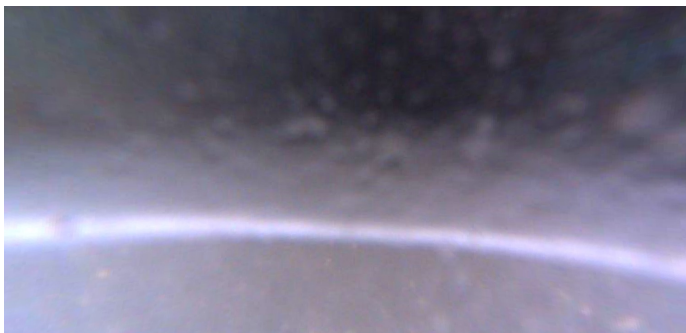
Code: **AMH**  
Description: **Manhole**

Distance (ft): **.0**  
Structural Grade: **0**  
O&M Grade: **0**  
Clock Start/From:  
Clock To:  
1st Value:  
2nd Value:  
Value Percent:  
Continuous Index:  
Within 8" of Joint: **NO**  
Remarks: **M-103-105**

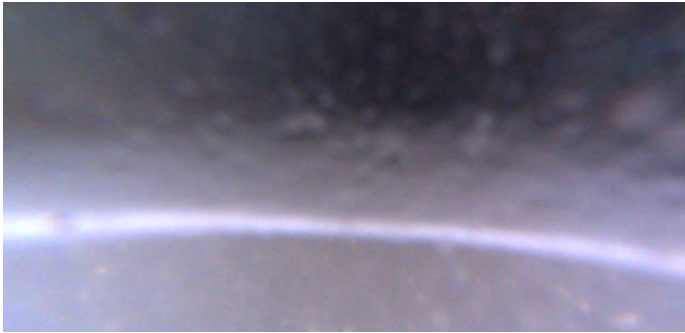
Code:	<b>MWL</b>
Description:	<b>Water Level</b>

Distance (ft):	<b>.0</b>
Structural Grade:	<b>0</b>
O&M Grade:	<b>0</b>
Clock Start/From:	
Clock To:	
1st Value:	
2nd Value:	
Value Percent:	<b>5.000</b>
Continuous Index:	
Within 8" of Joint:	<b>NO</b>
Remarks:

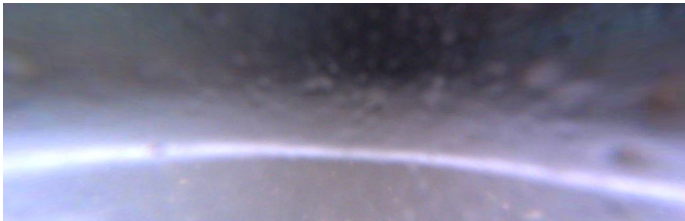
Code:	<b>MWLS</b>
Description:	<b>Water Level Sag</b>

Distance (ft):	<b>.0</b>
Structural Grade:	<b>2</b>
O&M Grade:	<b>3</b>
Clock Start/From:	
Clock To:	
1st Value:	
2nd Value:	
Value Percent:	<b>5.000</b>
Continuous Index:	<b>S01</b>
Within 8" of Joint:	<b>NO</b>
Remarks:

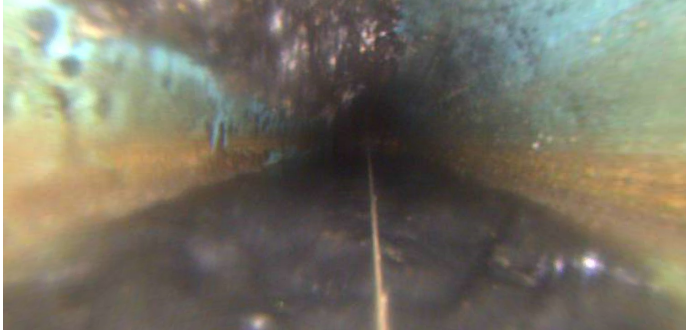
Code: **DAZ**  
Description: **Deposits Attached Other**

Distance (ft): **2.8**  
Structural Grade: **0**  
O&M Grade: **2**  
Clock Start/From: **8**  
Clock To: **4**  
1st Value:  
2nd Value:  
Value Percent: **10.000**  
Continuous Index: **S02**  
Within 8" of Joint: **NO**  
Remarks:

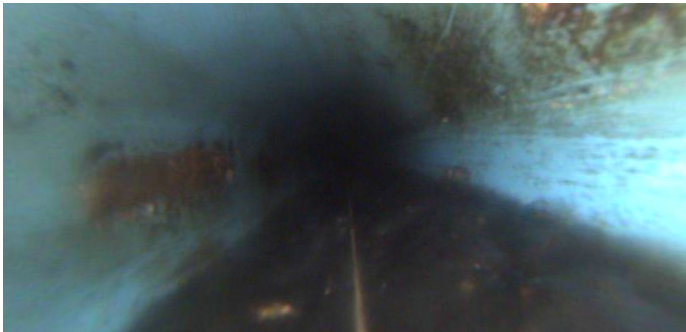
Code: **DAZ**  
Description: **Deposits Attached Other**

Distance (ft): **42.8**  
Structural Grade: **0**  
O&M Grade: **2**  
Clock Start/From: **8**  
Clock To: **4**  
1st Value:  
2nd Value:  
Value Percent: **10.000**  
Continuous Index: **F02**  
Within 8" of Joint: **NO**  
Remarks:

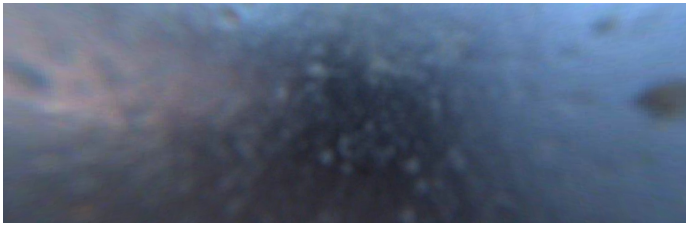
Code: **MWLS**  
Description: **Water Level Sag**

Distance (ft): **45.6**  
Structural Grade: **2**  
O&M Grade: **3**  
Clock Start/From:  
Clock To:  
1st Value:  
2nd Value:  
Value Percent: **5.000**  
Continuous Index: **F01**  
Within 8" of Joint: **NO**  
Remarks:

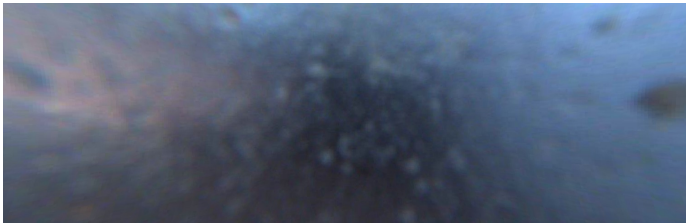
Code: **MSA**  
Description: **Abandoned Survey**

Distance (ft): **45.6**  
Structural Grade: **0**  
O&M Grade: **0**  
Clock Start/From:  
Clock To:  
1st Value:  
2nd Value:  
Value Percent:  
Continuous Index:  
Within 8" of Joint: **NO**  
Remarks: **camera underwater**
