Profile/Ph	oto Observatio	n Report				RedZone
Date:	03/22/2018	Weather:	NA		0	PACP 6.0
Pipe Length (ft P.O.#:	): <b>64.2</b>	Owner:	NA Selasie Honu	Pre		Not Known 2-103-119-118
Customer:		Surveyor: Clean Date:		-	аре: <b>С</b>	
Street:	W 38TH AVE & MISSOURI		Flow Control:	Not	Controlled	
City:	Hobart, IN		Year Renewed			
Location:	Other		Tape/Media #:			
Purpose:	Not Known		Dia/Height:	8"		
Use:	Sanitary		Material:	PVC		
Drain Area:	NA		Lining:			
Category:	NA					
Comment:						
Location Detail	ls:		Direction of Su	rvey: Dov	wnstream	
US MH:	M-103-118	DS MH:	M-103-119	Total Length S	urveyed (ft):	66.5
0&M Index:	0.00	O&M Quick:	00	000 O&M I	Rating:	0.00
itructural Index:	0.00	Structural Q			ural Rating:	0.00
Overall Index:	0.00	Overall Quic	k: 00	000 Overal	Il Rating:	0.00

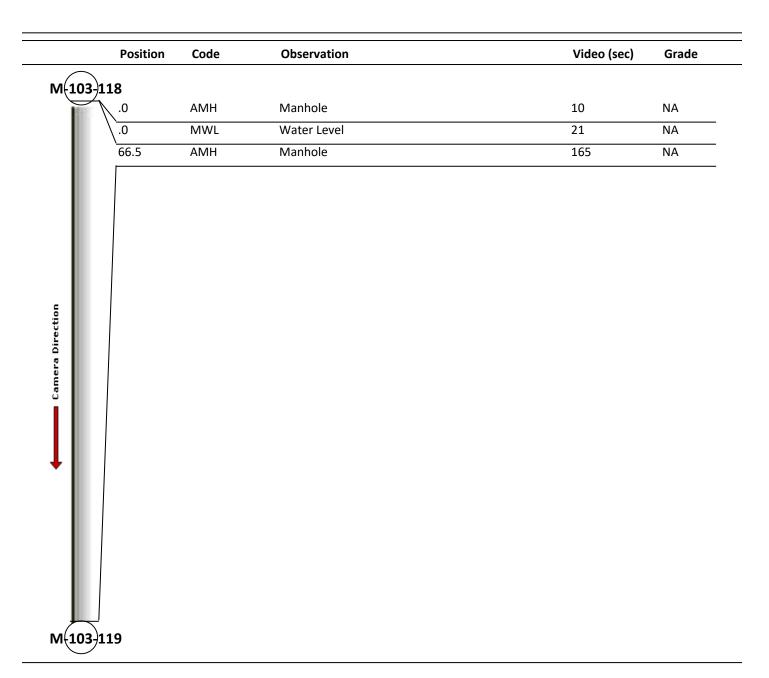
Code: Description:	AMH Manhole
Distance (ft):	.0
Structural Grade:	0
O&M Grade:	0
Clock Start/From:	
Clock To:	
1st Value:	
2nd Value:	
Value Percent:	
Continuous Index:	
Within 8" of Joint:	NO
Remarks:	M-103-118
