Profile/Photo Observation Report

Street:	E 38th Ave	Flow Control:	Not Controlled
City:	Hobart, IN	Year Renewed:	
Location:	Other	Tape/Media #:	
Purpose:	Not Known	Dia/Height:	8"
Use:	Sanitary	Material:	PVC
Drain Area:	NA	Lining:	
Category:	NA		
Comment:

Location Details:		Direction of Survey:	Downstream
US MH:	M-103-118	DS MH:	M-103-119
		Total Length Surveyed (ft):	66.5

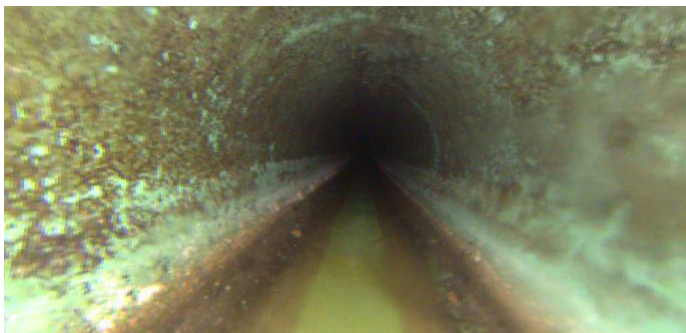
Code: **AMH**
Description: **Manhole**

Distance (ft): **.0**
Structural Grade: **0**
O&M Grade: **0**
Clock Start/From:
Clock To:
1st Value:
2nd Value:
Value Percent:
Continuous Index:
Within 8" of Joint: **NO**
Remarks: **M-103-118**

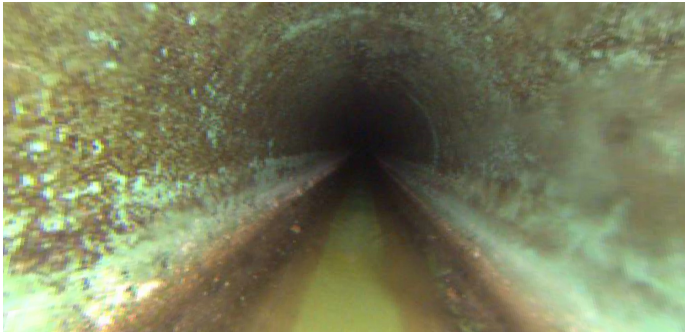
Code:	MWL
Description:	Water Level

Distance (ft):	.0
Structural Grade:	0
O&M Grade:	0
Clock Start/From:	
Clock To:	
1st Value:	
2nd Value:	
Value Percent:	5.000
Continuous Index:	
Within 8" of Joint:	NO
Remarks:

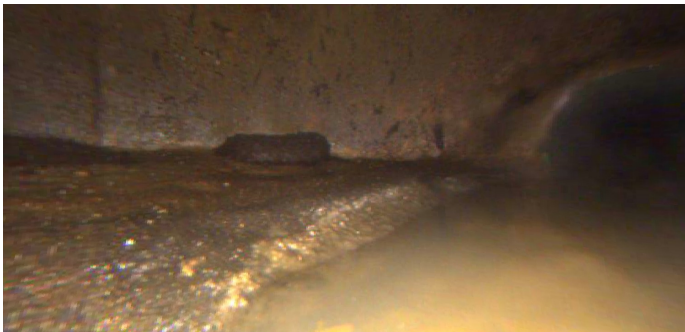
Code:	AMH
Description:	Manhole

Distance (ft):	66.5
Structural Grade:	0
O&M Grade:	0
Clock Start/From:	
Clock To:	
1st Value:	
2nd Value:	
Value Percent:	
Continuous Index:	
Within 8" of Joint:	NO
Remarks:	M-103-119
