Profile/Photo Observation Report

Street:	EASTIN AVE	Flow Control:	Not Controlled
City:	Hobart, IN	Year Renewed:	
Location:	Other	Tape/Media #:	
Purpose:	Not Known	Dia/Height:	8"
Use:	Sanitary	Material:	PVC
Drain Area:	NA	Lining:	
Category:	NA		
Comment:

Location Details:		Direction of Survey:	Downstream
US MH:	M-1004-015	DS MH:	M-1004-097
		Total Length Surveyed (ft):	143.5

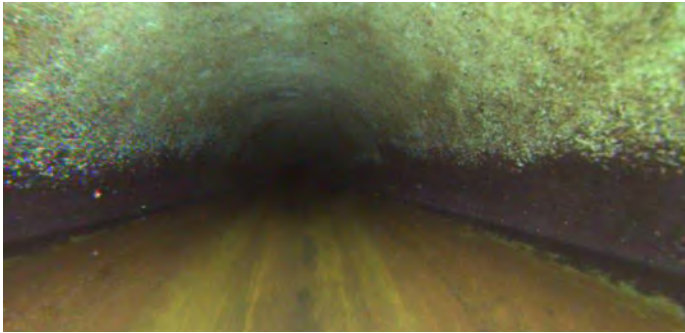
Code:	MWL
Description:	Water Level

Distance (ft):	.0
Structural Grade:	0
O&M Grade:	0
Clock Start/From:	
Clock To:	
1st Value:	
2nd Value:	
Value Percent:	10.000
Continuous Index:	
Within 8" of Joint:	NO
Remarks:

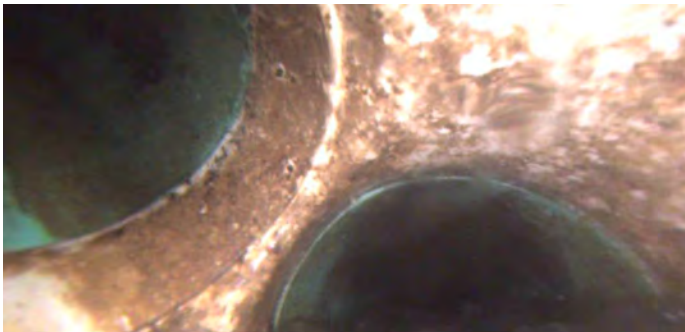
Code:	TF
Description:	Tap Factory

Distance (ft):	120.6
Structural Grade:	0
O&M Grade:	0
Clock Start/From:	2
Clock To:	
1st Value:	4.000
2nd Value:	
Value Percent:	
Continuous Index:	
Within 8" of Joint:	
Remarks:

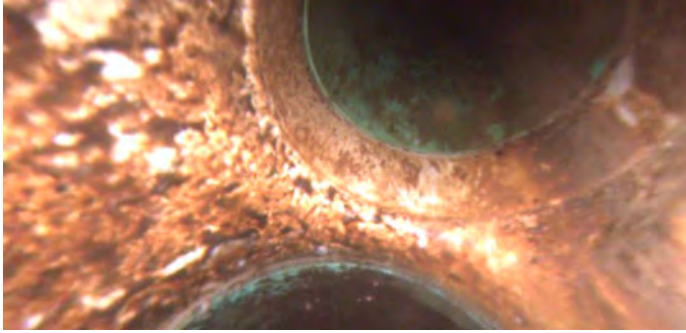
Code: **TF**
Description: **Tap Factory**

Distance (ft): **136.9**
Structural Grade: **0**
O&M Grade: **0**
Clock Start/From: **11**
Clock To:
1st Value: **4.000**
2nd Value:
Value Percent:
Continuous Index:
Within 8" of Joint:
Remarks: **Photo taken from rear camera.**

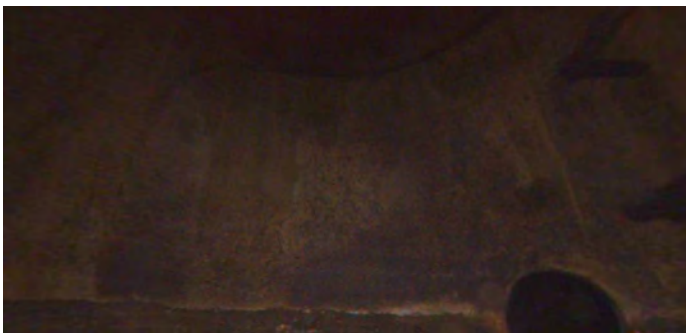
Code: **AMH**
Description: **Manhole**

Distance (ft): **143.5**
Structural Grade: **0**
O&M Grade: **0**
Clock Start/From:
Clock To:
1st Value:
2nd Value:
Value Percent:
Continuous Index:
Within 8" of Joint: **NO**
Remarks: **M-1004-097**
