Profile/Photo Observation Report

Date:	03/23/2018	Weather:		Coding:	PACP 6.0
Pipe Length (ft):	219.8	Owner:	NA	Pre Clean:	Not Known
P.O.#:		Surveyor:	Justin Gonzales	PSR:	P-103-121-120
Customer:		Clean Date:	01/01/1900	Shape:	C

Street:	E 38th Ave	Flow Control:	Not Controlled
City:	Hobart, IN	Year Renewed:	
Location:	Other	Tape/Media #:	
Purpose:	Not Known	Dia/Height:	8"
Use:	Sanitary	Material:	PVC
Drain Area:	NA	Lining:	
Category:	NA		
Comment:	possibly buried or paved over

Location Details:		Direction of Survey:	Downstream
US MH:	M-103-120	DS MH:	M-103-121
		Total Length Surveyed (ft):	217.4

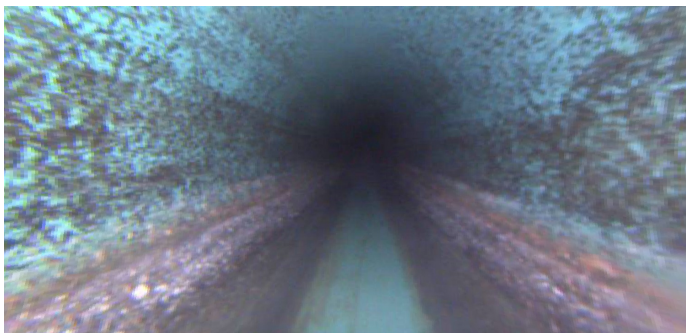
Code: **AMH**
Description: **Manhole**

Distance (ft): **.0**
Structural Grade: **0**
O&M Grade: **0**
Clock Start/From:
Clock To:
1st Value:
2nd Value:
Value Percent:
Continuous Index:
Within 8" of Joint: **NO**
Remarks: **M-103-120**

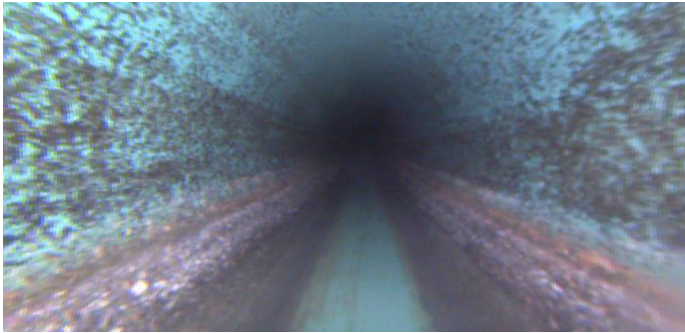
Code:	MWL
Description:	Water Level

Distance (ft):	.0
Structural Grade:	0
O&M Grade:	0
Clock Start/From:	
Clock To:	
1st Value:	
2nd Value:	
Value Percent:	5.000
Continuous Index:	
Within 8" of Joint:	NO
Remarks:

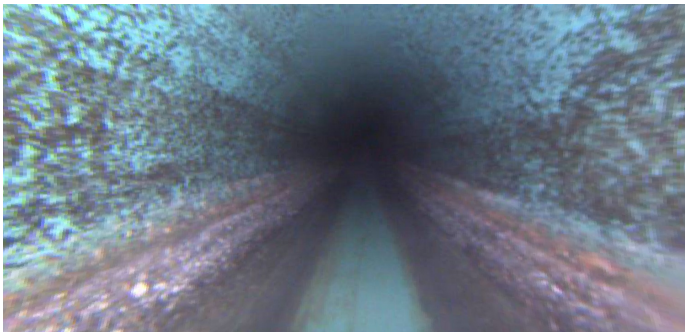
Code:	DAZ
Description:	Deposits Attached Other

Distance (ft):	.0
Structural Grade:	0
O&M Grade:	2
Clock Start/From:	7
Clock To:	5
1st Value:	
2nd Value:	
Value Percent:	5.000
Continuous Index:	S01
Within 8" of Joint:	YES
Remarks:	WANDER

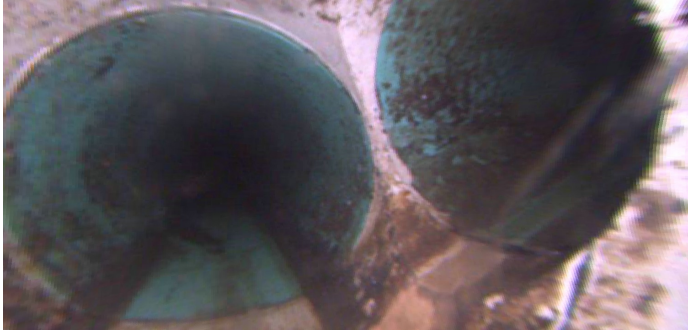
Code: **TF**
Description: **Tap Factory**

Distance (ft): **48.5**
Structural Grade: **0**
O&M Grade: **0**
Clock Start/From: **2**
Clock To:
1st Value: **4.000**
2nd Value:
Value Percent:
Continuous Index:
Within 8" of Joint:
Remarks:

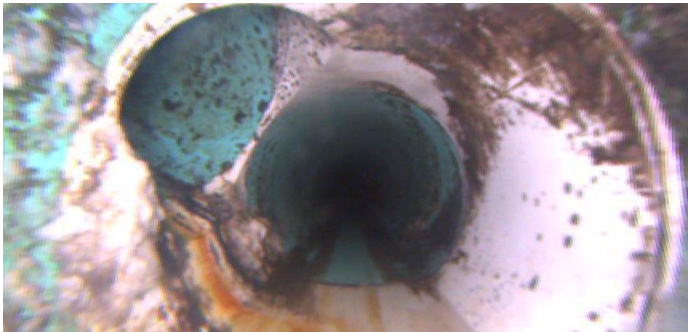
Code: **TF**
Description: **Tap Factory**

Distance (ft): **105.9**
Structural Grade: **0**
O&M Grade: **0**
Clock Start/From: **10**
Clock To:
1st Value: **4.000**
2nd Value:
Value Percent:
Continuous Index:
Within 8" of Joint:
Remarks:

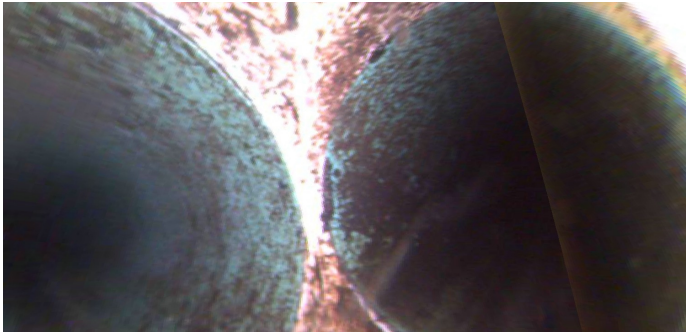
Code: **TF**
Description: **Tap Factory**

Distance (ft): **111.7**
Structural Grade: **0**
O&M Grade: **0**
Clock Start/From: **2**
Clock To:
1st Value: **4.000**
2nd Value:
Value Percent:
Continuous Index:
Within 8" of Joint:
Remarks:

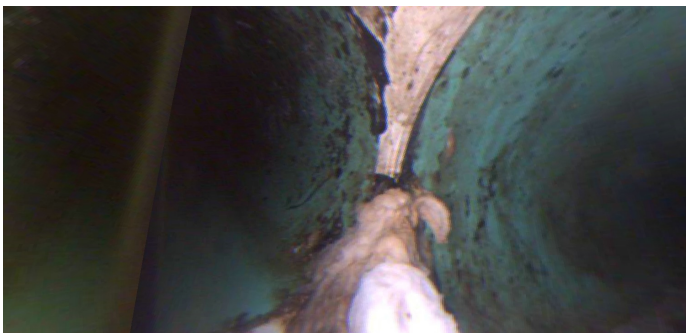
Code: **TF**
Description: **Tap Factory**

Distance (ft): **122.3**
Structural Grade: **0**
O&M Grade: **0**
Clock Start/From: **10**
Clock To:
1st Value: **4.000**
2nd Value:
Value Percent:
Continuous Index:
Within 8" of Joint:
Remarks:

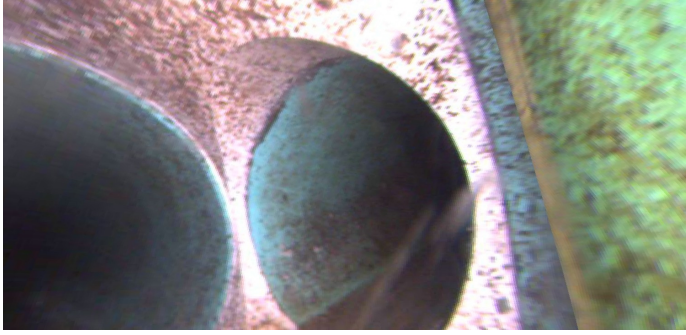
Code: **TF**
Description: **Tap Factory**

Distance (ft): **129.5**
Structural Grade: **0**
O&M Grade: **0**
Clock Start/From: **2**
Clock To:
1st Value: **4.000**
2nd Value:
Value Percent:
Continuous Index:
Within 8" of Joint:
Remarks:

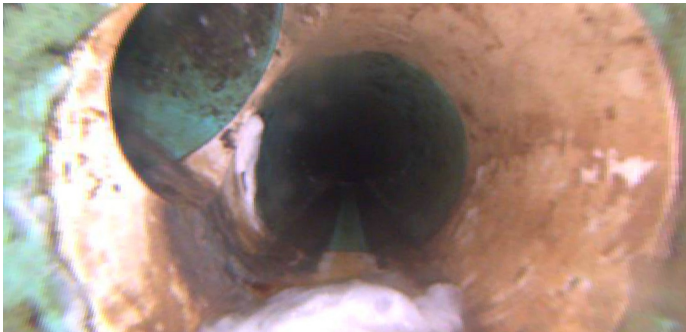
Code: **TF**
Description: **Tap Factory**

Distance (ft): **146.9**
Structural Grade: **0**
O&M Grade: **0**
Clock Start/From: **10**
Clock To:
1st Value: **4.000**
2nd Value:
Value Percent:
Continuous Index:
Within 8" of Joint:
Remarks:

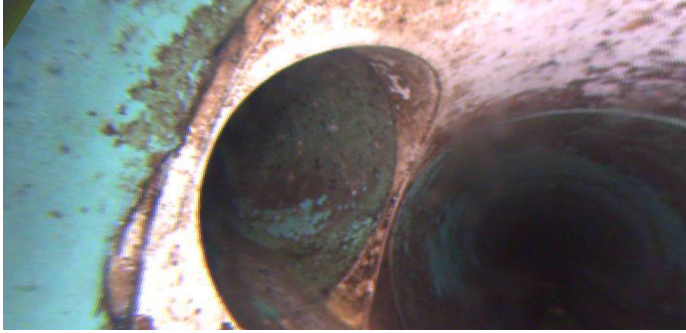
Code: **TF**
Description: **Tap Factory**

Distance (ft): **183.9**
Structural Grade: **0**
O&M Grade: **0**
Clock Start/From: **10**
Clock To:
1st Value: **4.000**
2nd Value:
Value Percent:
Continuous Index:
Within 8" of Joint:
Remarks:

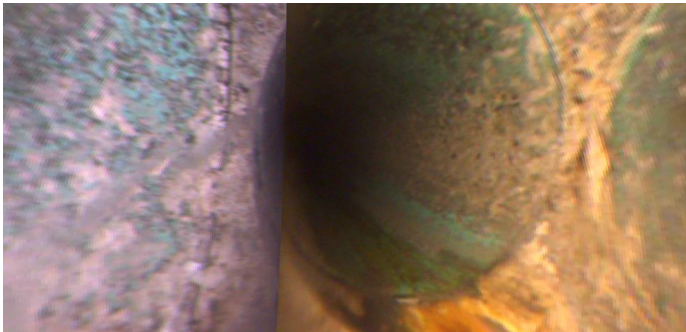
Code: **TF**
Description: **Tap Factory**

Distance (ft): **199.3**
Structural Grade: **0**
O&M Grade: **0**
Clock Start/From: **2**
Clock To:
1st Value: **4.000**
2nd Value:
Value Percent:
Continuous Index:
Within 8" of Joint:
Remarks:

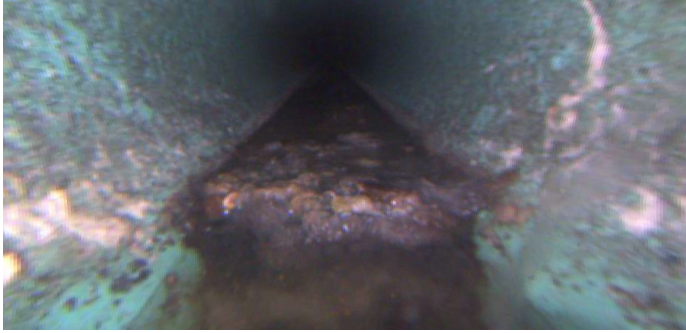
Code: **DSC**
Description: **Deposits Settled Compacted**

Distance (ft): **199.7**
Structural Grade: **0**
O&M Grade: **2**
Clock Start/From: **6**
Clock To:
1st Value:
2nd Value:
Value Percent: **5.000**
Continuous Index:
Within 8" of Joint: **NO**
Remarks:

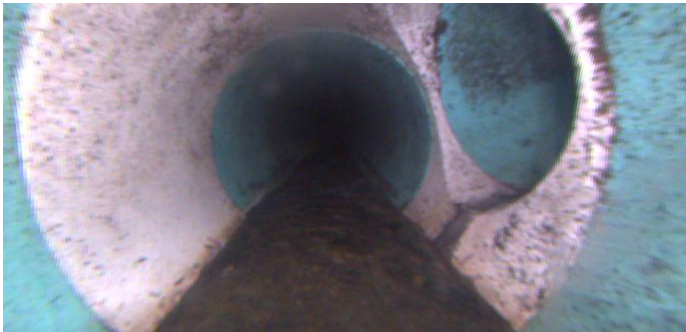
Code: **TF**
Description: **Tap Factory**

Distance (ft): **207.0**
Structural Grade: **0**
O&M Grade: **0**
Clock Start/From: **3**
Clock To:
1st Value: **4.000**
2nd Value:
Value Percent:
Continuous Index:
Within 8" of Joint:
Remarks:

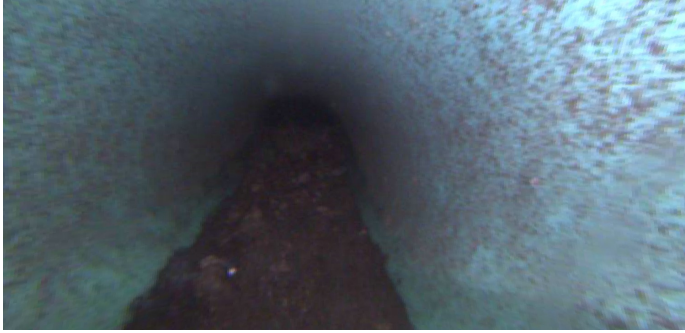
Code: **DSC**
Description: **Deposits Settled Compacted**

Distance (ft): **215.8**
Structural Grade: **0**
O&M Grade: **2**
Clock Start/From: **5**
Clock To: **7**
1st Value:
2nd Value:
Value Percent: **10.000**
Continuous Index:
Within 8" of Joint: **NO**
Remarks:

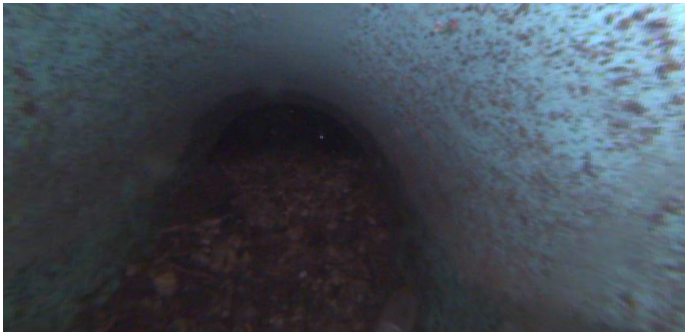
Code: **MSA**
Description: **Abandoned Survey**

Distance (ft): **217.4**
Structural Grade: **0**
O&M Grade: **0**
Clock Start/From:
Clock To:
1st Value:
2nd Value:
Value Percent:
Continuous Index:
Within 8" of Joint: **NO**
Remarks: **CANNOT PASS DSC**

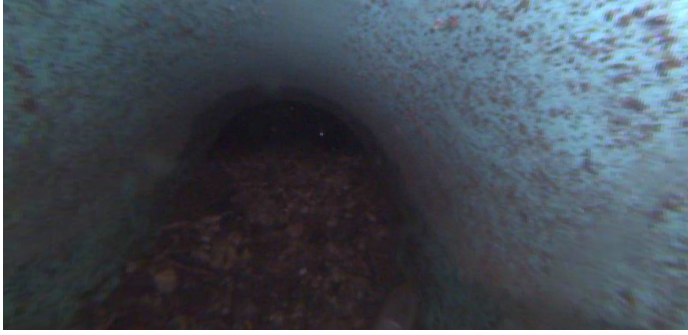
Code:	DAZ
Description:	Deposits Attached Other
Distance (ft):	217.4
Structural Grade:	0
O&M Grade:	2
Clock Start/From:	7
Clock To:	5
1st Value:	
2nd Value:	
Value Percent:	5.000
Continuous Index:	F01
Within 8" of Joint:	YES
Remarks:	WANDER
