_			
Date:	03/22/2018	Weather:		Coding:	PACP 6.0
Pipe Length (ft)	: <b>158.4</b>	Owner:	NA	Pre Clean:	Not Known
P.O.#:		Surveyor:	Selasie Honu	PSR:	P-103-122-116
Customer:		Clean Date:	01/01/1900	Shape:	С
Street:	E 38th Ave		Flow Control:	Not Controlled	
City:	Hobart, IN		Year Renewed:		
Location:	Other		Tape/Media #:		
Purpose:	Not Known		Dia/Height:	8"	
Use:	Sanitary		Material:	PVC	
Drain Area:	NA		Lining:		
Category:	NA				
Comment:	CNL, buried possibly	,			
Location Details	s:		Direction of Surve	y: Downstream	
US MH:	M-103-122	DS MH:	M-103-116	Total Length Surveyed (ft)	: <b>152.9</b>
D&M Index:	0.00	O&M Quick:	0000	O&M Rating:	0.00
Structural Index:	0.00	 Structural Qu	uick: 0000	Structural Rating:	0.00
Overall Index:	0.00	Overall Quick		Overall Rating:	0.00

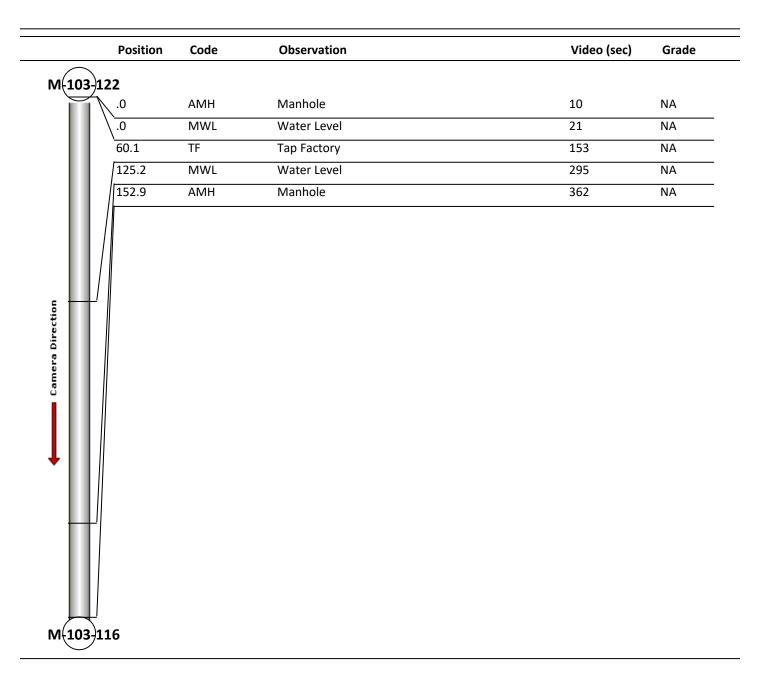
Code: Description:	AMH Manhole
Distance (ft):	.0
Structural Grade:	0
O&M Grade:	0
Clock Start/From:	
Clock To:	
1st Value:	
2nd Value:	
Value Percent:	
Continuous Index:	
Within 8" of Joint:	NO
Remarks:	M-103-122
