Profile/Photo Observation Report

Street:	E 38th Ave	Flow Control:	Not Controlled
City:	Hobart, IN	Year Renewed:	
Location:	Other	Tape/Media #:	
Purpose:	Not Known	Dia/Height:	8"
Use:	Sanitary	Material:	PVC
Drain Area:	NA	Lining:	
Category:	NA		
Comment:

Location Details:		Direction of Survey:	Downstream
US MH:	M-103-122	DS MH:	M-103-123
		Total Length Surveyed (ft):	63.4

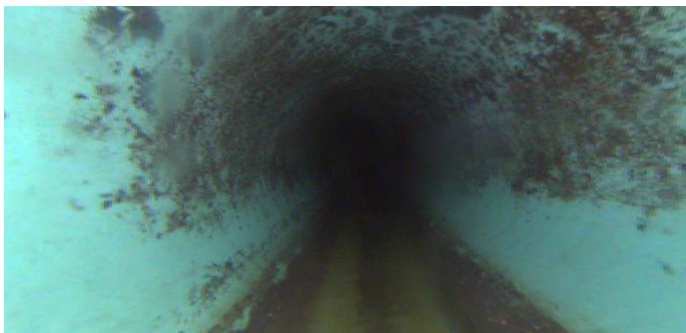
Code: **AMH**
Description: **Manhole**

Distance (ft): **.0**
Structural Grade: **0**
O&M Grade: **0**
Clock Start/From:
Clock To:
1st Value:
2nd Value:
Value Percent:
Continuous Index:
Within 8" of Joint: **NO**
Remarks: **M-103-123**

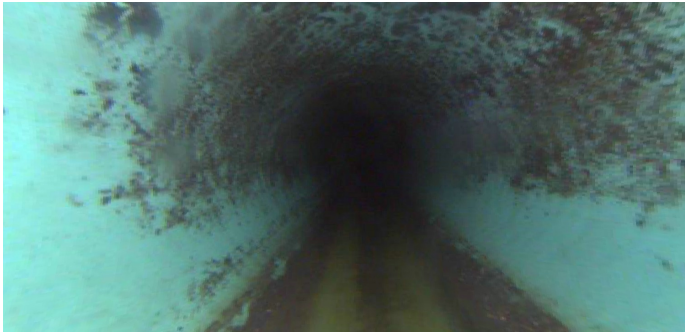
Code:	MWL
Description:	Water Level

Distance (ft):	.0
Structural Grade:	0
O&M Grade:	0
Clock Start/From:	
Clock To:	
1st Value:	
2nd Value:	
Value Percent:	5.000
Continuous Index:	
Within 8" of Joint:	NO
Remarks:

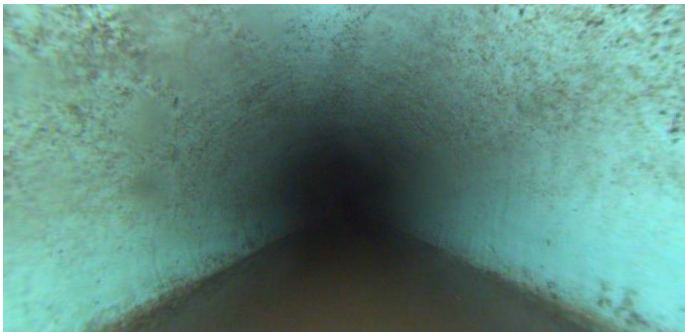
Code:	MWL
Description:	Water Level

Distance (ft):	39.8
Structural Grade:	0
O&M Grade:	0
Clock Start/From:	
Clock To:	
1st Value:	
2nd Value:	
Value Percent:	20.000
Continuous Index:	
Within 8" of Joint:	NO
Remarks:

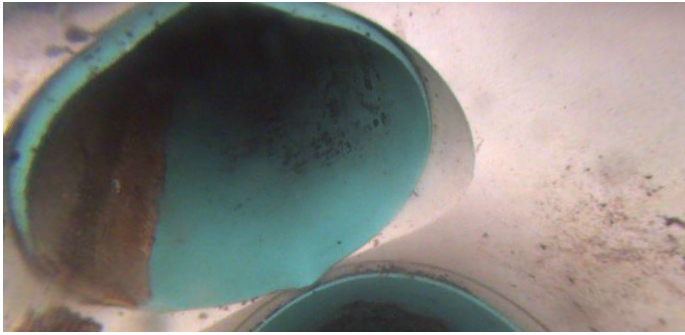
Code: **TF**
Description: **Tap Factory**

Distance (ft): **59.6**
Structural Grade: **0**
O&M Grade: **0**
Clock Start/From: **11**
Clock To:
1st Value: **4.000**
2nd Value:
Value Percent:
Continuous Index:
Within 8" of Joint:
Remarks:

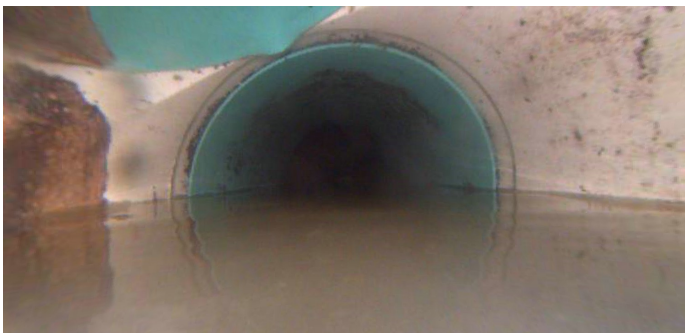
Code: **MWL**
Description: **Water Level**

Distance (ft): **59.6**
Structural Grade: **0**
O&M Grade: **0**
Clock Start/From:
Clock To:
1st Value:
2nd Value:
Value Percent: **40.000**
Continuous Index:
Within 8" of Joint: **NO**
Remarks:

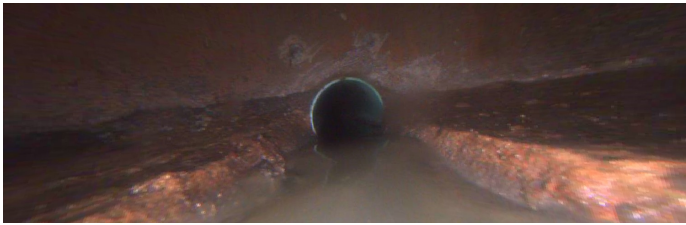
Code: **AMH**
Description: **Manhole**

Distance (ft): **63.4**
Structural Grade: **0**
O&M Grade: **0**
Clock Start/From:
Clock To:
1st Value:
2nd Value:
Value Percent:
Continuous Index:
Within 8" of Joint: **NO**
Remarks: **M-103-123**
