Profile/Photo Observation Report

Date:	03/22/2018	Weather:		Coding:	PACP 6.0
Pipe Length (ft):	249.1	Owner:	NA	Pre Clean:	Not Known
P.O.#:		Surveyor:	Selasie Honu	PSR:	P-103-126-122
Customer:		Clean Date:	01/01/1900	Shape:	C

Street:	E 38th Ave	Flow Control:	Not Controlled
City:	Hobart, IN	Year Renewed:	
Location:	Other	Tape/Media #:	
Purpose:	Not Known	Dia/Height:	8"
Use:	Sanitary	Material:	PVC
Drain Area:	NA	Lining:	
Category:	NA		
Comment:

Location Details:		Direction of Survey:	Downstream
US MH:	M-103-122	DS MH:	M-103-126
		Total Length Surveyed (ft):	240.3

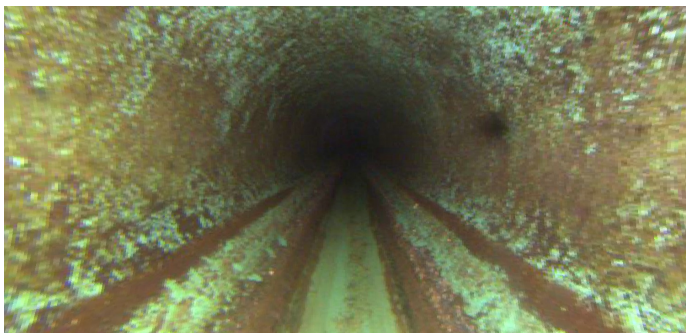
Code: **AMH**
Description: **Manhole**

Distance (ft): **.0**
Structural Grade: **0**
O&M Grade: **0**
Clock Start/From:
Clock To:
1st Value:
2nd Value:
Value Percent:
Continuous Index:
Within 8" of Joint: **NO**
Remarks: **M-103-122**

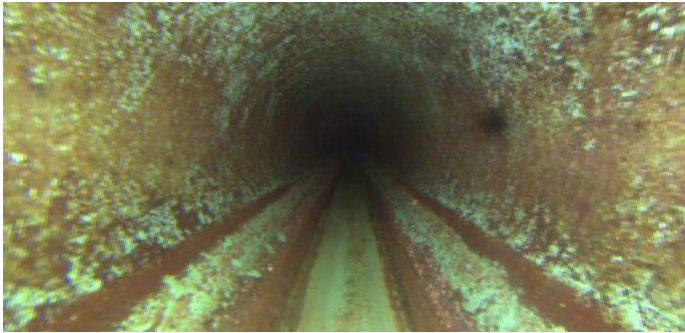
Code:	MWL
Description:	Water Level

Distance (ft):	.0
Structural Grade:	0
O&M Grade:	0
Clock Start/From:	
Clock To:	
1st Value:	
2nd Value:	
Value Percent:	5.000
Continuous Index:	
Within 8" of Joint:	NO
Remarks:

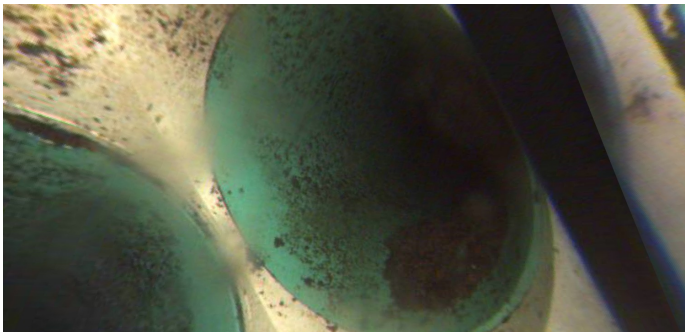
Code:	TF
Description:	Tap Factory

Distance (ft):	56.4
Structural Grade:	0
O&M Grade:	0
Clock Start/From:	10
Clock To:	
1st Value:	4.000
2nd Value:	
Value Percent:	
Continuous Index:	
Within 8" of Joint:	
Remarks:

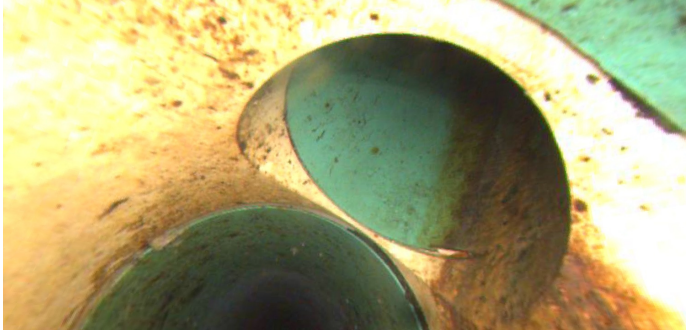
Code: **TF**
Description: **Tap Factory**

Distance (ft): **57.9**
Structural Grade: **0**
O&M Grade: **0**
Clock Start/From: **1**
Clock To:
1st Value: **4.000**
2nd Value:
Value Percent:
Continuous Index:
Within 8" of Joint:
Remarks:

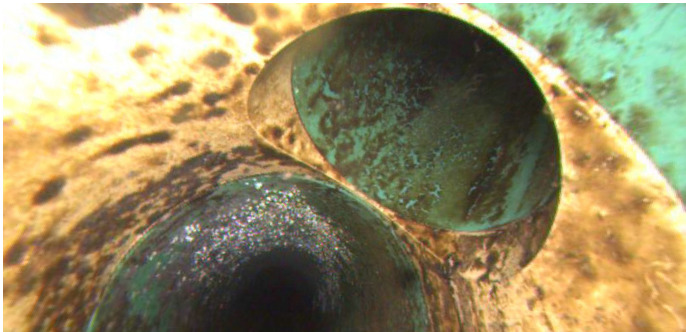
Code: **TF**
Description: **Tap Factory**

Distance (ft): **75.7**
Structural Grade: **0**
O&M Grade: **0**
Clock Start/From: **1**
Clock To:
1st Value: **4.000**
2nd Value:
Value Percent:
Continuous Index:
Within 8" of Joint:
Remarks:

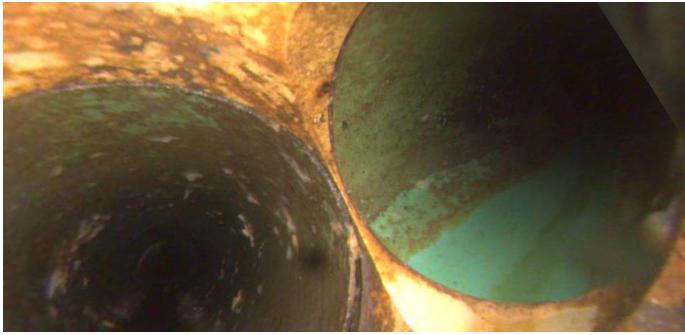
Code: **TF**
Description: **Tap Factory**

Distance (ft): **115.2**
Structural Grade: **0**
O&M Grade: **0**
Clock Start/From: **2**
Clock To:
1st Value: **4.000**
2nd Value:
Value Percent:
Continuous Index:
Within 8" of Joint:
Remarks:

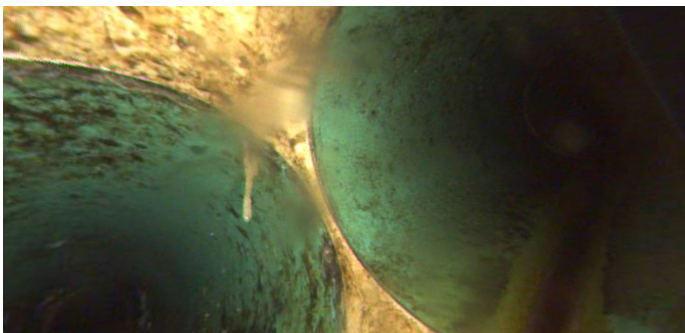
Code: **TF**
Description: **Tap Factory**

Distance (ft): **119.8**
Structural Grade: **0**
O&M Grade: **0**
Clock Start/From: **10**
Clock To:
1st Value: **4.000**
2nd Value:
Value Percent:
Continuous Index:
Within 8" of Joint:
Remarks:

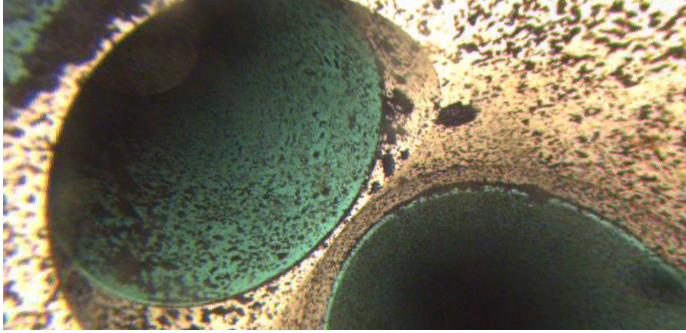
Code: **TF**
Description: **Tap Factory**

Distance (ft): **198.5**
Structural Grade: **0**
O&M Grade: **0**
Clock Start/From: **10**
Clock To:
1st Value: **4.000**
2nd Value:
Value Percent:
Continuous Index:
Within 8" of Joint:
Remarks:

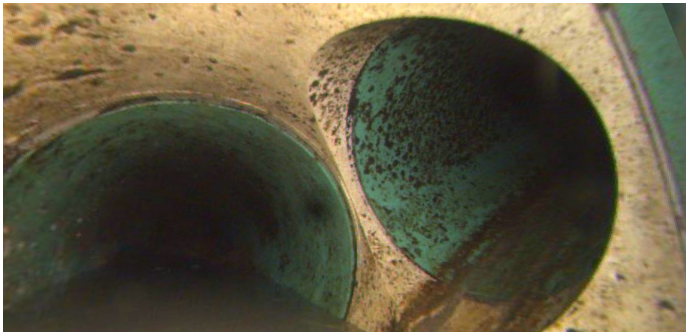
Code: **TFA**
Description: **Tap Factory Active**

Distance (ft): **236.9**
Structural Grade: **0**
O&M Grade: **0**
Clock Start/From: **3**
Clock To:
1st Value: **4.000**
2nd Value:
Value Percent:
Continuous Index:
Within 8" of Joint:
Remarks:

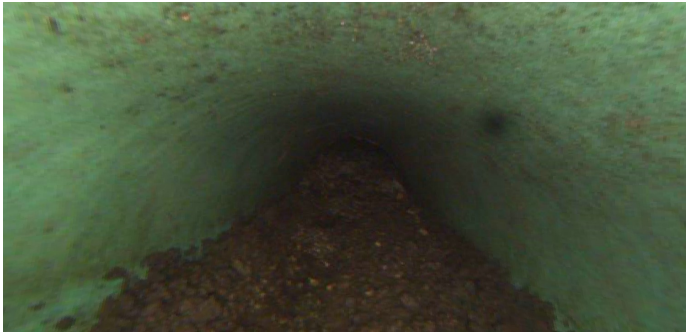
Code: **MSA**
Description: **Abandoned Survey**

Distance (ft): **240.3**
Structural Grade: **0**
O&M Grade: **0**
Clock Start/From:
Clock To:
1st Value:
2nd Value:
Value Percent:
Continuous Index:
Within 8" of Joint: **NO**
Remarks: **DSGV**

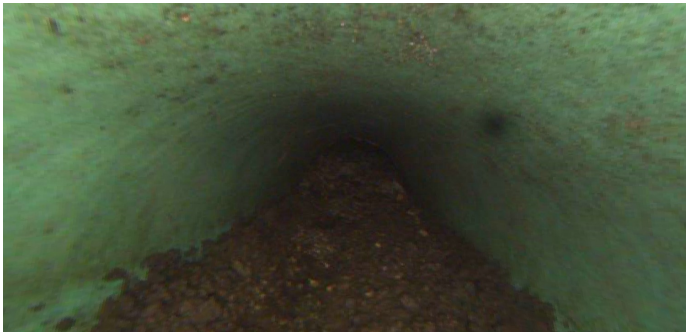
Code: **DSGV**
Description: **Deposits Settled Gravel**

Distance (ft): **240.3**
Structural Grade: **0**
O&M Grade: **5**
Clock Start/From: **12**
Clock To: **12**
1st Value:
2nd Value:
Value Percent: **45.000**
Continuous Index:
Within 8" of Joint: **NO**
Remarks:
