Profile/Photo Observation Report

Street:	ALLEY BEWTWEEN MAPLE ST & ALA	Flow Control:	Not Controlled
City:	Hobart, IN	Year Renewed:	
Location:	Other	Tape/Media #:	
Purpose:	Not Known	Dia/Height:	8"
Use:	Sanitary	Material:	PVC
Drain Area:	NA	Lining:	
Category:	NA		
Comment:

Location Details:		Direction of Survey:	Upstream
US MH:	M-103-123	DS MH:	M-103-124
		Total Length Surveyed (ft):	204.6

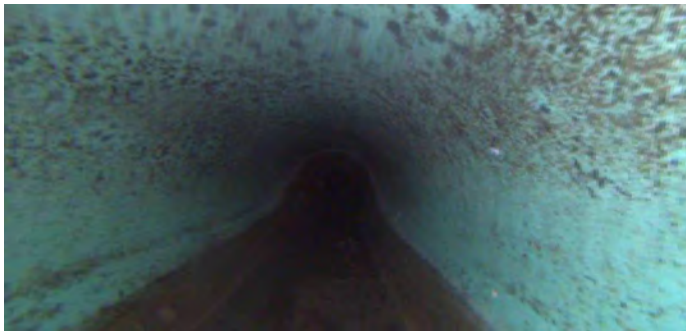
Code: **AMH**
Description: **Manhole**

Distance (ft): **.0**
Structural Grade: **0**
O&M Grade: **0**
Clock Start/From:
Clock To:
1st Value:
2nd Value:
Value Percent:
Continuous Index:
Within 8" of Joint: **NO**
Remarks: **M-103-124**

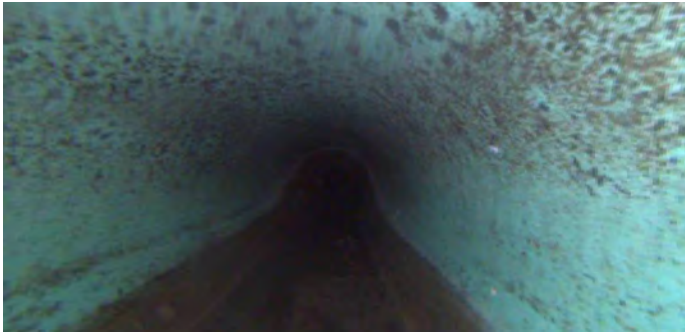
Code:	MWL
Description:	Water Level

Distance (ft):	.0
Structural Grade:	0
O&M Grade:	0
Clock Start/From:	
Clock To:	
1st Value:	
2nd Value:	
Value Percent:	5.000
Continuous Index:	
Within 8" of Joint:	NO
Remarks:

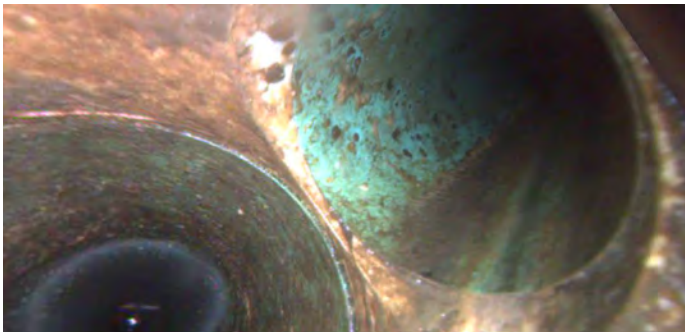
Code:	TF
Description:	Tap Factory

Distance (ft):	5.2
Structural Grade:	0
O&M Grade:	0
Clock Start/From:	10
Clock To:	
1st Value:	4.000
2nd Value:	
Value Percent:	
Continuous Index:	
Within 8" of Joint:	
Remarks:

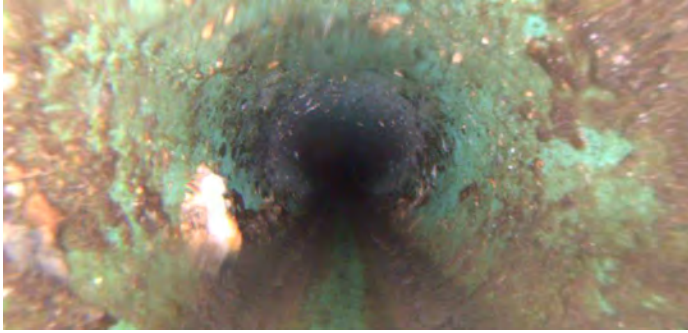
Code:	DAGS
Description:	Deposits Attached Grease
Distance (ft):	5.5
Structural Grade:	0
O&M Grade:	2
Clock Start/From:	8
Clock To:	4
1st Value:	
2nd Value:	
Value Percent:	5.000
Continuous Index:	
Within 8" of Joint:	NO
Remarks:

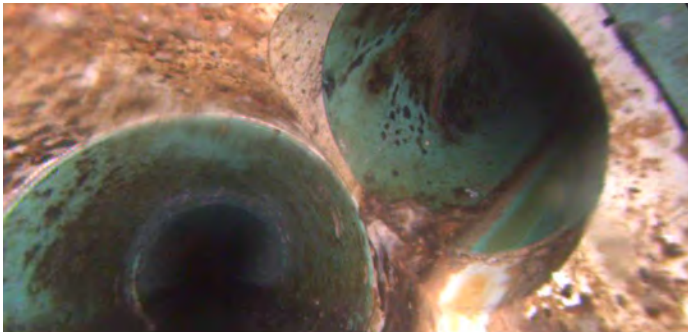
Code:	TF
Description:	Tap Factory
Distance (ft):	14.7
Structural Grade:	0
O&M Grade:	0
Clock Start/From:	2
Clock To:	
1st Value:	4.000
2nd Value:	
Value Percent:	
Continuous Index:	
Within 8" of Joint:	
Remarks:

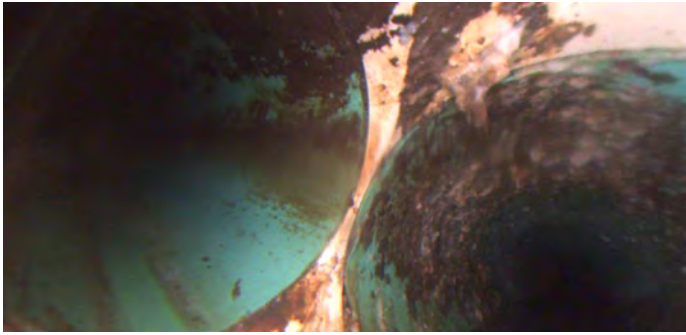
Code: **TF**
Description: **Tap Factory**

Distance (ft): **27.5**
Structural Grade: **0**
O&M Grade: **0**
Clock Start/From: **10**
Clock To:
1st Value: **4.000**
2nd Value:
Value Percent:
Continuous Index:
Within 8" of Joint:
Remarks:

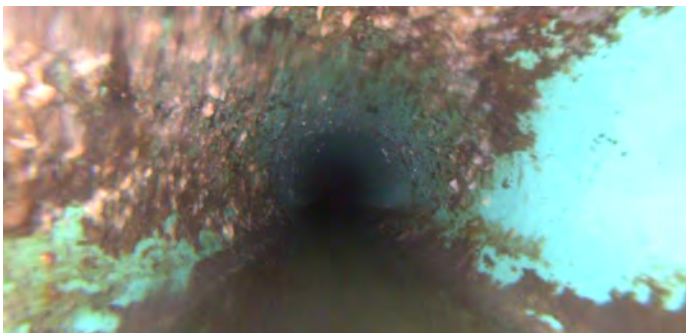
Code: **DAGS**
Description: **Deposits Attached Grease**

Distance (ft): **28.0**
Structural Grade: **0**
O&M Grade: **2**
Clock Start/From: **8**
Clock To: **4**
1st Value:
2nd Value:
Value Percent: **5.000**
Continuous Index:
Within 8" of Joint: **NO**
Remarks:

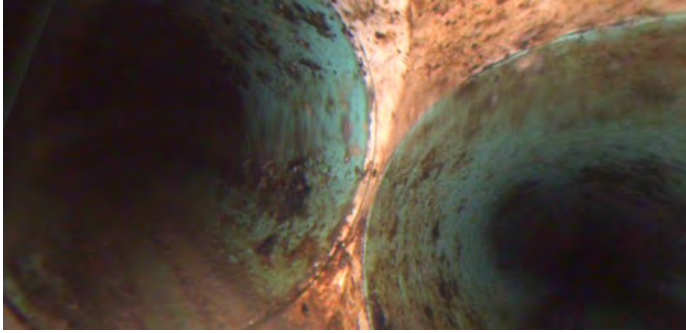
Code: **TF**
Description: **Tap Factory**

Distance (ft): **70.0**
Structural Grade: **0**
O&M Grade: **0**
Clock Start/From: **9**
Clock To:
1st Value: **4.000**
2nd Value:
Value Percent:
Continuous Index:
Within 8" of Joint:
Remarks:

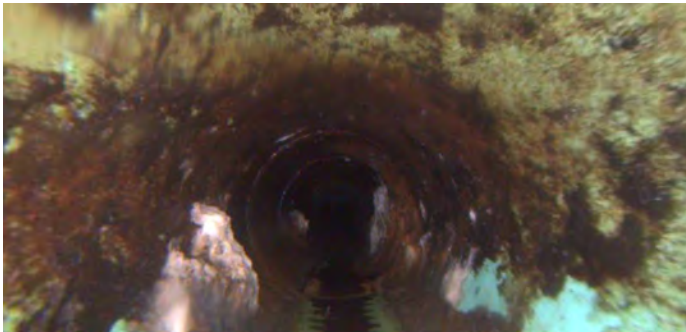
Code: **DAGS**
Description: **Deposits Attached Grease**

Distance (ft): **92.6**
Structural Grade: **0**
O&M Grade: **2**
Clock Start/From: **8**
Clock To: **4**
1st Value:
2nd Value:
Value Percent: **5.000**
Continuous Index:
Within 8" of Joint: **NO**
Remarks:

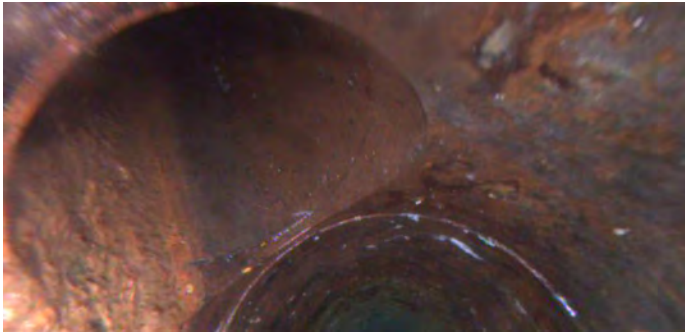
Code: **TF**
Description: **Tap Factory**

Distance (ft): **94.2**
Structural Grade: **0**
O&M Grade: **0**
Clock Start/From: **1**
Clock To:
1st Value: **4.000**
2nd Value:
Value Percent:
Continuous Index:
Within 8" of Joint:
Remarks:

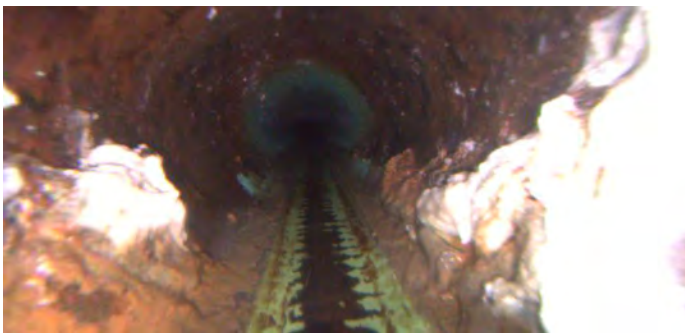
Code: **DAGS**
Description: **Deposits Attached Grease**

Distance (ft): **94.2**
Structural Grade: **0**
O&M Grade: **3**
Clock Start/From: **8**
Clock To: **4**
1st Value:
2nd Value:
Value Percent: **20.000**
Continuous Index:
Within 8" of Joint: **NO**
Remarks:

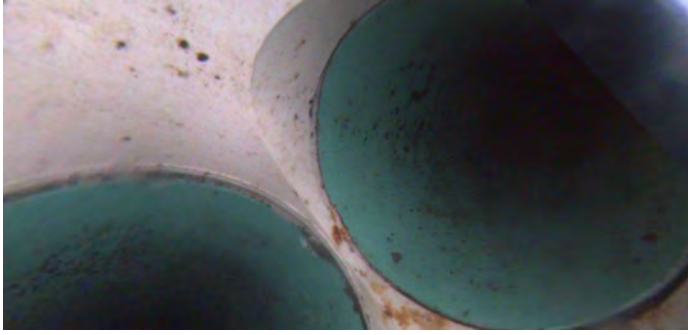
Code: **TF**
Description: **Tap Factory**

Distance (ft): **127.8**
Structural Grade: **0**
O&M Grade: **0**
Clock Start/From: **2**
Clock To:
1st Value: **4.000**
2nd Value:
Value Percent:
Continuous Index:
Within 8" of Joint:
Remarks:

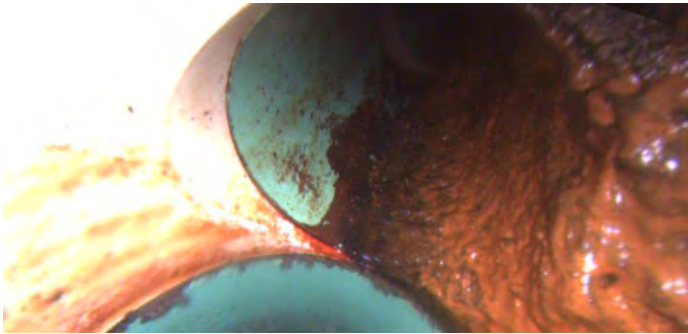
Code: **TFD**
Description: **Tap Factory Defective**

Distance (ft): **140.5**
Structural Grade: **0**
O&M Grade: **2**
Clock Start/From: **12**
Clock To:
1st Value: **4.000**
2nd Value:
Value Percent:
Continuous Index:
Within 8" of Joint:
Remarks: **dae**

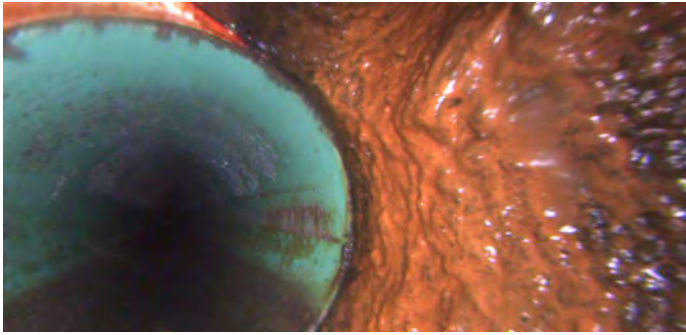
Code: **DAE**
Description: **Deposits Attached Encrustation**

Distance (ft): **140.5**
Structural Grade: **0**
O&M Grade: **2**
Clock Start/From: **1**
Clock To: **5**
1st Value:
2nd Value:
Value Percent: **10.000**
Continuous Index:
Within 8" of Joint: **NO**
Remarks:

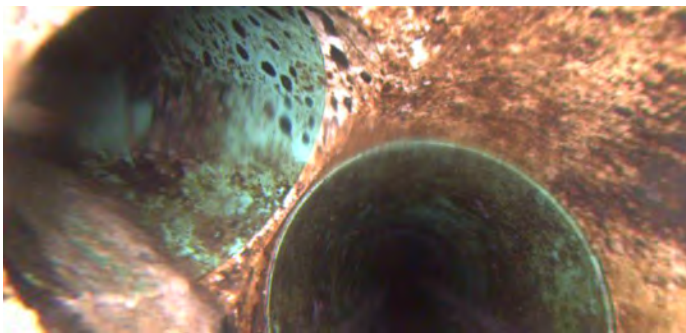
Code: **TFA**
Description: **Tap Factory Active**

Distance (ft): **189.9**
Structural Grade: **0**
O&M Grade: **0**
Clock Start/From: **10**
Clock To:
1st Value: **4.000**
2nd Value:
Value Percent:
Continuous Index:
Within 8" of Joint:
Remarks:

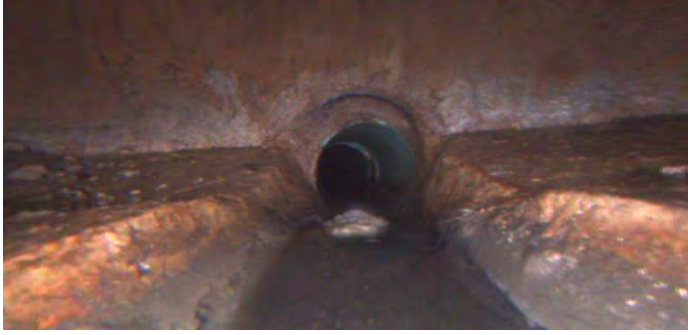
Code:	AMH
Description:	Manhole
Distance (ft):	204.6
Structural Grade:	0
O&M Grade:	0
Clock Start/From:	
Clock To:	
1st Value:	
2nd Value:	
Value Percent:	
Continuous Index:	
Within 8" of Joint:	NO
Remarks:	M-103-123
