Profile/Photo Observation Report

Street:	E 38th Ave	Flow Control:	Not Controlled
City:	Hobart, IN	Year Renewed:	
Location:	Other	Tape/Media #:	
Purpose:	Not Known	Dia/Height:	8"
Use:	Sanitary	Material:	PVC
Drain Area:	NA	Lining:	
Category:	NA		
Comment:

Location Details:		Direction of Survey:	Upstream
US MH:	M-103-123	DS MH:	M-103-124
		Total Length Surveyed (ft):	204.6

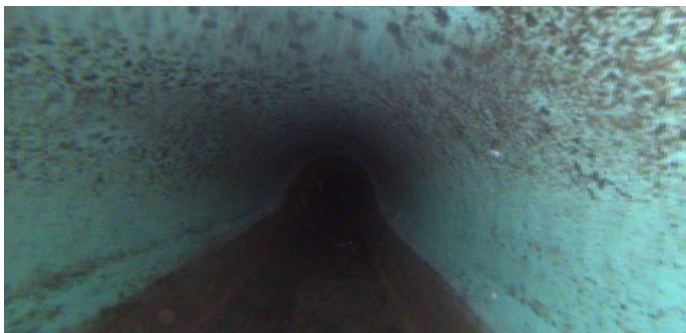
Code: **AMH**
Description: **Manhole**

Distance (ft): **.0**
Structural Grade: **0**
O&M Grade: **0**
Clock Start/From:
Clock To:
1st Value:
2nd Value:
Value Percent:
Continuous Index:
Within 8" of Joint: **NO**
Remarks: **M-103-124**

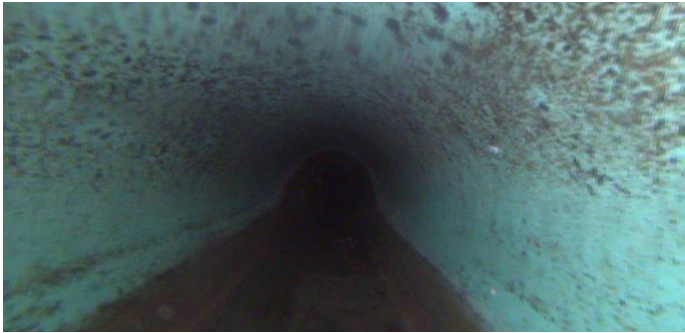
Code:	MWL
Description:	Water Level

Distance (ft):	.0
Structural Grade:	0
O&M Grade:	0
Clock Start/From:	
Clock To:	
1st Value:	
2nd Value:	
Value Percent:	5.000
Continuous Index:	
Within 8" of Joint:	NO
Remarks:

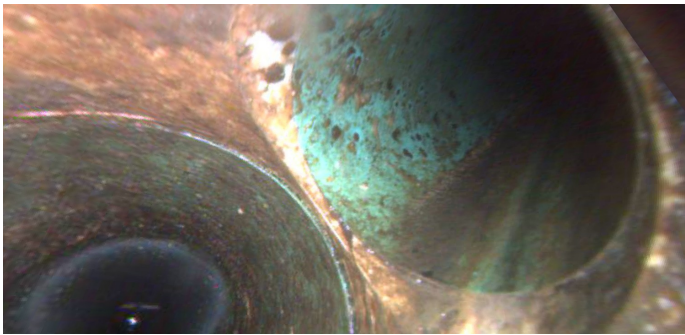
Code:	TF
Description:	Tap Factory

Distance (ft):	5.2
Structural Grade:	0
O&M Grade:	0
Clock Start/From:	10
Clock To:	
1st Value:	4.000
2nd Value:	
Value Percent:	
Continuous Index:	
Within 8" of Joint:	
Remarks:

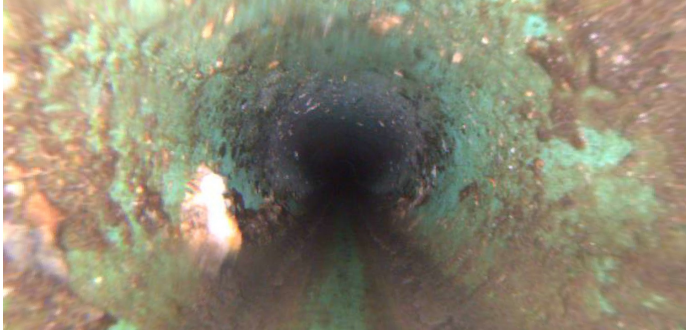
Code:	DAGS
Description:	Deposits Attached Grease
Distance (ft):	5.5
Structural Grade:	0
O&M Grade:	2
Clock Start/From:	8
Clock To:	4
1st Value:	
2nd Value:	
Value Percent:	5.000
Continuous Index:	
Within 8" of Joint:	NO
Remarks:

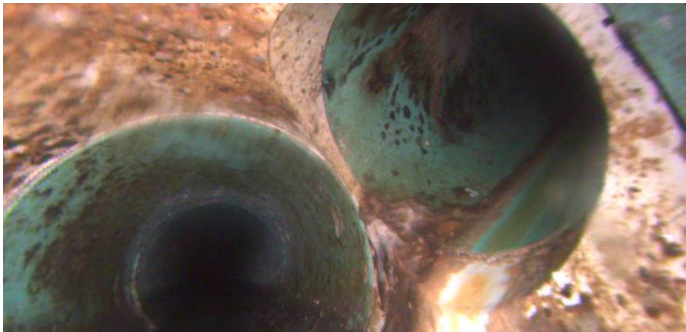
Code:	TF
Description:	Tap Factory
Distance (ft):	14.7
Structural Grade:	0
O&M Grade:	0
Clock Start/From:	2
Clock To:	
1st Value:	4.000
2nd Value:	
Value Percent:	
Continuous Index:	
Within 8" of Joint:	
Remarks:

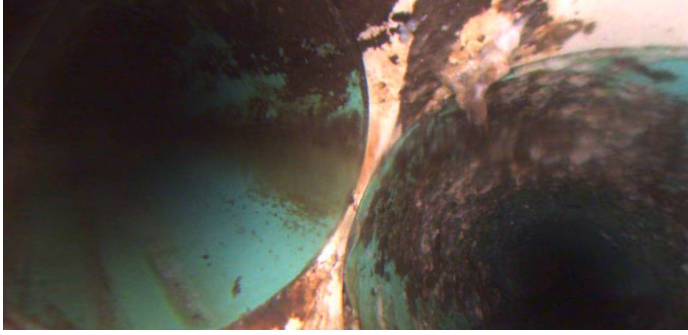
Code: **TF**
Description: **Tap Factory**

Distance (ft): **27.5**
Structural Grade: **0**
O&M Grade: **0**
Clock Start/From: **10**
Clock To:
1st Value: **4.000**
2nd Value:
Value Percent:
Continuous Index:
Within 8" of Joint:
Remarks:

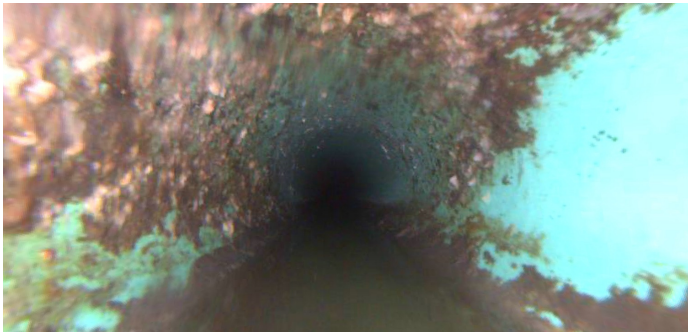
Code: **DAGS**
Description: **Deposits Attached Grease**

Distance (ft): **28.0**
Structural Grade: **0**
O&M Grade: **2**
Clock Start/From: **8**
Clock To: **4**
1st Value:
2nd Value:
Value Percent: **5.000**
Continuous Index:
Within 8" of Joint: **NO**
Remarks:

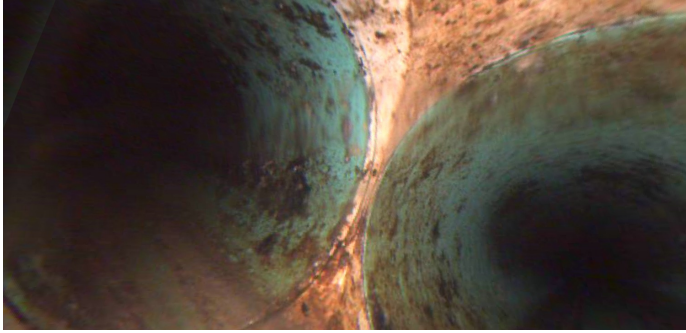
Code: **TF**
Description: **Tap Factory**

Distance (ft): **70.0**
Structural Grade: **0**
O&M Grade: **0**
Clock Start/From: **9**
Clock To:
1st Value: **4.000**
2nd Value:
Value Percent:
Continuous Index:
Within 8" of Joint:
Remarks:

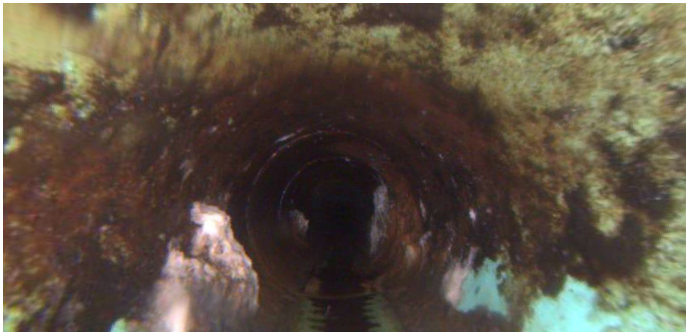
Code: **DAGS**
Description: **Deposits Attached Grease**

Distance (ft): **92.6**
Structural Grade: **0**
O&M Grade: **2**
Clock Start/From: **8**
Clock To: **4**
1st Value:
2nd Value:
Value Percent: **5.000**
Continuous Index:
Within 8" of Joint: **NO**
Remarks:

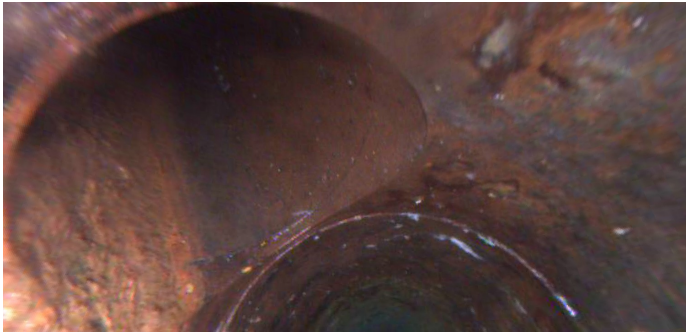
Code: **TF**
Description: **Tap Factory**

Distance (ft): **94.2**
Structural Grade: **0**
O&M Grade: **0**
Clock Start/From: **1**
Clock To:
1st Value: **4.000**
2nd Value:
Value Percent:
Continuous Index:
Within 8" of Joint:
Remarks:

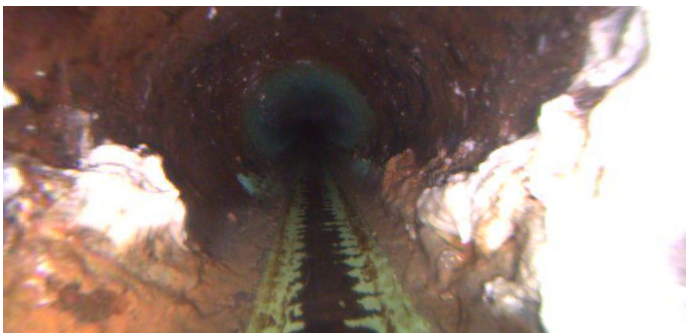
Code: **DAGS**
Description: **Deposits Attached Grease**

Distance (ft): **94.2**
Structural Grade: **0**
O&M Grade: **3**
Clock Start/From: **8**
Clock To: **4**
1st Value:
2nd Value:
Value Percent: **20.000**
Continuous Index:
Within 8" of Joint: **NO**
Remarks:

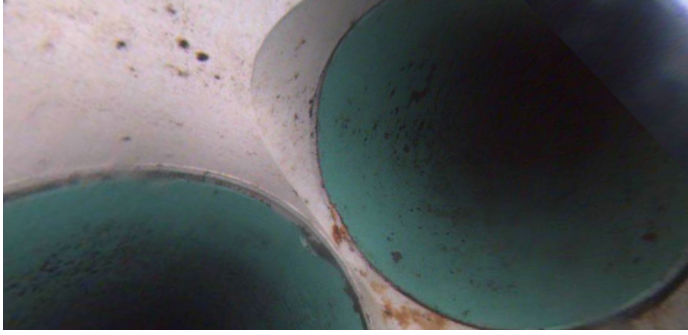
Code: **TF**
Description: **Tap Factory**

Distance (ft): **127.8**
Structural Grade: **0**
O&M Grade: **0**
Clock Start/From: **2**
Clock To:
1st Value: **4.000**
2nd Value:
Value Percent:
Continuous Index:
Within 8" of Joint:
Remarks:

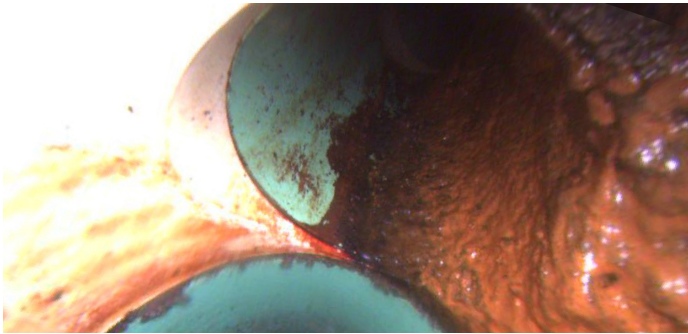
Code: **TFD**
Description: **Tap Factory Defective**

Distance (ft): **140.5**
Structural Grade: **0**
O&M Grade: **2**
Clock Start/From: **12**
Clock To:
1st Value: **4.000**
2nd Value:
Value Percent:
Continuous Index:
Within 8" of Joint:
Remarks: **dae**

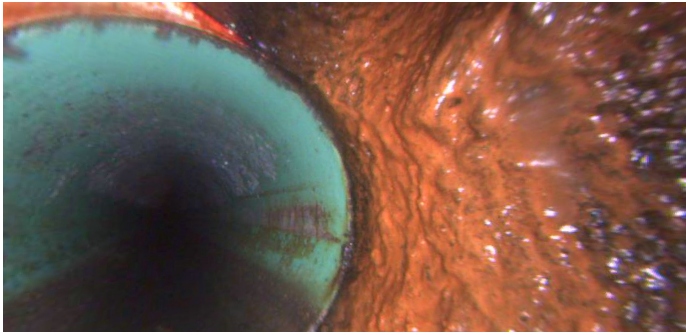
Code: **DAE**
Description: **Deposits Attached Encrustation**

Distance (ft): **140.5**
Structural Grade: **0**
O&M Grade: **2**
Clock Start/From: **1**
Clock To: **5**
1st Value:
2nd Value:
Value Percent: **10.000**
Continuous Index:
Within 8" of Joint: **NO**
Remarks:

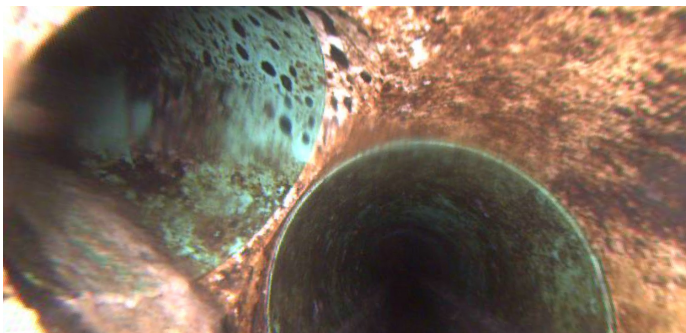
Code: **TFA**
Description: **Tap Factory Active**

Distance (ft): **189.9**
Structural Grade: **0**
O&M Grade: **0**
Clock Start/From: **10**
Clock To:
1st Value: **4.000**
2nd Value:
Value Percent:
Continuous Index:
Within 8" of Joint:
Remarks:

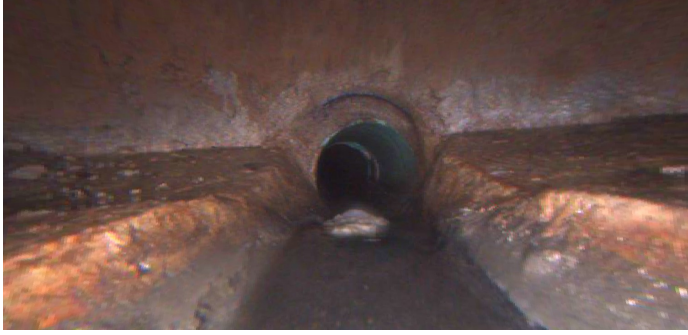
Code:	AMH
Description:	Manhole
Distance (ft):	204.6
Structural Grade:	0
O&M Grade:	0
Clock Start/From:	
Clock To:	
1st Value:	
2nd Value:	
Value Percent:	
Continuous Index:	
Within 8" of Joint:	NO
Remarks:	M-103-123
