Profile/Photo Observation Report

Date:	03/22/2018	Weather:		Coding:	PACP 6.0
Pipe Length (ft):	206.6	Owner:	NA	Pre Clean:	Not Known
P.O.#:		Surveyor:	Selasie Honu	PSR:	P-103-125-124
Customer:		Clean Date:	01/01/1900	Shape:	C

Street:	E 38th Ave	Flow Control:	Not Controlled
City:	Hobart, IN	Year Renewed:	
Location:	Other	Tape/Media #:	
Purpose:	Not Known	Dia/Height:	8"
Use:	Sanitary	Material:	PVC
Drain Area:	NA	Lining:	
Category:	NA		
Comment:	Pipe filled with dry debris

Location Details:		Direction of Survey:	Downstream
US MH:	M-103-124	DS MH:	M-103-125
		Total Length Surveyed (ft):	200.5

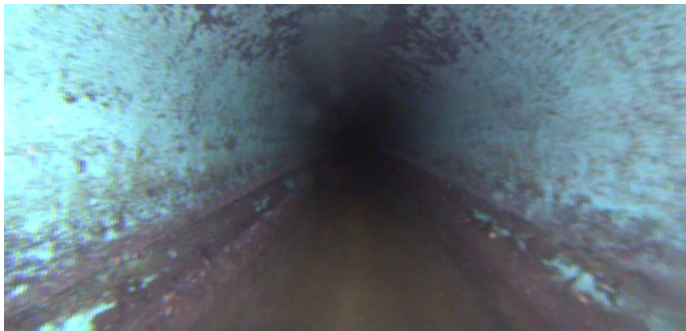
Code: **AMH**
Description: **Manhole**

Distance (ft): **.0**
Structural Grade: **0**
O&M Grade: **0**
Clock Start/From:
Clock To:
1st Value:
2nd Value:
Value Percent:
Continuous Index:
Within 8" of Joint: **NO**
Remarks: **M-103-124**

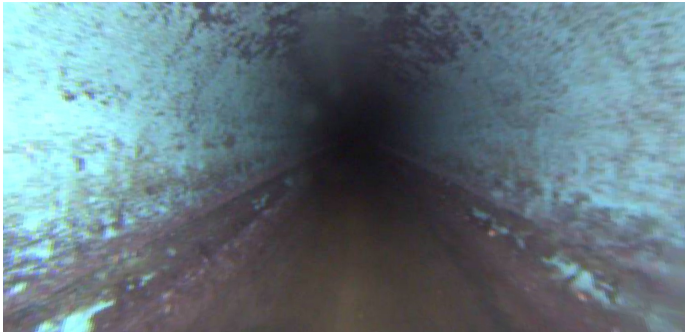
Code:	MWL
Description:	Water Level

Distance (ft):	.0
Structural Grade:	0
O&M Grade:	0
Clock Start/From:	
Clock To:	
1st Value:	
2nd Value:	
Value Percent:	5.000
Continuous Index:	
Within 8" of Joint:	NO
Remarks:

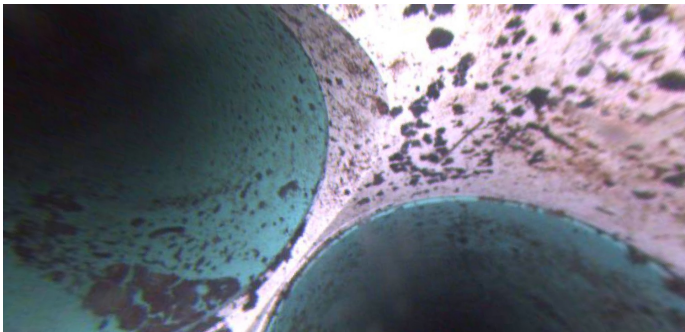
Code:	TF
Description:	Tap Factory

Distance (ft):	48.7
Structural Grade:	0
O&M Grade:	0
Clock Start/From:	10
Clock To:	
1st Value:	4.000
2nd Value:	
Value Percent:	
Continuous Index:	
Within 8" of Joint:	
Remarks:

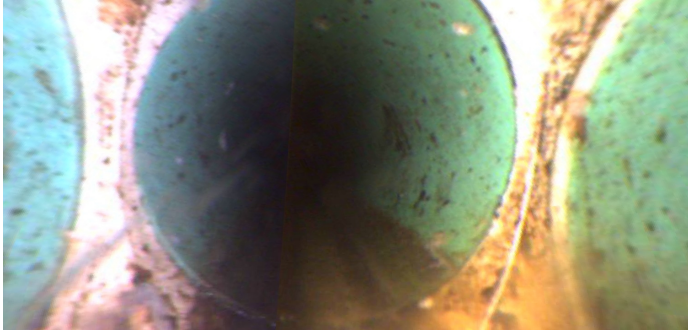
Code: **TFA**
Description: **Tap Factory Active**

Distance (ft): **67.5**
Structural Grade: **0**
O&M Grade: **0**
Clock Start/From: **3**
Clock To:
1st Value: **4.000**
2nd Value:
Value Percent:
Continuous Index:
Within 8" of Joint:
Remarks:

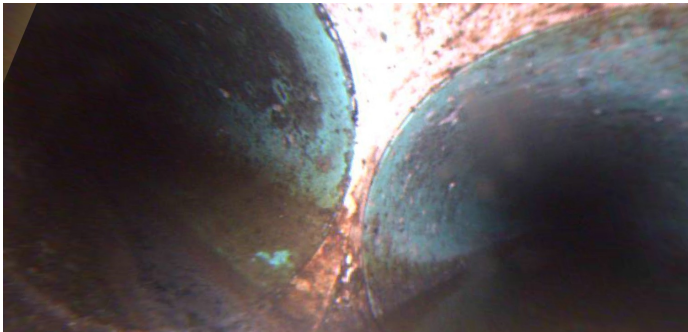
Code: **TFA**
Description: **Tap Factory Active**

Distance (ft): **99.0**
Structural Grade: **0**
O&M Grade: **0**
Clock Start/From: **9**
Clock To:
1st Value: **4.000**
2nd Value:
Value Percent:
Continuous Index:
Within 8" of Joint:
Remarks:

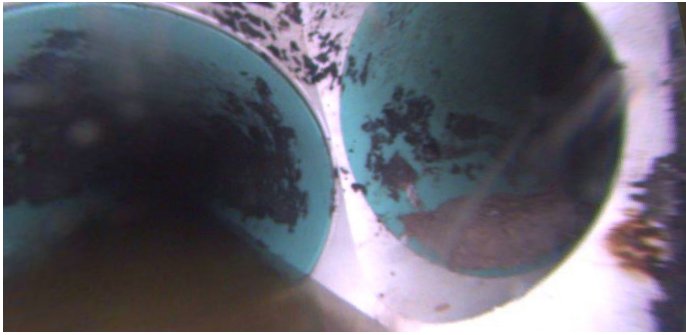
Code: **TF**
Description: **Tap Factory**

Distance (ft): **117.1**
Structural Grade: **0**
O&M Grade: **0**
Clock Start/From: **3**
Clock To:
1st Value: **4.000**
2nd Value:
Value Percent:
Continuous Index:
Within 8" of Joint:
Remarks:

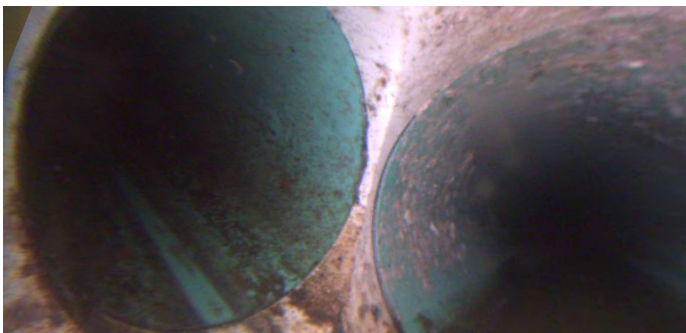
Code: **TF**
Description: **Tap Factory**

Distance (ft): **148.3**
Structural Grade: **0**
O&M Grade: **0**
Clock Start/From: **9**
Clock To:
1st Value: **4.000**
2nd Value:
Value Percent:
Continuous Index:
Within 8" of Joint:
Remarks:

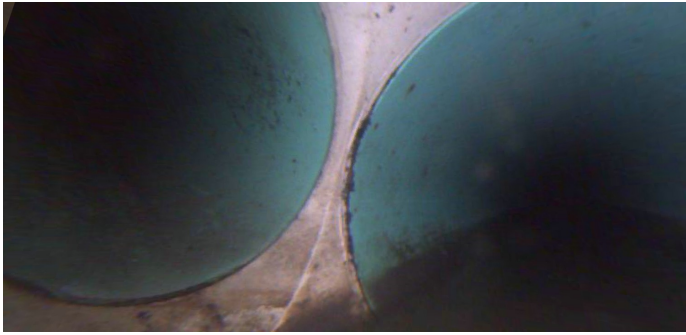
Code: **TF**
Description: **Tap Factory**

Distance (ft): **161.2**
Structural Grade: **0**
O&M Grade: **0**
Clock Start/From: **9**
Clock To:
1st Value: **4.000**
2nd Value:
Value Percent:
Continuous Index:
Within 8" of Joint:
Remarks:

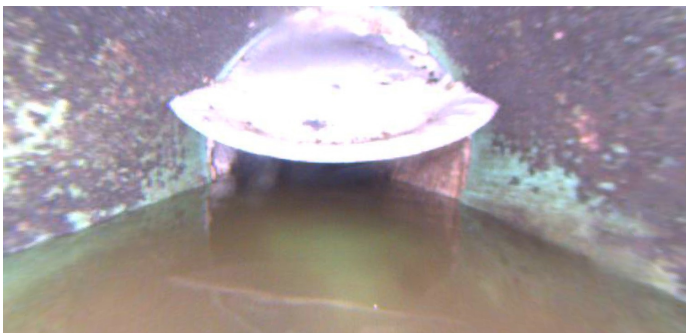
Code: **OBZ**
Description: **Obstacle Other**

Distance (ft): **198.4**
Structural Grade: **0**
O&M Grade: **5**
Clock Start/From: **3**
Clock To: **9**
1st Value:
2nd Value:
Value Percent: **40.000**
Continuous Index:
Within 8" of Joint: **NO**
Remarks: **PLATE BLOCKING MH**

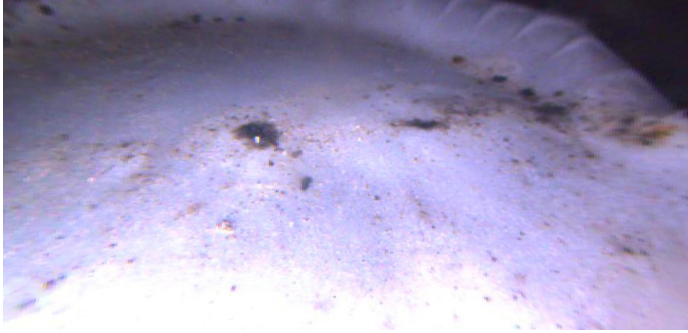
Code:	AMH
Description:	Manhole
Distance (ft):	200.5
Structural Grade:	0
O&M Grade:	0
Clock Start/From:	
Clock To:	
1st Value:	
2nd Value:	
Value Percent:	
Continuous Index:	
Within 8" of Joint:	NO
Remarks:	M-103-125
