Profile/Photo Observation Report

Street:	W 38TH AVE	Flow Control:	Not Controlled
City:	Hobart, IN	Year Renewed:	
Location:	Other	Tape/Media #:	
Purpose:	Not Known	Dia/Height:	8"
Use:	Sanitary	Material:	PVC
Drain Area:	NA	Lining:	
Category:	NA		
Comment:

Location Details:		Direction of Survey:	Downstream
US MH:	M-103-127	DS MH:	M-103-122
		Total Length Surveyed (ft):	319.4

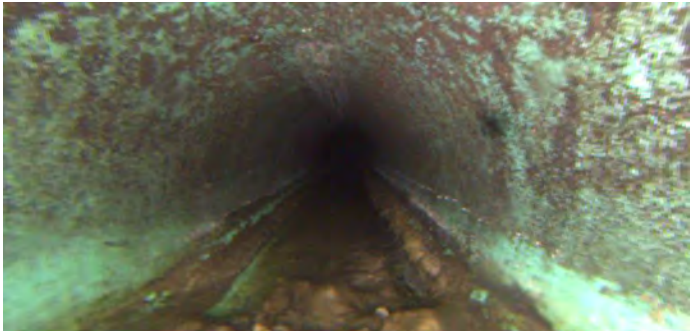
Code: AMH

Description: Manhole

Distance (ft): .0

Remarks: M-103-127

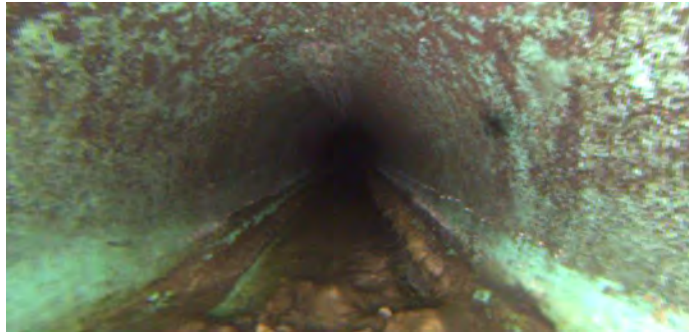
Code: **MWL**
Description: **Water Level**

Distance (ft): **.0**
Structural Grade: **0**
O&M Grade: **0**
Clock Start/From:
Clock To:
1st Value:
2nd Value:
Value Percent: **5.000**
Continuous Index:
Within 8" of Joint: **NO**
Remarks:

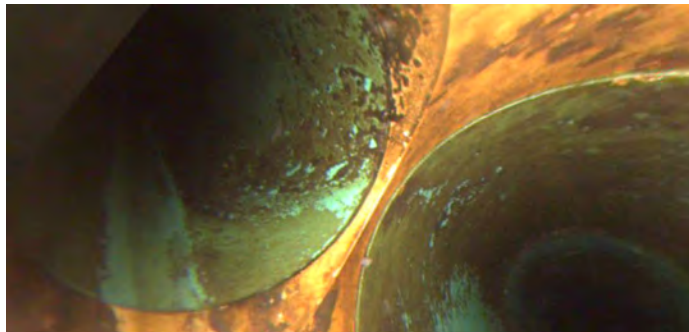
Code: **TF**
Description: **Tap Factory**

Distance (ft): **240.5**
Structural Grade: **0**
O&M Grade: **0**
Clock Start/From: **10**
Clock To:
1st Value: **4.000**
2nd Value:
Value Percent:
Continuous Index:
Within 8" of Joint:
Remarks:

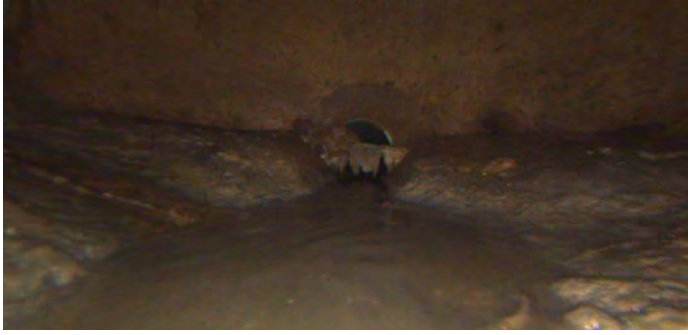
Code:	AMH
Description:	Manhole
Distance (ft):	319.4
Structural Grade:	0
O&M Grade:	0
Clock Start/From:	
Clock To:	
1st Value:	
2nd Value:	
Value Percent:	
Continuous Index:	
Within 8" of Joint:	NO
Remarks:	M-103-122
