Profile/Photo Observation Report

Street:	E 38th Ave	Flow Control:	Not Controlled
City:	Hobart, IN	Year Renewed:	
Location:	Other	Tape/Media #:	
Purpose:	Not Known	Dia/Height:	8"
Use:	Sanitary	Material:	PVC
Drain Area:	NA	Lining:	
Category:	NA		
Comment:

Location Details:		Direction of Survey:	Downstream
US MH:	M-103-127	DS MH:	M-103-122
		Total Length Surveyed (ft):	319.4

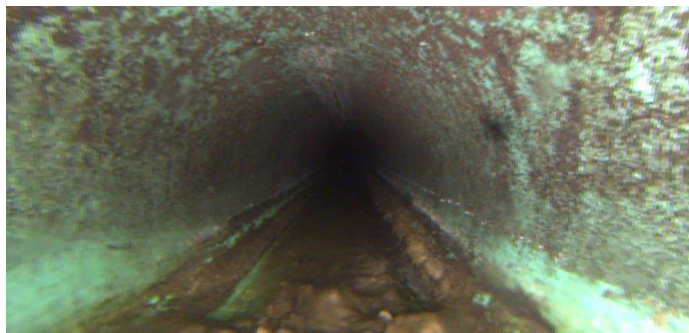
Code: **AMH**
Description: **Manhole**

Distance (ft): **.0**
Structural Grade: **0**
O&M Grade: **0**
Clock Start/From:
Clock To:
1st Value:
2nd Value:
Value Percent:
Continuous Index:
Within 8" of Joint: **NO**
Remarks: **M-103-127**

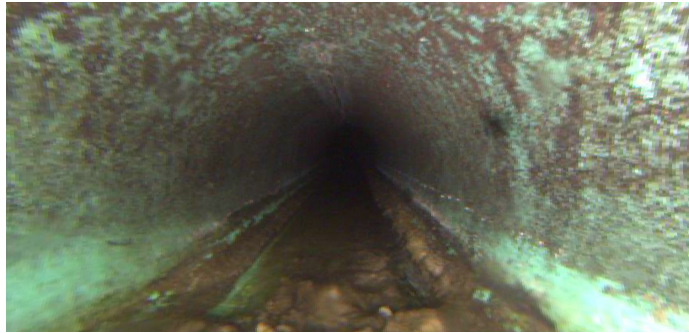
Code:	MWL
Description:	Water Level
Distance (ft):	.0
Structural Grade:	0
O&M Grade:	0
Clock Start/From:	
Clock To:	
1st Value:	
2nd Value:	
Value Percent:	5.000
Continuous Index:	
Within 8" of Joint:	NO
Remarks:

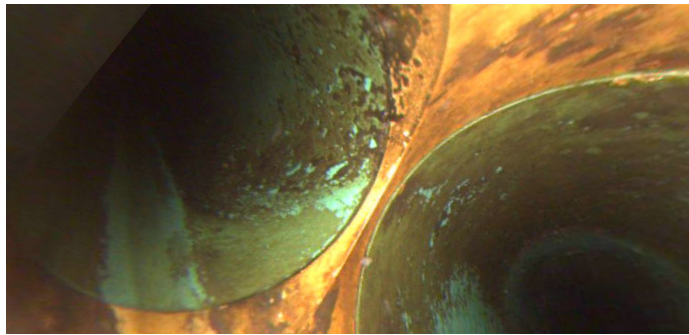
Code:	TF
Description:	Tap Factory
Distance (ft):	240.5
Structural Grade:	0
O&M Grade:	0
Clock Start/From:	10
Clock To:	
1st Value:	4.000
2nd Value:	
Value Percent:	
Continuous Index:	
Within 8" of Joint:	
Remarks:

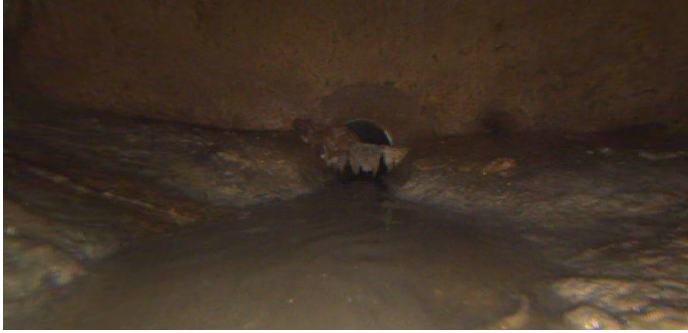
Code:	AMH
Description:	Manhole
Distance (ft):	319.4
Structural Grade:	0
O&M Grade:	0
Clock Start/From:	
Clock To:	
1st Value:	
2nd Value:	
Value Percent:	
Continuous Index:	
Within 8" of Joint:	NO
Remarks:	M-103-122
