## Profile/Photo Observation Report

Street:	<b>ALLEY BEWTWEEN SWIFT ST &amp; ALAB</b>	Flow Control:	<b>Not Controlled</b>
City:	<b>Hobart, IN</b>	Year Renewed:	
Location:	<b>Other</b>	Tape/Media #:	
Purpose:	<b>Not Known</b>	Dia/Height:	<b>8"</b>
Use:	<b>Sanitary</b>	Material:	<b>PVC</b>
Drain Area:	<b>NA</b>	Lining:	
Category:	<b>NA</b>		
Comment:

Location Details:		Direction of Survey:	<b>Downstream</b>
US MH:	<b>M-103-127</b>	DS MH:	<b>M-103-128</b>
		Total Length Surveyed (ft):	<b>114.4</b>

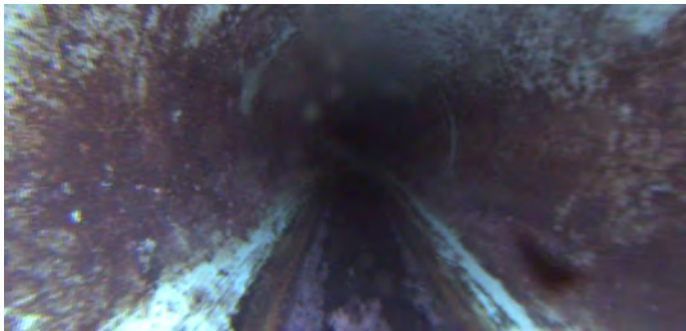
Code: **AMH**  
Description: **Manhole**

Distance (ft): **.0**  
Structural Grade: **0**  
O&M Grade: **0**  
Clock Start/From:  
Clock To:  
1st Value:  
2nd Value:  
Value Percent:  
Continuous Index:  
Within 8" of Joint: **NO**  
Remarks: **M-103-127**

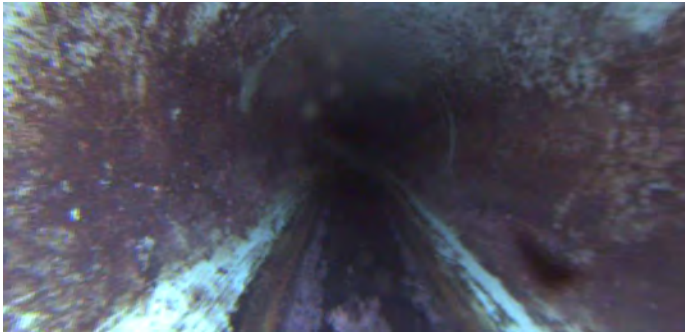
Code:	<b>MWL</b>
Description:	<b>Water Level</b>

Distance (ft):	<b>.0</b>
Structural Grade:	<b>0</b>
O&M Grade:	<b>0</b>
Clock Start/From:	
Clock To:	
1st Value:	
2nd Value:	
Value Percent:	<b>5.000</b>
Continuous Index:	
Within 8" of Joint:	<b>NO</b>
Remarks:

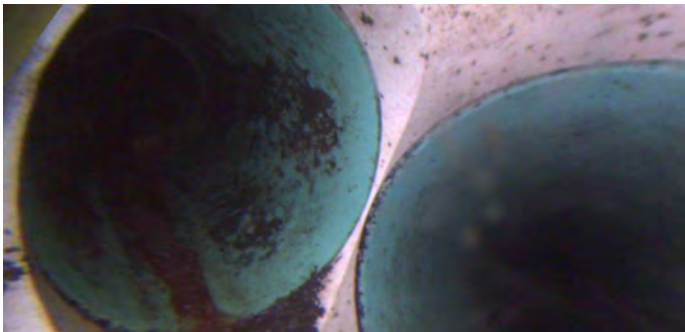
Code:	<b>TF</b>
Description:	<b>Tap Factory</b>

Distance (ft):	<b>63.8</b>
Structural Grade:	<b>0</b>
O&M Grade:	<b>0</b>
Clock Start/From:	<b>10</b>
Clock To:	
1st Value:	<b>4.000</b>
2nd Value:	
Value Percent:	
Continuous Index:	
Within 8" of Joint:	
Remarks:

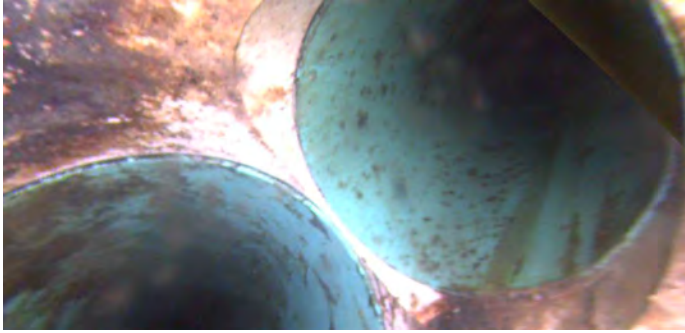
Code: **TF**  
Description: **Tap Factory**

Distance (ft): **82.5**  
Structural Grade: **0**  
O&M Grade: **0**  
Clock Start/From: **2**  
Clock To:  
1st Value: **4.000**  
2nd Value:  
Value Percent:  
Continuous Index:  
Within 8" of Joint:  
Remarks:

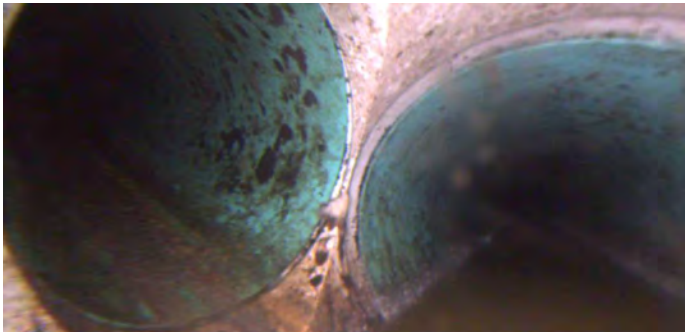
Code: **TF**  
Description: **Tap Factory**

Distance (ft): **98.3**  
Structural Grade: **0**  
O&M Grade: **0**  
Clock Start/From: **9**  
Clock To:  
1st Value: **4.000**  
2nd Value:  
Value Percent:  
Continuous Index:  
Within 8" of Joint:  
Remarks:

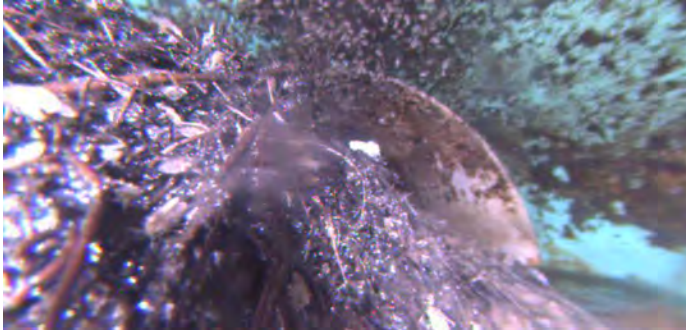
Code: **RBB**  
Description: **Roots Ball Barrel**

Distance (ft): **113.6**  
Structural Grade: **0**  
O&M Grade: **5**  
Clock Start/From: **12**  
Clock To: **12**  
1st Value:  
2nd Value:  
Value Percent: **90.000**  
Continuous Index:  
Within 8" of Joint: **NO**  
Remarks:

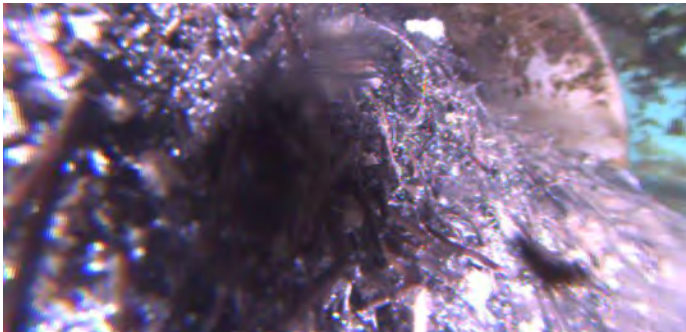
Code: **MSA**  
Description: **Abandoned Survey**

Distance (ft): **114.4**  
Structural Grade: **0**  
O&M Grade: **0**  
Clock Start/From:  
Clock To:  
1st Value:  
2nd Value:  
Value Percent:  
Continuous Index:  
Within 8" of Joint: **NO**  
Remarks: **root ball infiltration**
