Profile/Photo Observation Report

Street:	E 38th Ave	Flow Control:	Not Controlled
City:	Hobart, IN	Year Renewed:	
Location:	Other	Tape/Media #:	
Purpose:	Not Known	Dia/Height:	8"
Use:	Sanitary	Material:	PVC
Drain Area:	NA	Lining:	
Category:	NA		
Comment:

Location Details:		Direction of Survey:	Downstream
US MH:	M-103-127	DS MH:	M-103-128
		Total Length Surveyed (ft):	114.4

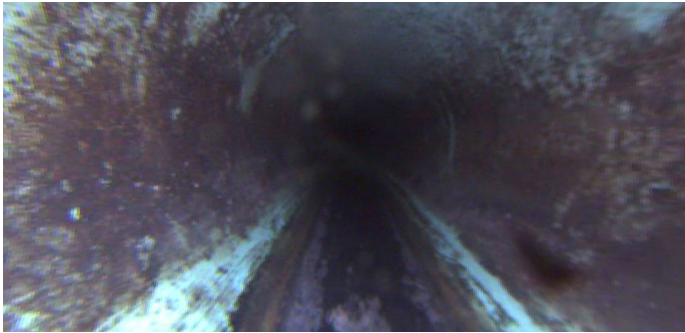
Code:	MWL
Description:	Water Level

Distance (ft):	.0
Structural Grade:	0
O&M Grade:	0
Clock Start/From:	
Clock To:	
1st Value:	
2nd Value:	
Value Percent:	5.000
Continuous Index:	
Within 8" of Joint:	NO
Remarks:

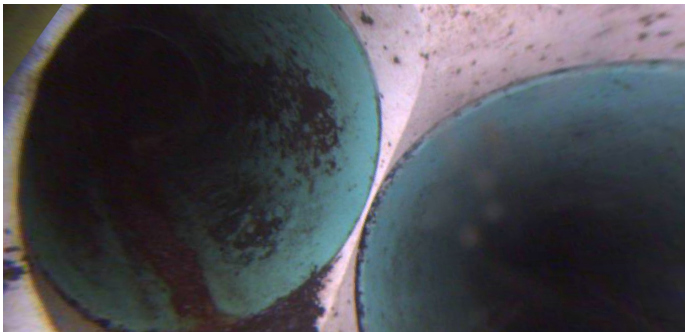
Code:	TF
Description:	Tap Factory

Distance (ft):	63.8
Structural Grade:	0
O&M Grade:	0
Clock Start/From:	10
Clock To:	
1st Value:	4.000
2nd Value:	
Value Percent:	
Continuous Index:	
Within 8" of Joint:	
Remarks:

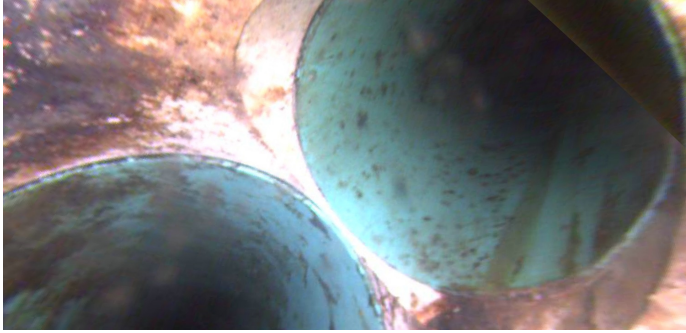
Code: **TF**
Description: **Tap Factory**

Distance (ft): **82.5**
Structural Grade: **0**
O&M Grade: **0**
Clock Start/From: **2**
Clock To:
1st Value: **4.000**
2nd Value:
Value Percent:
Continuous Index:
Within 8" of Joint:
Remarks:

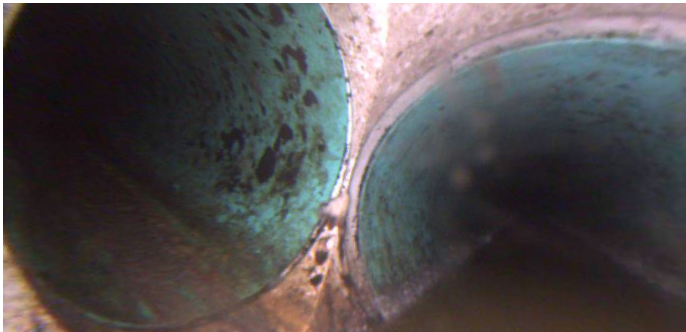
Code: **TF**
Description: **Tap Factory**

Distance (ft): **98.3**
Structural Grade: **0**
O&M Grade: **0**
Clock Start/From: **9**
Clock To:
1st Value: **4.000**
2nd Value:
Value Percent:
Continuous Index:
Within 8" of Joint:
Remarks:

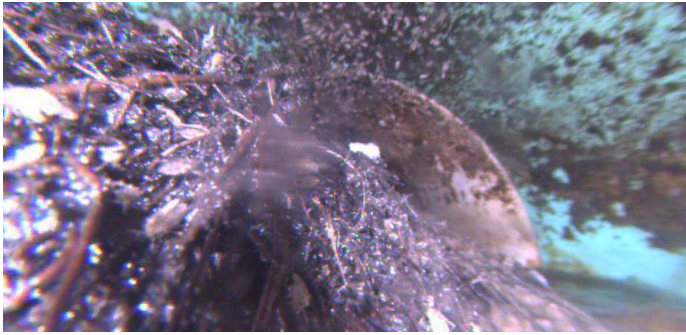
Code: **RBB**
Description: **Roots Ball Barrel**

Distance (ft): **113.6**
Structural Grade: **0**
O&M Grade: **5**
Clock Start/From: **12**
Clock To: **12**
1st Value:
2nd Value:
Value Percent: **90.000**
Continuous Index:
Within 8" of Joint: **NO**
Remarks:

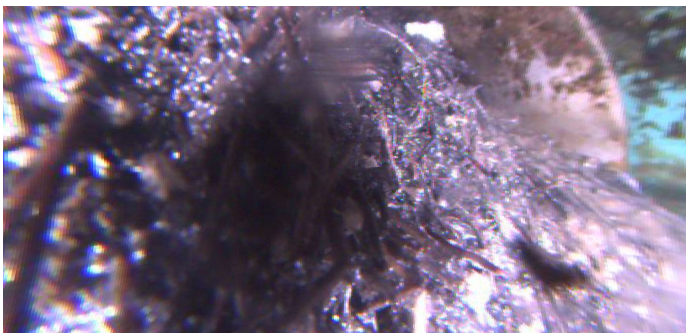
Code: **MSA**
Description: **Abandoned Survey**

Distance (ft): **114.4**
Structural Grade: **0**
O&M Grade: **0**
Clock Start/From:
Clock To:
1st Value:
2nd Value:
Value Percent:
Continuous Index:
Within 8" of Joint: **NO**
Remarks: **root ball infiltration**
