Profile/Photo Observation Report

Street:	E 38th Ave	Flow Control:	Not Controlled
City:	Hobart, IN	Year Renewed:	
Location:	Other	Tape/Media #:	
Purpose:	Not Known	Dia/Height:	12"
Use:	Sanitary	Material:	PVC
Drain Area:	NA	Lining:	
Category:	NA		
Comment:

Location Details:		Direction of Survey:	Downstream
US MH:	M-103-129	DS MH:	M-103-130
		Total Length Surveyed (ft):	244.9

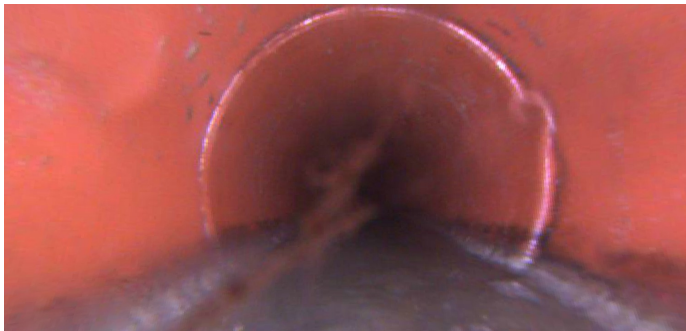
Code: **AMH**
Description: **Manhole**

Distance (ft): **.0**
Structural Grade: **0**
O&M Grade: **0**
Clock Start/From:
Clock To:
1st Value:
2nd Value:
Value Percent:
Continuous Index:
Within 8" of Joint: **NO**
Remarks: **M-103-129**

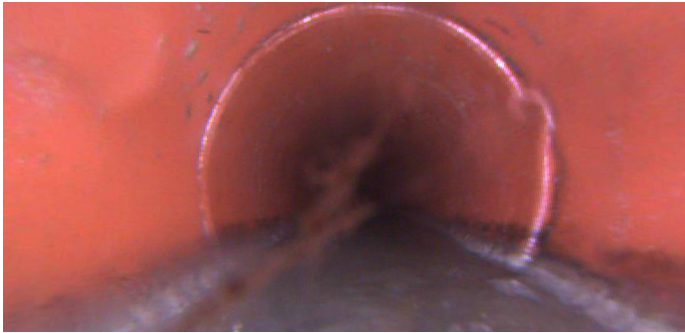
Code:	MWL
Description:	Water Level

Distance (ft):	.0
Structural Grade:	0
O&M Grade:	0
Clock Start/From:	
Clock To:	
1st Value:	
2nd Value:	
Value Percent:	15.000
Continuous Index:	
Within 8" of Joint:	NO
Remarks:

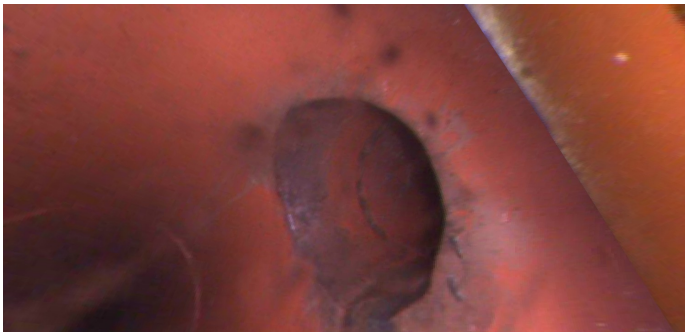
Code:	TF
Description:	Tap Factory

Distance (ft):	42.5
Structural Grade:	0
O&M Grade:	0
Clock Start/From:	2
Clock To:	
1st Value:	4.000
2nd Value:	
Value Percent:	
Continuous Index:	
Within 8" of Joint:	
Remarks:

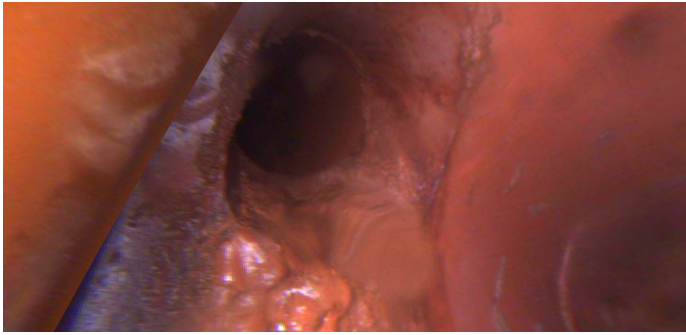
Code: **TF**
Description: **Tap Factory**

Distance (ft): **64.9**
Structural Grade: **0**
O&M Grade: **0**
Clock Start/From: **10**
Clock To:
1st Value: **4.000**
2nd Value:
Value Percent:
Continuous Index:
Within 8" of Joint:
Remarks:

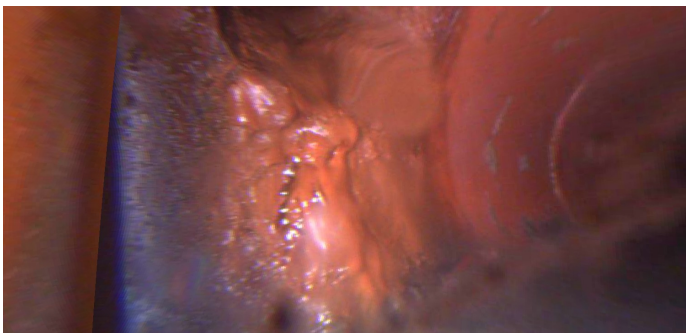
Code: **DAE**
Description: **Deposits Attached Encrustation**

Distance (ft): **64.9**
Structural Grade: **0**
O&M Grade: **2**
Clock Start/From: **7**
Clock To: **9**
1st Value:
2nd Value:
Value Percent: **5.000**
Continuous Index:
Within 8" of Joint: **NO**
Remarks:

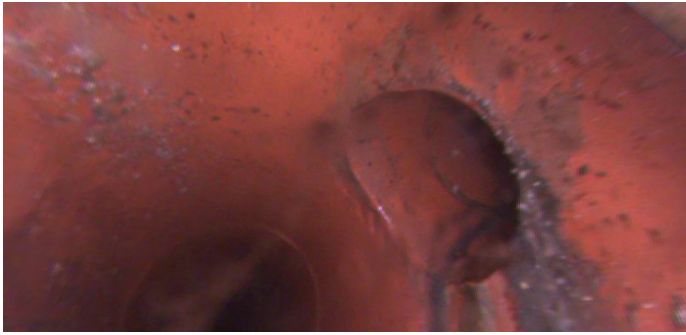
Code: **TF**
Description: **Tap Factory**

Distance (ft): **81.7**
Structural Grade: **0**
O&M Grade: **0**
Clock Start/From: **2**
Clock To:
1st Value: **4.000**
2nd Value:
Value Percent:
Continuous Index:
Within 8" of Joint:
Remarks:

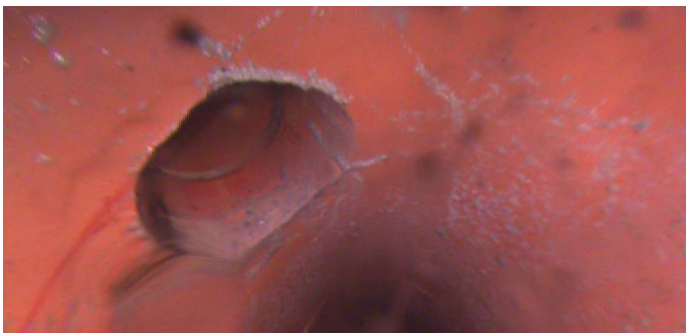
Code: **TF**
Description: **Tap Factory**

Distance (ft): **133.6**
Structural Grade: **0**
O&M Grade: **0**
Clock Start/From: **10**
Clock To:
1st Value: **4.000**
2nd Value:
Value Percent:
Continuous Index:
Within 8" of Joint:
Remarks:

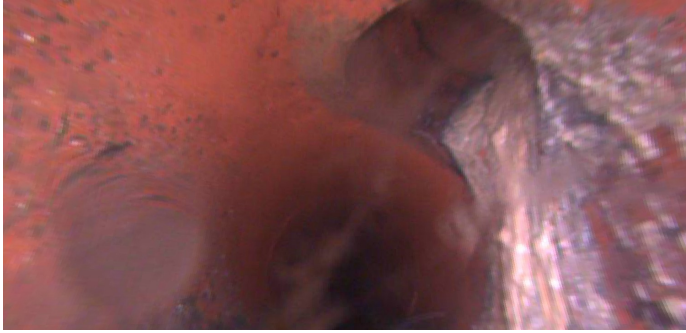
Code: **TFD**
Description: **Tap Factory Defective**

Distance (ft): **145.7**
Structural Grade: **0**
O&M Grade: **2**
Clock Start/From: **2**
Clock To:
1st Value: **4.000**
2nd Value:
Value Percent:
Continuous Index:
Within 8" of Joint:
Remarks:

**DEPOSITS ATTACHED UNKNOWN;
BLOCKING MOUTH OF TAP**

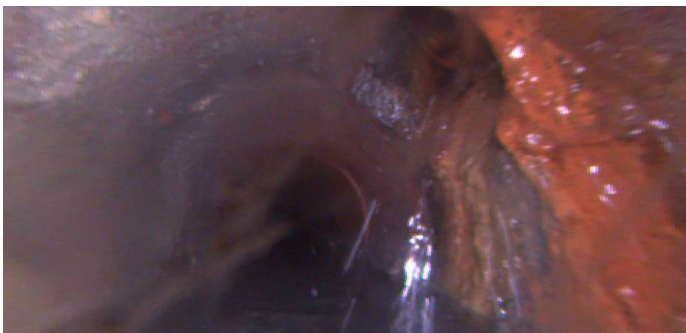
Code: **TFA**
Description: **Tap Factory Active**

Distance (ft): **177.8**
Structural Grade: **0**
O&M Grade: **0**
Clock Start/From: **2**
Clock To:
1st Value: **4.000**
2nd Value:
Value Percent:
Continuous Index:
Within 8" of Joint:
Remarks:

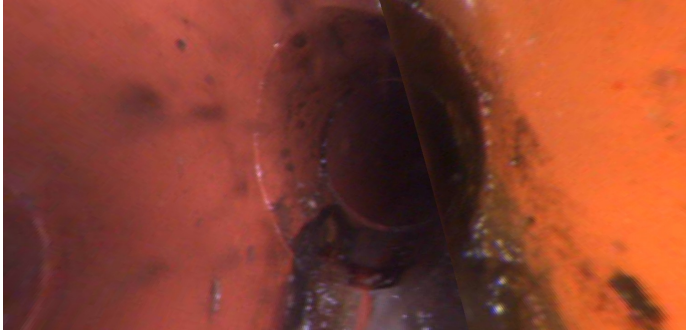
Code: **TF**
Description: **Tap Factory**

Distance (ft): **232.5**
Structural Grade: **0**
O&M Grade: **0**
Clock Start/From: **2**
Clock To:
1st Value: **4.000**
2nd Value:
Value Percent:
Continuous Index:
Within 8" of Joint:
Remarks:

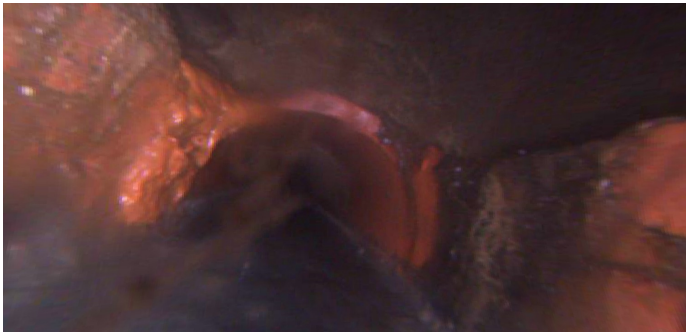
Code: **AMH**
Description: **Manhole**

Distance (ft): **244.9**
Structural Grade: **0**
O&M Grade: **0**
Clock Start/From:
Clock To:
1st Value:
2nd Value:
Value Percent:
Continuous Index:
Within 8" of Joint: **NO**
Remarks: **M-103-130**
