Profile/Photo Observation Report

Date:	03/22/2018	Weather:		Coding:	PACP 6.0
Pipe Length (ft):	331.9	Owner:	NA	Pre Clean:	Not Known
P.O.#:		Surveyor:	Selasie Honu	PSR:	P-103-131-127
Customer:		Clean Date:	01/01/1900	Shape:	C

Street:	W 38TH AVE	Flow Control:	Not Controlled
City:	Hobart, IN	Year Renewed:	
Location:	Other	Tape/Media #:	
Purpose:	Not Known	Dia/Height:	8"
Use:	Sanitary	Material:	PVC
Drain Area:	NA	Lining:	
Category:	NA		
Comment:

Location Details:		Direction of Survey:	Upstream
US MH:	M-103-131	DS MH:	M-103-127
		Total Length Surveyed (ft):	285.8

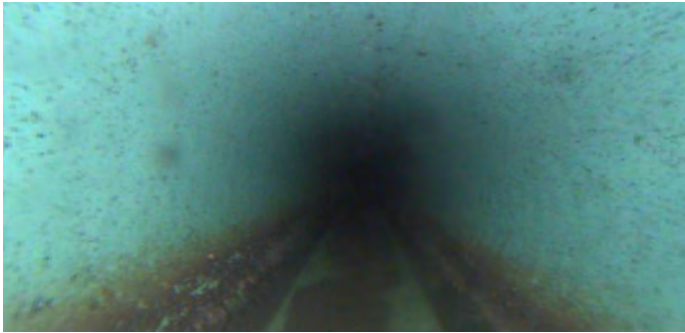
Code:	MWL
Description:	Water Level

Distance (ft):	.0
Structural Grade:	0
O&M Grade:	0
Clock Start/From:	
Clock To:	
1st Value:	
2nd Value:	
Value Percent:	5.000
Continuous Index:	
Within 8" of Joint:	NO
Remarks:

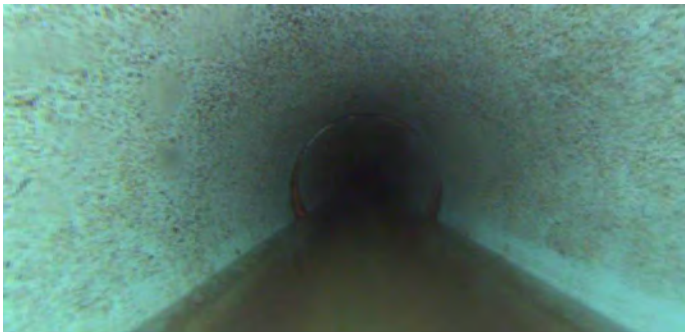
Code:	DAE
Description:	Deposits Attached Encrustation

Distance (ft):	121.9
Structural Grade:	0
O&M Grade:	2
Clock Start/From:	7
Clock To:	5
1st Value:	
2nd Value:	
Value Percent:	5.000
Continuous Index:	
Within 8" of Joint:	YES
Remarks:

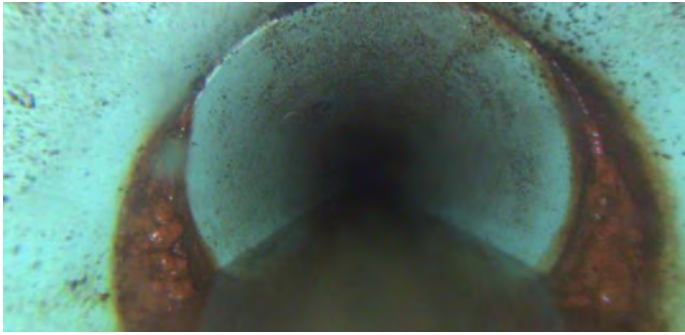
Code: **IW**
Description: **Infil Weeper**

Distance (ft): **122.9**
Structural Grade: **0**
O&M Grade: **2**
Clock Start/From: **8**
Clock To: **4**
1st Value:
2nd Value:
Value Percent:
Continuous Index:
Within 8" of Joint: **YES**
Remarks:

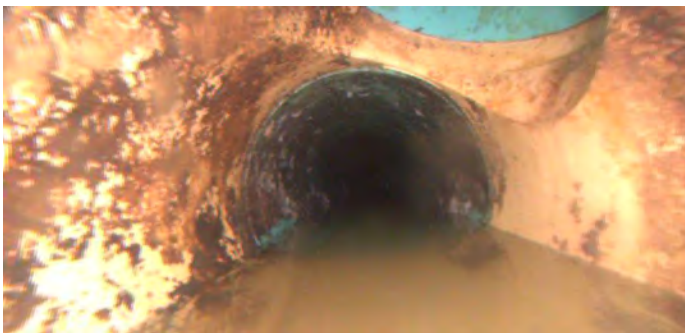
Code: **TF**
Description: **Tap Factory**

Distance (ft): **280.5**
Structural Grade: **0**
O&M Grade: **0**
Clock Start/From: **12**
Clock To:
1st Value: **4.000**
2nd Value:
Value Percent:
Continuous Index:
Within 8" of Joint:
Remarks:

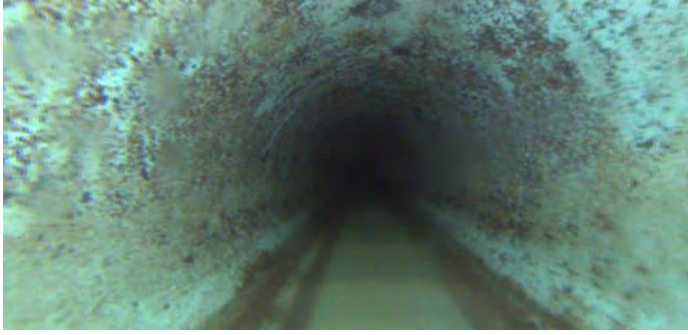
Code:	MSA
Description:	Abandoned Survey
Distance (ft):	285.8
Structural Grade:	0
O&M Grade:	0
Clock Start/From:	
Clock To:	
1st Value:	
2nd Value:	
Value Percent:	
Continuous Index:	
Within 8" of Joint:	NO
Remarks:	camera stopped
