Profile/Photo Observation Report

Street:	W 38TH AVE	Flow Control:	Not Controlled
City:	Hobart, IN	Year Renewed:	
Location:	Other	Tape/Media #:	
Purpose:	Not Known	Dia/Height:	8"
Use:	Sanitary	Material:	PVC
Drain Area:	NA	Lining:	
Category:	NA		
Comment:

Location Details:		Direction of Survey:	Upstream
US MH:	M-103-131	DS MH:	M-103-127
		Total Length Surveyed (ft):	330.6

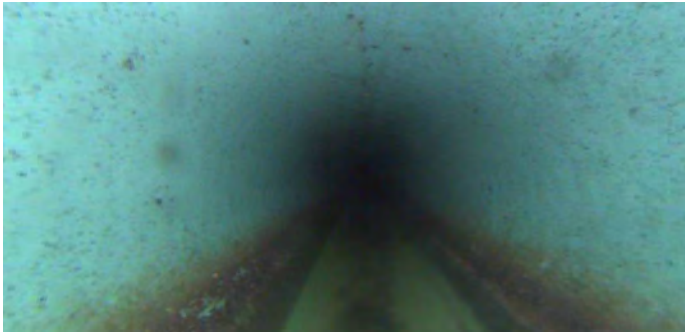
Code:	MWL
Description:	Water Level

Distance (ft):	.0
Structural Grade:	0
O&M Grade:	0
Clock Start/From:	
Clock To:	
1st Value:	
2nd Value:	
Value Percent:	5.000
Continuous Index:	
Within 8" of Joint:	NO
Remarks:

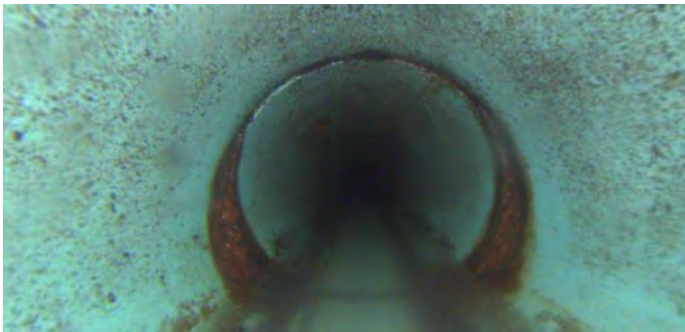
Code:	IW
Description:	Infil Weeper

Distance (ft):	122.1
Structural Grade:	0
O&M Grade:	2
Clock Start/From:	8
Clock To:	4
1st Value:	
2nd Value:	
Value Percent:	
Continuous Index:	
Within 8" of Joint:	YES
Remarks:

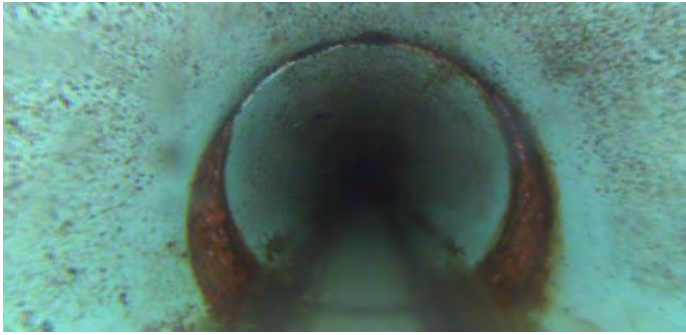
Code: **DAE**
Description: **Deposits Attached Encrustation**

Distance (ft): **122.1**
Structural Grade: **0**
O&M Grade: **2**
Clock Start/From: **7**
Clock To: **5**
1st Value:
2nd Value:
Value Percent: **5.000**
Continuous Index:
Within 8" of Joint: **YES**
Remarks:

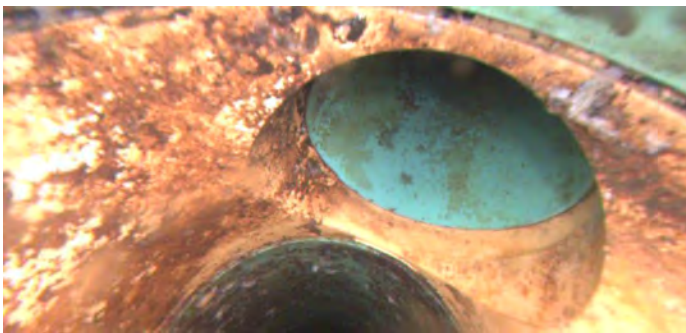
Code: **TF**
Description: **Tap Factory**

Distance (ft): **279.7**
Structural Grade: **0**
O&M Grade: **0**
Clock Start/From: **1**
Clock To:
1st Value: **4.000**
2nd Value:
Value Percent:
Continuous Index:
Within 8" of Joint:
Remarks:

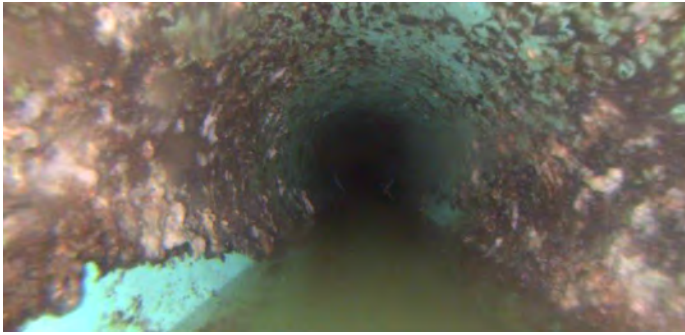
Code: **DAGS**
Description: **Deposits Attached Grease**

Distance (ft): **280.3**
Structural Grade: **0**
O&M Grade: **2**
Clock Start/From: **8**
Clock To: **4**
1st Value:
2nd Value:
Value Percent: **5.000**
Continuous Index:
Within 8" of Joint: **NO**
Remarks:

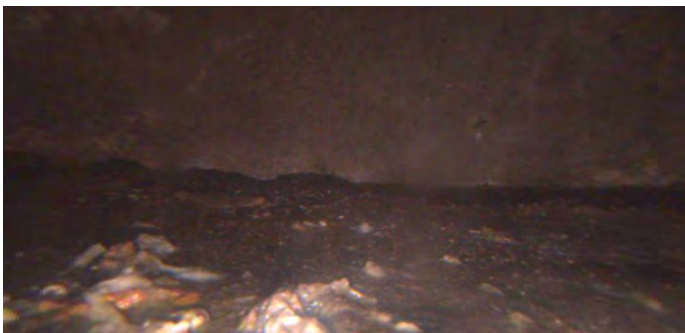
Code: **AMH**
Description: **Manhole**

Distance (ft): **330.6**
Structural Grade: **0**
O&M Grade: **0**
Clock Start/From:
Clock To:
1st Value:
2nd Value:
Value Percent:
Continuous Index:
Within 8" of Joint: **NO**
Remarks: **M-103-131**
