Profile/Photo Observation Report

Street:	E 38th Ave	Flow Control:	Not Controlled
City:	Hobart, IN	Year Renewed:	
Location:	Other	Tape/Media #:	
Purpose:	Not Known	Dia/Height:	8"
Use:	Sanitary	Material:	PVC
Drain Area:	NA	Lining:	
Category:	NA		
Comment:

Location Details:		Direction of Survey:	Downstream
US MH:	M-103-131	DS MH:	M-103-132
		Total Length Surveyed (ft):	181.5

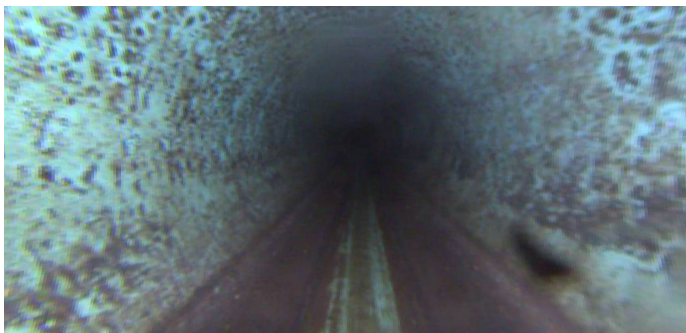
Code: **AMH**
Description: **Manhole**

Distance (ft): **.0**
Structural Grade: **0**
O&M Grade: **0**
Clock Start/From:
Clock To:
1st Value:
2nd Value:
Value Percent:
Continuous Index:
Within 8" of Joint: **NO**
Remarks: **M-103-131**

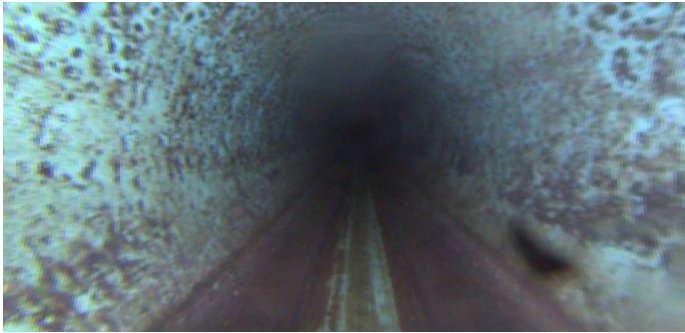
Code:	MWL
Description:	Water Level

Distance (ft):	.0
Structural Grade:	0
O&M Grade:	0
Clock Start/From:	
Clock To:	
1st Value:	
2nd Value:	
Value Percent:	5.000
Continuous Index:	
Within 8" of Joint:	NO
Remarks:

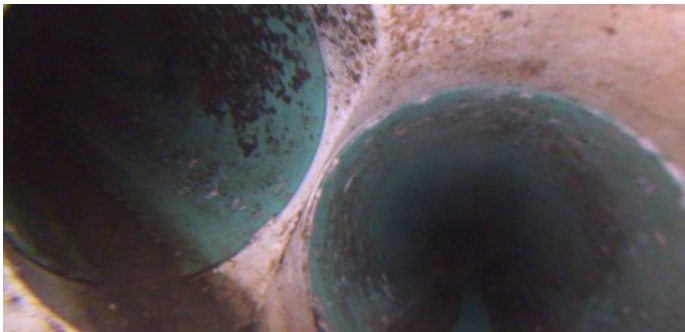
Code:	TF
Description:	Tap Factory

Distance (ft):	91.7
Structural Grade:	0
O&M Grade:	0
Clock Start/From:	9
Clock To:	
1st Value:	4.000
2nd Value:	
Value Percent:	
Continuous Index:	
Within 8" of Joint:	
Remarks:

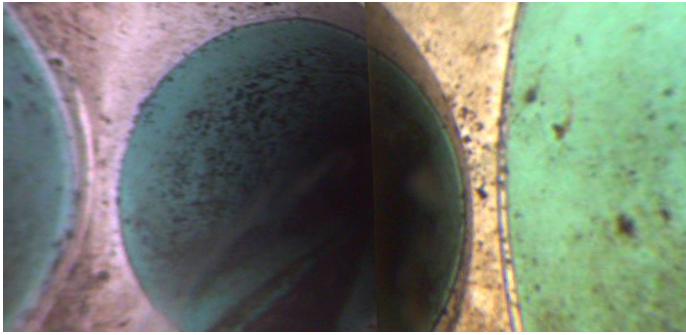
Code: **TF**
Description: **Tap Factory**

Distance (ft): **96.9**
Structural Grade: **0**
O&M Grade: **0**
Clock Start/From: **3**
Clock To:
1st Value: **4.000**
2nd Value:
Value Percent:
Continuous Index:
Within 8" of Joint:
Remarks:

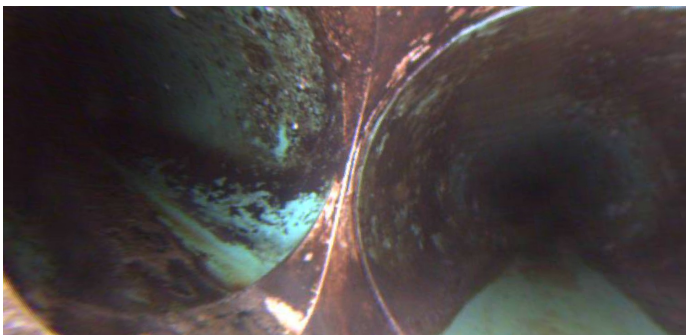
Code: **TF**
Description: **Tap Factory**

Distance (ft): **121.0**
Structural Grade: **0**
O&M Grade: **0**
Clock Start/From: **9**
Clock To:
1st Value: **4.000**
2nd Value:
Value Percent:
Continuous Index:
Within 8" of Joint:
Remarks:

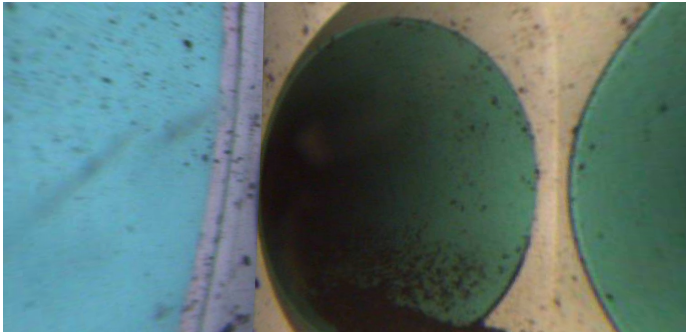
Code: **TF**
Description: **Tap Factory**

Distance (ft): **155.7**
Structural Grade: **0**
O&M Grade: **0**
Clock Start/From: **3**
Clock To:
1st Value: **4.000**
2nd Value:
Value Percent:
Continuous Index:
Within 8" of Joint:
Remarks:

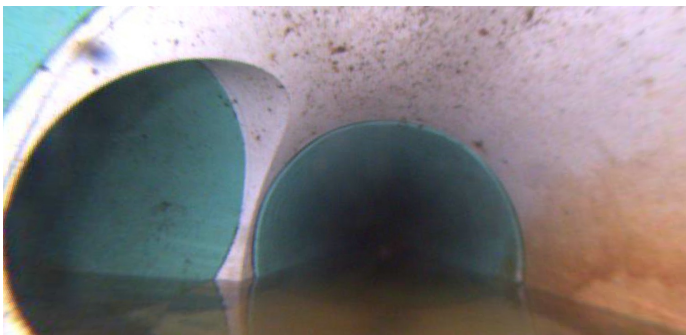
Code: **TFA**
Description: **Tap Factory Active**

Distance (ft): **175.2**
Structural Grade: **0**
O&M Grade: **0**
Clock Start/From: **9**
Clock To:
1st Value: **4.000**
2nd Value:
Value Percent:
Continuous Index:
Within 8" of Joint:
Remarks:

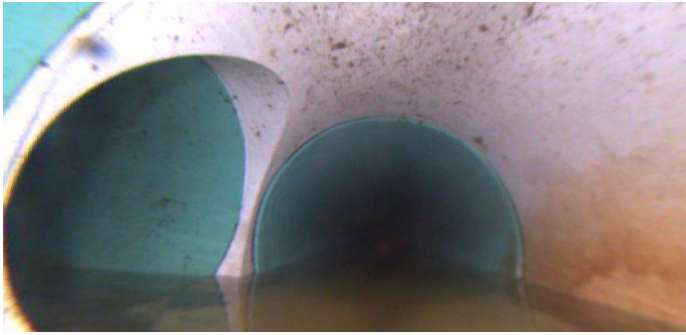
Code: **MWL**
Description: **Water Level**

Distance (ft): **175.2**
Structural Grade: **0**
O&M Grade: **0**
Clock Start/From:
Clock To:
1st Value:
2nd Value:
Value Percent: **30.000**
Continuous Index:
Within 8" of Joint: **NO**
Remarks:

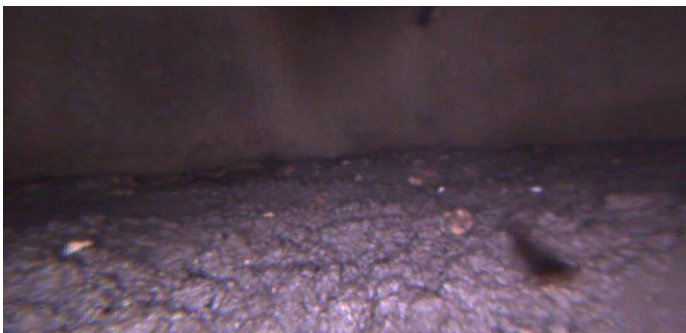
Code: **AMH**
Description: **Manhole**

Distance (ft): **181.5**
Structural Grade: **0**
O&M Grade: **0**
Clock Start/From:
Clock To:
1st Value:
2nd Value:
Value Percent:
Continuous Index:
Within 8" of Joint: **NO**
Remarks: **M-103-132**
