Profile/Photo Observation Report

Date:	03/22/2018	Weather:		Coding:	PACP 6.0
Pipe Length (ft):	262.6	Owner:	NA	Pre Clean:	Not Known
P.O.#:		Surveyor:	Selasie Honu	PSR:	P-103-133-131
Customer:		Clean Date:	01/01/1900	Shape:	C

Street:	W 38TH AVE	Flow Control:	Not Controlled
City:	Hobart, IN	Year Renewed:	
Location:	Other	Tape/Media #:	
Purpose:	Not Known	Dia/Height:	8"
Use:	Sanitary	Material:	PVC
Drain Area:	NA	Lining:	
Category:	NA		
Comment:

Location Details:		Direction of Survey:	Upstream
US MH:	M-103-133	DS MH:	M-103-131
		Total Length Surveyed (ft):	260.0

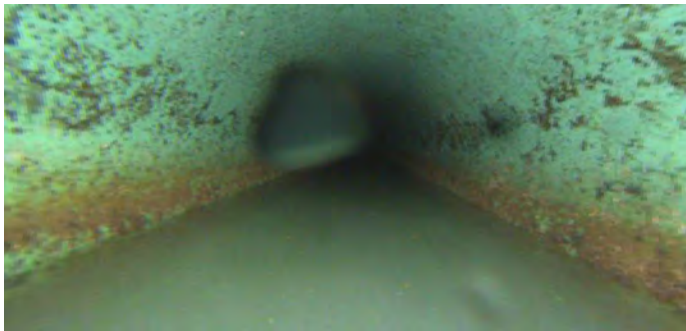
Code: **AMH**
Description: **Manhole**

Distance (ft): **.0**
Structural Grade: **0**
O&M Grade: **0**
Clock Start/From:
Clock To:
1st Value:
2nd Value:
Value Percent:
Continuous Index:
Within 8" of Joint: **NO**
Remarks: **M-103-131**

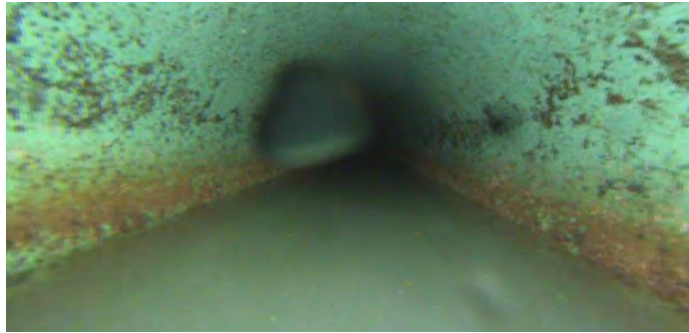
Code: **MWL**
Description: **Water Level**

Distance (ft): **.0**
Structural Grade: **0**
O&M Grade: **0**
Clock Start/From:
Clock To:
1st Value:
2nd Value:
Value Percent: **5.000**
Continuous Index:
Within 8" of Joint: **NO**
Remarks:

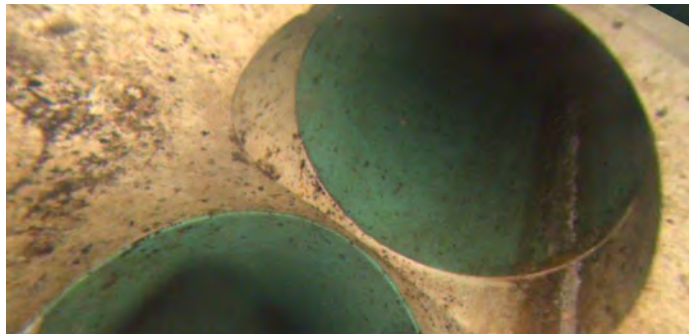
Code: **TF**
Description: **Tap Factory**

Distance (ft): **93.5**
Structural Grade: **0**
O&M Grade: **0**
Clock Start/From: **1**
Clock To:
1st Value: **4.000**
2nd Value:
Value Percent:
Continuous Index:
Within 8" of Joint:
Remarks:

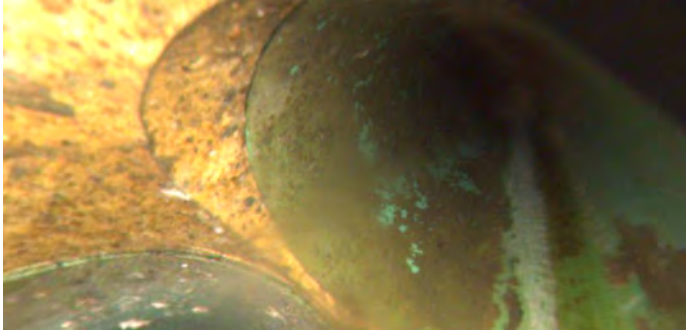
Code: **TF**
Description: **Tap Factory**

Distance (ft): **105.3**
Structural Grade: **0**
O&M Grade: **0**
Clock Start/From: **10**
Clock To:
1st Value: **4.000**
2nd Value:
Value Percent:
Continuous Index:
Within 8" of Joint:
Remarks:

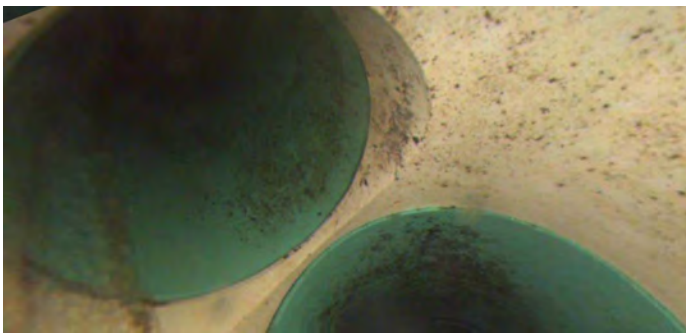
Code: **TFA**
Description: **Tap Factory Active**

Distance (ft): **174.2**
Structural Grade: **0**
O&M Grade: **0**
Clock Start/From: **11**
Clock To:
1st Value: **4.000**
2nd Value:
Value Percent:
Continuous Index:
Within 8" of Joint:
Remarks:

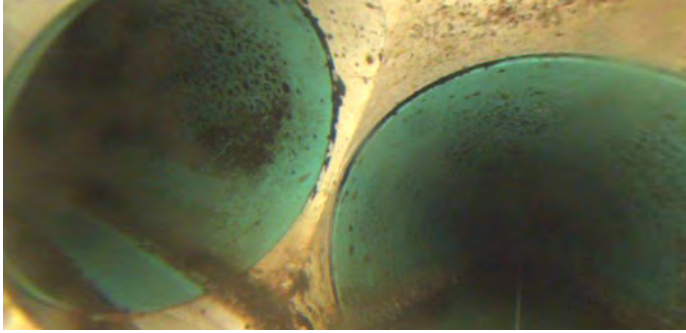
Code: **TFA**
Description: **Tap Factory Active**

Distance (ft): **187.6**
Structural Grade: **0**
O&M Grade: **0**
Clock Start/From: **3**
Clock To:
1st Value: **4.000**
2nd Value:
Value Percent:
Continuous Index:
Within 8" of Joint:
Remarks:

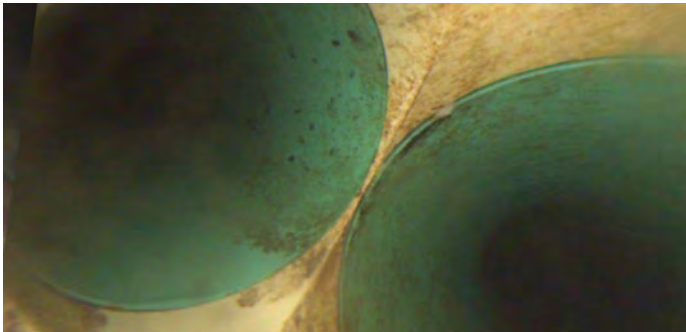
Code: **TF**
Description: **Tap Factory**

Distance (ft): **217.0**
Structural Grade: **0**
O&M Grade: **0**
Clock Start/From: **2**
Clock To:
1st Value: **4.000**
2nd Value:
Value Percent:
Continuous Index:
Within 8" of Joint:
Remarks:

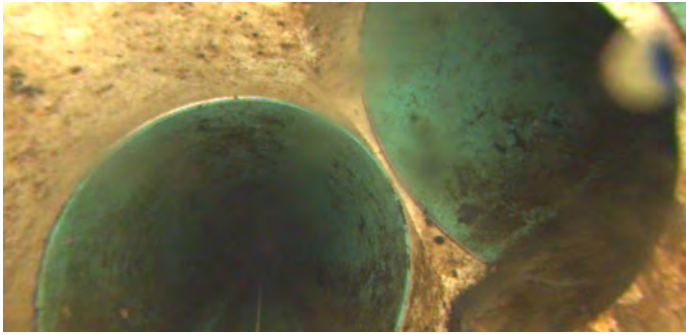
Code: **TFA**
Description: **Tap Factory Active**

Distance (ft): **242.2**
Structural Grade: **0**
O&M Grade: **0**
Clock Start/From: **9**
Clock To:
1st Value: **4.000**
2nd Value:
Value Percent:
Continuous Index:
Within 8" of Joint:
Remarks:

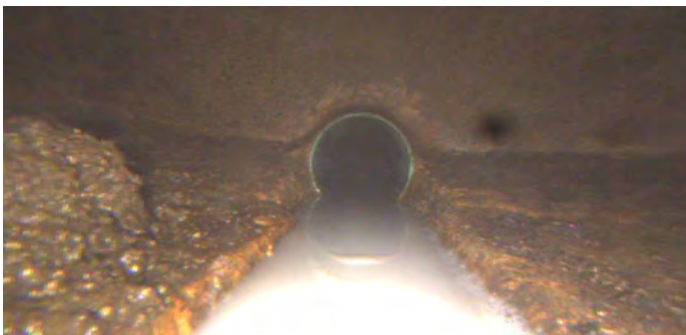
Code: **AMH**
Description: **Manhole**

Distance (ft): **260.0**
Structural Grade: **0**
O&M Grade: **0**
Clock Start/From:
Clock To:
1st Value:
2nd Value:
Value Percent:
Continuous Index:
Within 8" of Joint: **NO**
Remarks: **M-103-133**
