## Profile/Photo Observation Report

Street:	<b>E 38th Ave</b>	Flow Control:	<b>Not Controlled</b>
City:	<b>Hobart, IN</b>	Year Renewed:	
Location:	<b>Other</b>	Tape/Media #:	
Purpose:	<b>Not Known</b>	Dia/Height:	<b>8"</b>
Use:	<b>Sanitary</b>	Material:	<b>PVC</b>
Drain Area:	<b>NA</b>	Lining:	
Category:	<b>NA</b>		
Comment:

Location Details:		Direction of Survey:	<b>Upstream</b>
US MH:	<b>M-103-133</b>	DS MH:	<b>M-103-131</b>
		Total Length Surveyed (ft):	<b>260.0</b>

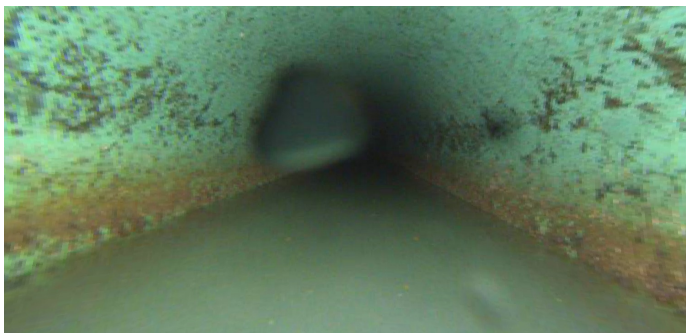
Code: **AMH**  
Description: **Manhole**

Distance (ft): **.0**  
Structural Grade: **0**  
O&M Grade: **0**  
Clock Start/From:  
Clock To:  
1st Value:  
2nd Value:  
Value Percent:  
Continuous Index:  
Within 8" of Joint: **NO**  
Remarks: **M-103-131**

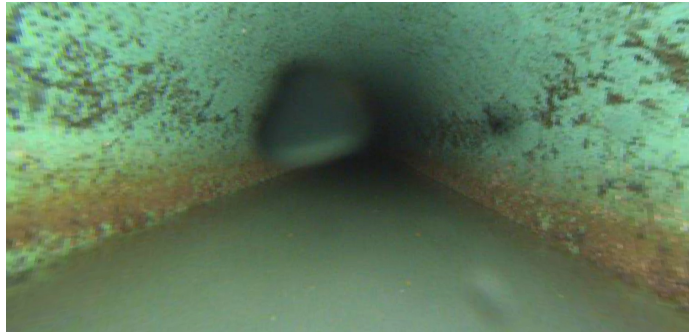
Code: **MWL**  
Description: **Water Level**

Distance (ft): **.0**  
Structural Grade: **0**  
O&M Grade: **0**  
Clock Start/From:  
Clock To:  
1st Value:  
2nd Value:  
Value Percent: **5.000**  
Continuous Index:  
Within 8" of Joint: **NO**  
Remarks:

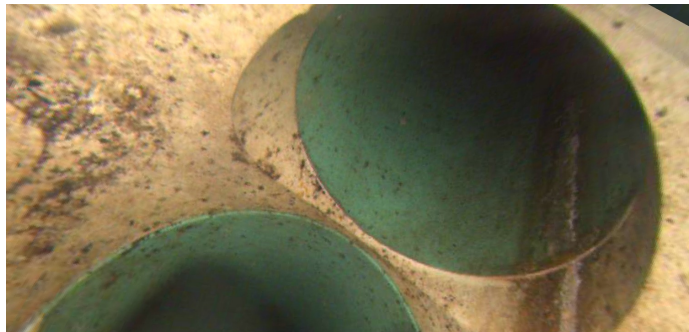
Code: **TF**  
Description: **Tap Factory**

Distance (ft): **93.5**  
Structural Grade: **0**  
O&M Grade: **0**  
Clock Start/From: **1**  
Clock To:  
1st Value: **4.000**  
2nd Value:  
Value Percent:  
Continuous Index:  
Within 8" of Joint:  
Remarks:

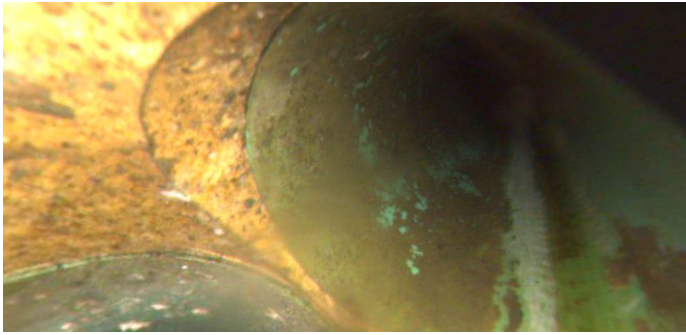
Code: **TF**  
Description: **Tap Factory**

Distance (ft): **105.3**  
Structural Grade: **0**  
O&M Grade: **0**  
Clock Start/From: **10**  
Clock To:  
1st Value: **4.000**  
2nd Value:  
Value Percent:  
Continuous Index:  
Within 8" of Joint:  
Remarks:

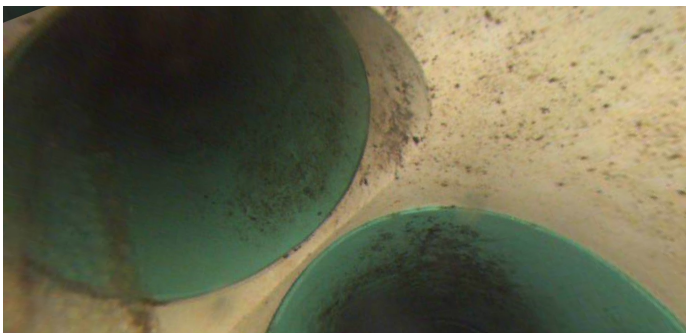
Code: **TFA**  
Description: **Tap Factory Active**

Distance (ft): **174.2**  
Structural Grade: **0**  
O&M Grade: **0**  
Clock Start/From: **11**  
Clock To:  
1st Value: **4.000**  
2nd Value:  
Value Percent:  
Continuous Index:  
Within 8" of Joint:  
Remarks:

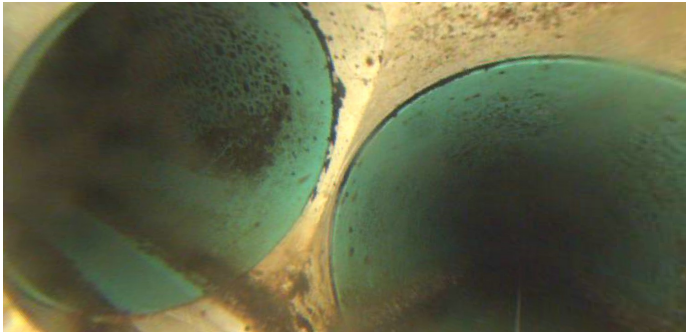
Code: **TFA**  
Description: **Tap Factory Active**

Distance (ft): **187.6**  
Structural Grade: **0**  
O&M Grade: **0**  
Clock Start/From: **3**  
Clock To:  
1st Value: **4.000**  
2nd Value:  
Value Percent:  
Continuous Index:  
Within 8" of Joint:  
Remarks:

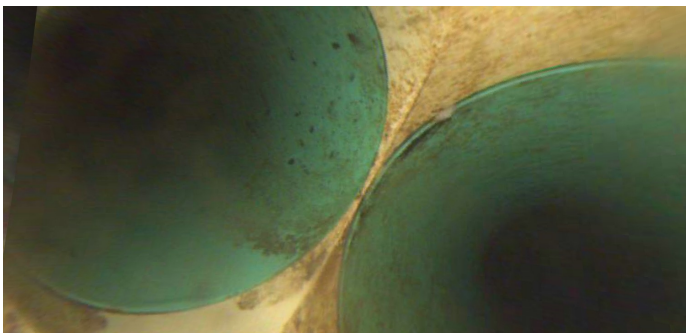
Code: **TF**  
Description: **Tap Factory**

Distance (ft): **217.0**  
Structural Grade: **0**  
O&M Grade: **0**  
Clock Start/From: **2**  
Clock To:  
1st Value: **4.000**  
2nd Value:  
Value Percent:  
Continuous Index:  
Within 8" of Joint:  
Remarks:

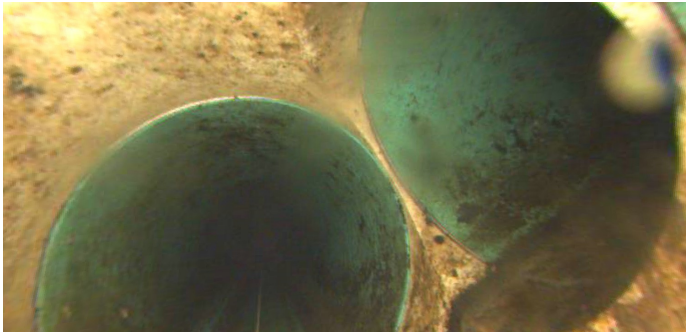
Code: **TFA**  
Description: **Tap Factory Active**

Distance (ft): **242.2**  
Structural Grade: **0**  
O&M Grade: **0**  
Clock Start/From: **9**  
Clock To:  
1st Value: **4.000**  
2nd Value:  
Value Percent:  
Continuous Index:  
Within 8" of Joint:  
Remarks:

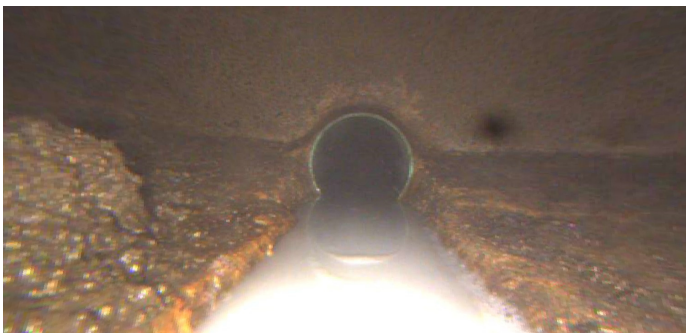
Code: **AMH**  
Description: **Manhole**

Distance (ft): **260.0**  
Structural Grade: **0**  
O&M Grade: **0**  
Clock Start/From:  
Clock To:  
1st Value:  
2nd Value:  
Value Percent:  
Continuous Index:  
Within 8" of Joint: **NO**  
Remarks: **M-103-133**
