Profile/Photo Observation Report

Street:	ALLEY BEWTWEEN SWIFT ST & MISS	Flow Control:	Not Controlled
City:	Hobart, IN	Year Renewed:	
Location:	Other	Tape/Media #:	
Purpose:	Not Known	Dia/Height:	8"
Use:	Sanitary	Material:	PVC
Drain Area:	NA	Lining:	
Category:	NA		
Comment:

Location Details:		Direction of Survey:	Downstream
US MH:	M-103-134	DS MH:	M-103-133
		Total Length Surveyed (ft):	210.8

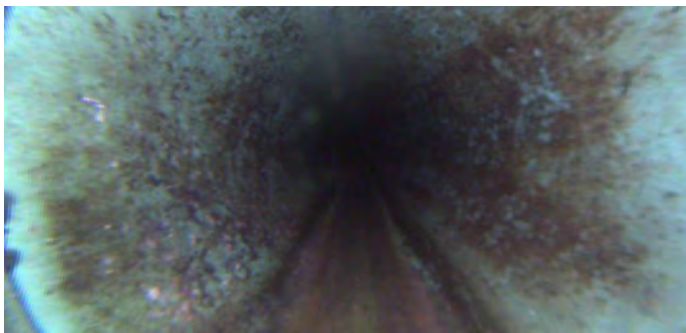
Code: **AMH**
Description: **Manhole**

Distance (ft): **.0**
Structural Grade: **0**
O&M Grade: **0**
Clock Start/From:
Clock To:
1st Value:
2nd Value:
Value Percent:
Continuous Index:
Within 8" of Joint: **NO**
Remarks: **M-103-134**

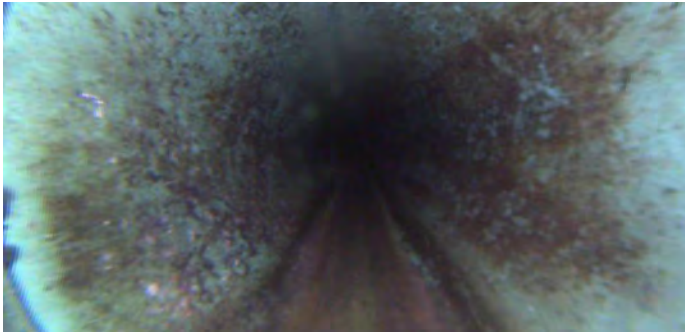
Code:	MWL
Description:	Water Level

Distance (ft):	.0
Structural Grade:	0
O&M Grade:	0
Clock Start/From:	
Clock To:	
1st Value:	
2nd Value:	
Value Percent:	5.000
Continuous Index:	
Within 8" of Joint:	NO
Remarks:

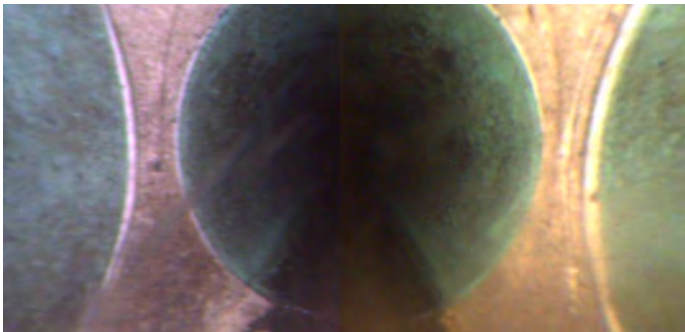
Code:	TFA
Description:	Tap Factory Active

Distance (ft):	48.5
Structural Grade:	0
O&M Grade:	0
Clock Start/From:	3
Clock To:	
1st Value:	4.000
2nd Value:	
Value Percent:	
Continuous Index:	
Within 8" of Joint:	
Remarks:

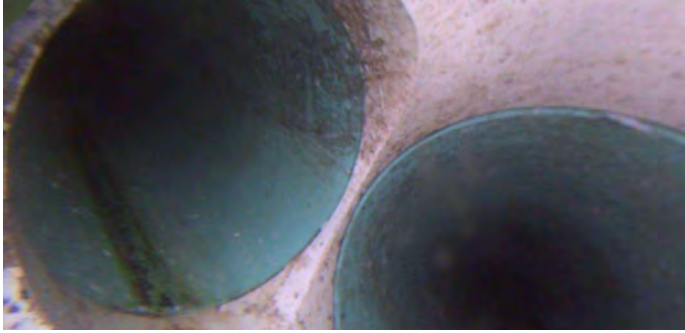
Code: **TF**
Description: **Tap Factory**

Distance (ft): **61.3**
Structural Grade: **0**
O&M Grade: **0**
Clock Start/From: **10**
Clock To:
1st Value: **4.000**
2nd Value:
Value Percent:
Continuous Index:
Within 8" of Joint:
Remarks:

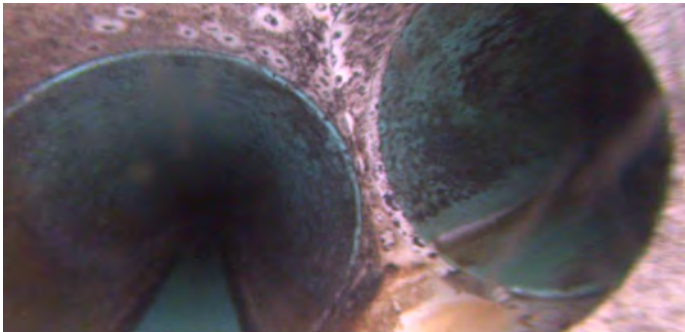
Code: **TFA**
Description: **Tap Factory Active**

Distance (ft): **85.7**
Structural Grade: **0**
O&M Grade: **0**
Clock Start/From: **3**
Clock To:
1st Value: **4.000**
2nd Value:
Value Percent:
Continuous Index:
Within 8" of Joint:
Remarks:

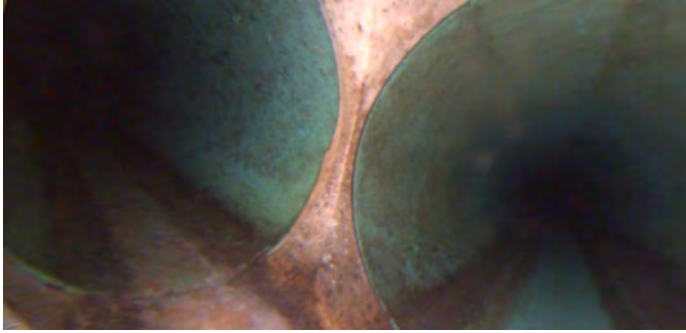
Code: **TFA**
Description: **Tap Factory Active**

Distance (ft): **121.7**
Structural Grade: **0**
O&M Grade: **0**
Clock Start/From: **9**
Clock To:
1st Value: **4.000**
2nd Value:
Value Percent:
Continuous Index:
Within 8" of Joint:
Remarks:

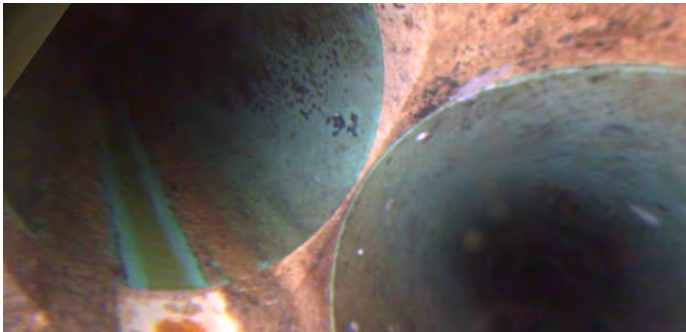
Code: **TF**
Description: **Tap Factory**

Distance (ft): **160.8**
Structural Grade: **0**
O&M Grade: **0**
Clock Start/From: **10**
Clock To:
1st Value: **4.000**
2nd Value:
Value Percent:
Continuous Index:
Within 8" of Joint:
Remarks:

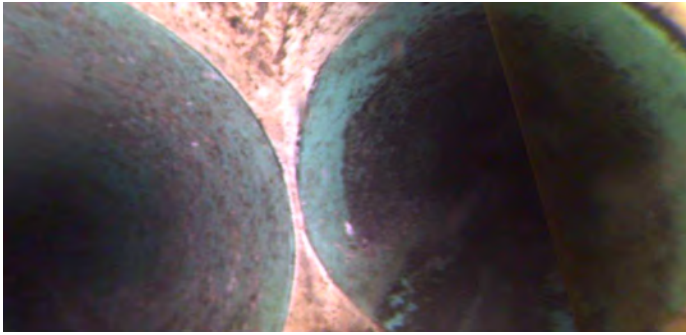
Code: **TF**
Description: **Tap Factory**

Distance (ft): **165.8**
Structural Grade: **0**
O&M Grade: **0**
Clock Start/From: **2**
Clock To:
1st Value: **4.000**
2nd Value:
Value Percent:
Continuous Index:
Within 8" of Joint:
Remarks:

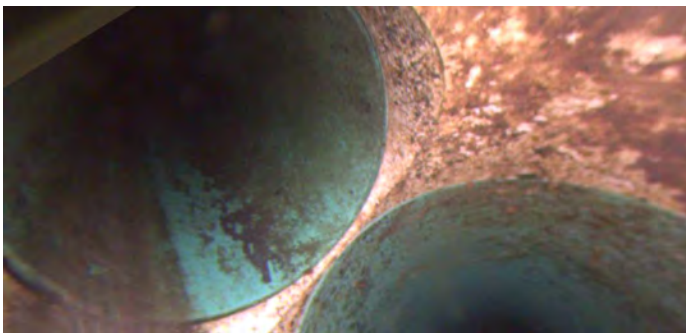
Code: **TF**
Description: **Tap Factory**

Distance (ft): **205.0**
Structural Grade: **0**
O&M Grade: **0**
Clock Start/From: **10**
Clock To:
1st Value: **4.000**
2nd Value:
Value Percent:
Continuous Index:
Within 8" of Joint:
Remarks:
