## Profile/Photo Observation Report

Street:	<b>E 38th Ave</b>	Flow Control:	<b>Not Controlled</b>
City:	<b>Hobart, IN</b>	Year Renewed:	
Location:	<b>Other</b>	Tape/Media #:	
Purpose:	<b>Not Known</b>	Dia/Height:	<b>8"</b>
Use:	<b>Sanitary</b>	Material:	<b>PVC</b>
Drain Area:	<b>NA</b>	Lining:	
Category:	<b>NA</b>		
Comment:

Location Details:		Direction of Survey:	<b>Downstream</b>
US MH:	<b>M-103-134</b>	DS MH:	<b>M-103-133</b>
		Total Length Surveyed (ft):	<b>210.8</b>

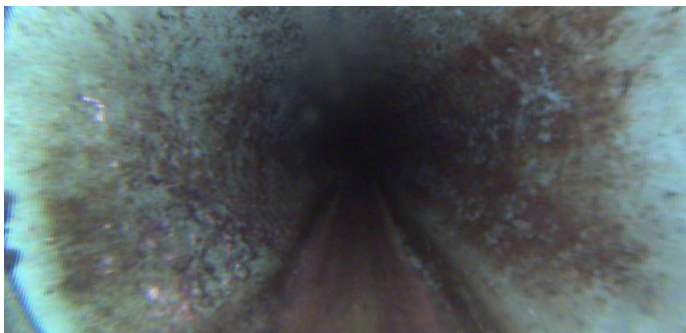
Code: **AMH**  
Description: **Manhole**

Distance (ft): **.0**  
Structural Grade: **0**  
O&M Grade: **0**  
Clock Start/From:  
Clock To:  
1st Value:  
2nd Value:  
Value Percent:  
Continuous Index:  
Within 8" of Joint: **NO**  
Remarks: **M-103-134**

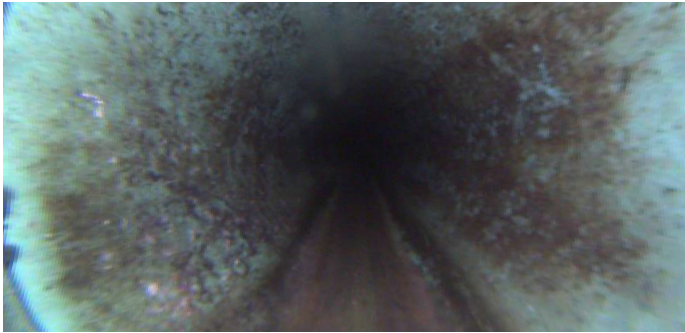
Code:	<b>MWL</b>
Description:	<b>Water Level</b>

Distance (ft):	<b>.0</b>
Structural Grade:	<b>0</b>
O&M Grade:	<b>0</b>
Clock Start/From:	
Clock To:	
1st Value:	
2nd Value:	
Value Percent:	<b>5.000</b>
Continuous Index:	
Within 8" of Joint:	<b>NO</b>
Remarks:

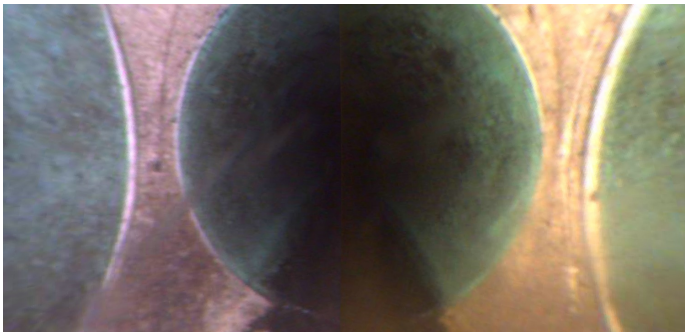
Code:	<b>TFA</b>
Description:	<b>Tap Factory Active</b>

Distance (ft):	<b>48.5</b>
Structural Grade:	<b>0</b>
O&M Grade:	<b>0</b>
Clock Start/From:	<b>3</b>
Clock To:	
1st Value:	<b>4.000</b>
2nd Value:	
Value Percent:	
Continuous Index:	
Within 8" of Joint:	
Remarks:

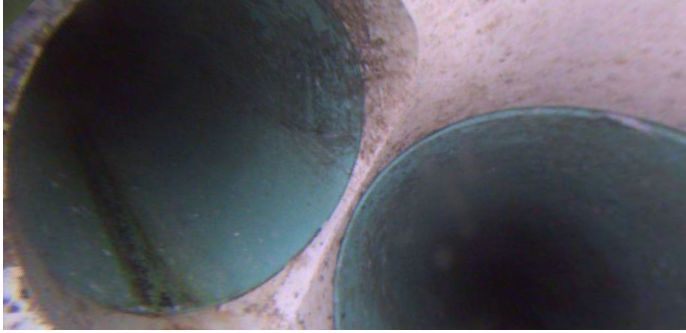
Code: **TF**  
Description: **Tap Factory**

Distance (ft): **61.3**  
Structural Grade: **0**  
O&M Grade: **0**  
Clock Start/From: **10**  
Clock To:  
1st Value: **4.000**  
2nd Value:  
Value Percent:  
Continuous Index:  
Within 8" of Joint:  
Remarks:

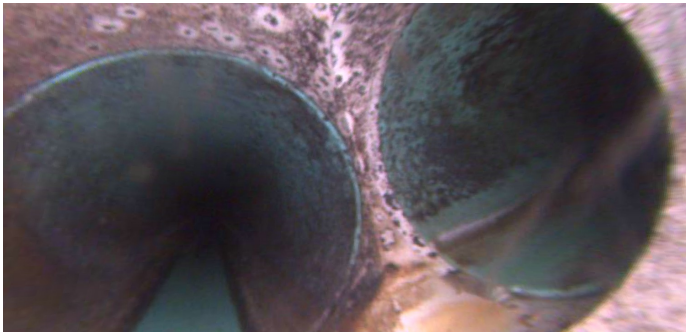
Code: **TFA**  
Description: **Tap Factory Active**

Distance (ft): **85.7**  
Structural Grade: **0**  
O&M Grade: **0**  
Clock Start/From: **3**  
Clock To:  
1st Value: **4.000**  
2nd Value:  
Value Percent:  
Continuous Index:  
Within 8" of Joint:  
Remarks:

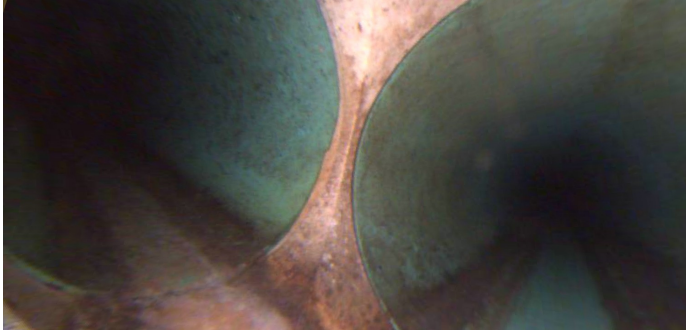
Code: **TFA**  
Description: **Tap Factory Active**

Distance (ft): **121.7**  
Structural Grade: **0**  
O&M Grade: **0**  
Clock Start/From: **9**  
Clock To:  
1st Value: **4.000**  
2nd Value:  
Value Percent:  
Continuous Index:  
Within 8" of Joint:  
Remarks:

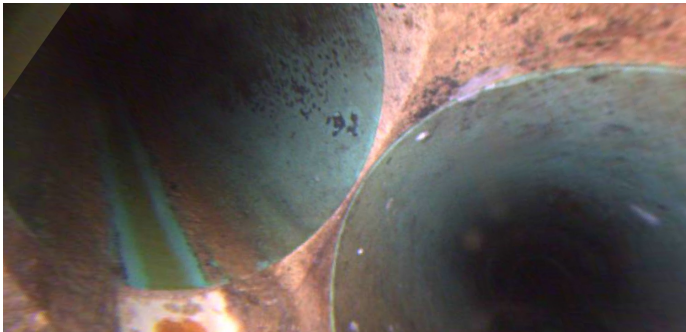
Code: **TF**  
Description: **Tap Factory**

Distance (ft): **160.8**  
Structural Grade: **0**  
O&M Grade: **0**  
Clock Start/From: **10**  
Clock To:  
1st Value: **4.000**  
2nd Value:  
Value Percent:  
Continuous Index:  
Within 8" of Joint:  
Remarks:

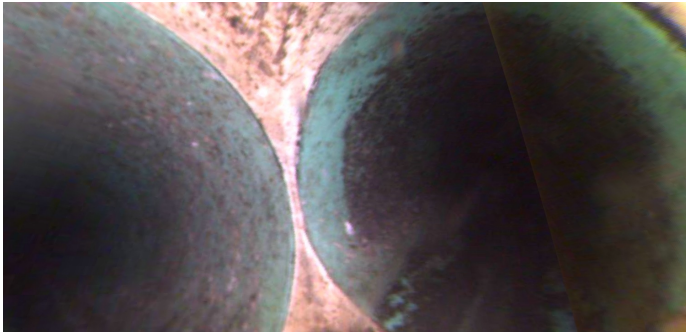
Code: **TF**  
Description: **Tap Factory**

Distance (ft): **165.8**  
Structural Grade: **0**  
O&M Grade: **0**  
Clock Start/From: **2**  
Clock To:  
1st Value: **4.000**  
2nd Value:  
Value Percent:  
Continuous Index:  
Within 8" of Joint:  
Remarks:

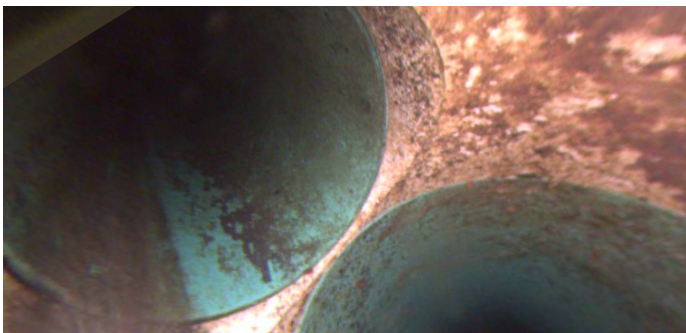
Code: **TF**  
Description: **Tap Factory**

Distance (ft): **205.0**  
Structural Grade: **0**  
O&M Grade: **0**  
Clock Start/From: **10**  
Clock To:  
1st Value: **4.000**  
2nd Value:  
Value Percent:  
Continuous Index:  
Within 8" of Joint:  
Remarks:
