Profile/Photo Observation Report

Date:	04/13/2018	Weather:		Coding:	PACP 6.0
Pipe Length (ft):		Owner:	City of Hobart	Pre Clean:	No Pre-Cleaning
P.O.#:	42-1	Surveyor:	M. Pielacha	PSR:	M-103-135-M-103-135
Customer:	City of Hobart	Clean Date:		Shape:	C

Street:	Off 37th Street	Flow Control:	Not Controlled
City:	Hobart, IN	Year Renewed:	
Location:	Light Highway	Tape/Media #:	DEP 42
Purpose:	Routine Assessment	Dia/Height:	6"
Use:	Sanitary	Material:	PVC
Drain Area:		Lining:	
Category:	NA		
Comment:			
Location Details:		Direction of Survey:	Upstream
US MH:	M-103-135	DS MH:	M-103-135
		Total Length Surveyed (ft):	52.0

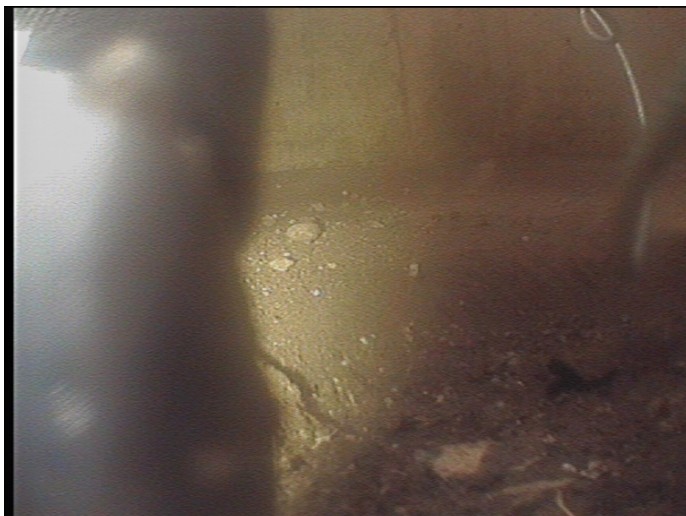
Code: **AMH**
Description: **Manhole**

Distance (ft): **.0**
Structural Grade: **0**
O&M Grade: **0**
Clock Start/From:
Clock To:
1st Value:
2nd Value:
Value Percent:
Continuous Index:
Within 8" of Joint: **NO**
Remarks: **M-103-135**

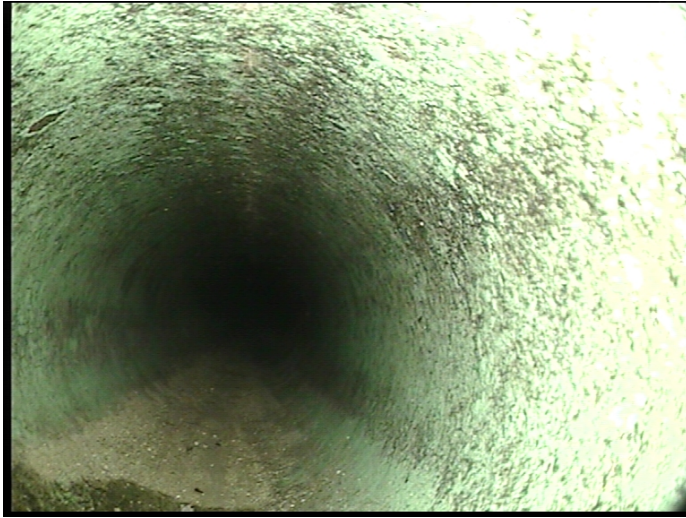
Code:	MWL
Description:	Water Level
Distance (ft):	.0
Structural Grade:	0
O&M Grade:	0
Clock Start/From:	
Clock To:	
1st Value:	
2nd Value:	
Value Percent:	5.000
Continuous Index:	
Within 8" of Joint:	NO
Remarks:

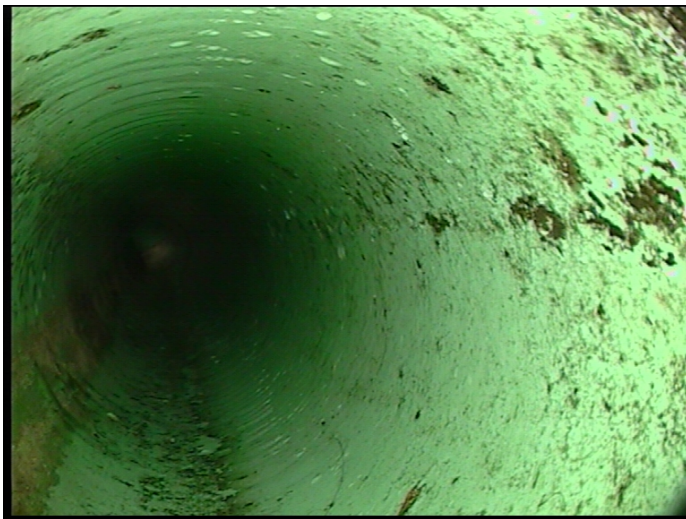
Code:	LL
Description:	Alignment Left
Distance (ft):	51.3
Structural Grade:	0
O&M Grade:	2
Clock Start/From:	
Clock To:	
1st Value:	
2nd Value:	
Value Percent:	20.000
Continuous Index:	
Within 8" of Joint:	NO
Remarks:

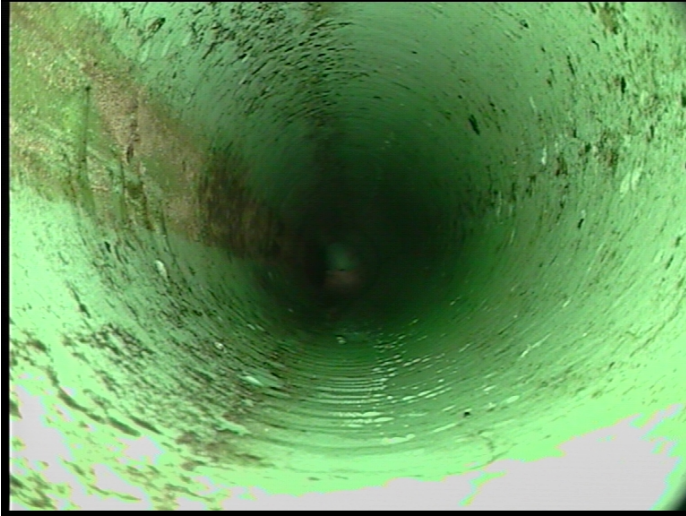
Code:	MSA
Description:	Abandoned Survey
Distance (ft):	51.8
Structural Grade:	0
O&M Grade:	0
Clock Start/From:	
Clock To:	
1st Value:	
2nd Value:	
Value Percent:	
Continuous Index:	
Within 8" of Joint:	NO
Remarks:	can not pass bend
