Profile/Photo Observation Report

Street:	Off 41st Avenue	Flow Control:	
City:	Hobart, IN	Year Renewed:	
Location:	Yard	Tape/Media #:	840
Purpose:	Routine Assessment	Dia/Height:	10"
Use:	Sanitary	Material:	VCP
Drain Area:		Lining:	
Category:	NA		
Comment:

Location Details:		Direction of Survey:	Upstream
US MH:	M-104-1	DS MH:	M-104-3
		Total Length Surveyed (ft):	25.8

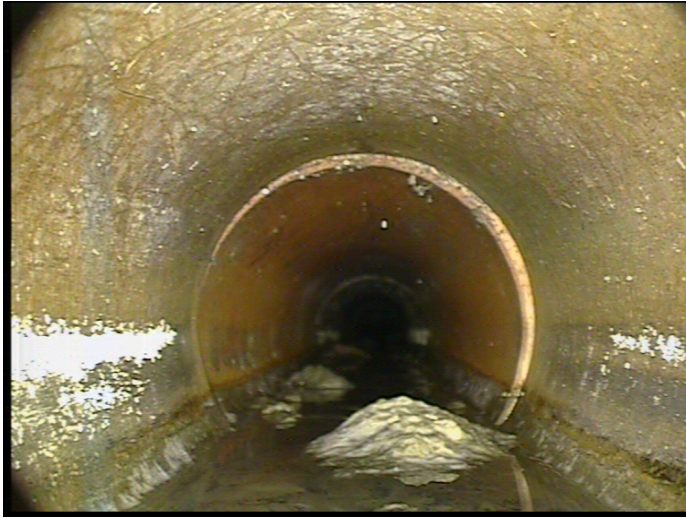
Code: **MWL**
Description: **Water Level**

Distance (ft): **.0**
Structural Grade: **0**
O&M Grade: **0**
Clock Start/From:
Clock To:
1st Value:
2nd Value:
Value Percent: **5.000**
Continuous Index:
Within 8" of Joint: **NO**
Remarks:

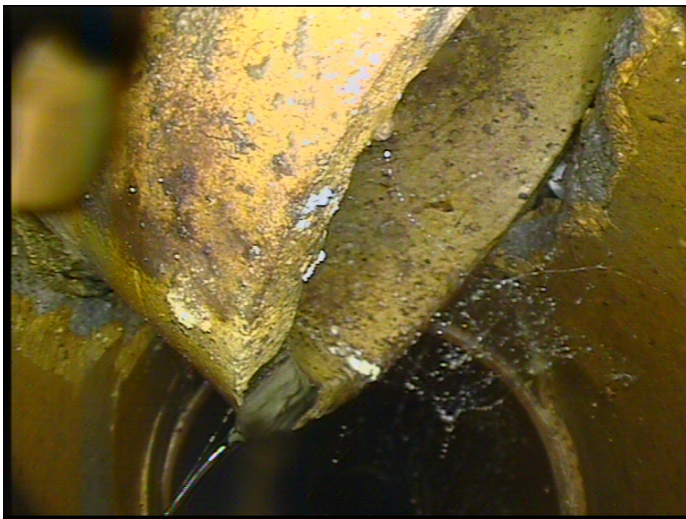
Code: **TBI**
Description: **Tap Break-in Intruding**

Distance (ft): **25.8**
Structural Grade: **0**
O&M Grade: **2**
Clock Start/From: **10**
Clock To:
1st Value: **4.000**
2nd Value: **2.000**
Value Percent:
Continuous Index:
Within 8" of Joint: **NO**
Remarks:

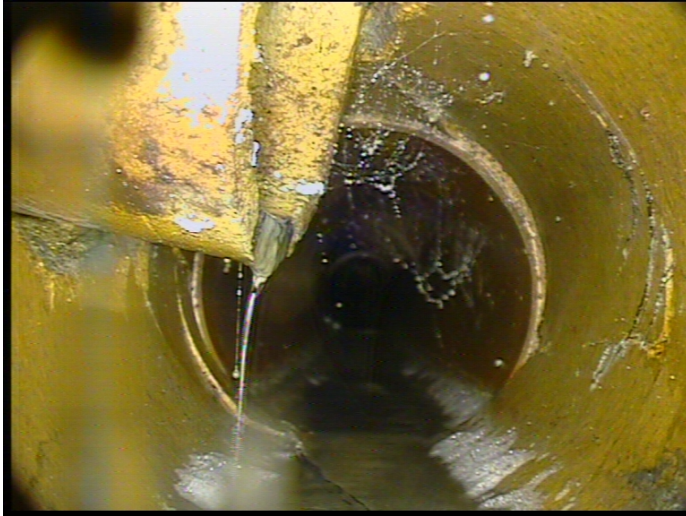
Code:	MSA
Description:	Abandoned Survey
Distance (ft):	25.8
Structural Grade:	0
O&M Grade:	0
Clock Start/From:	
Clock To:	
1st Value:	
2nd Value:	
Value Percent:	
Continuous Index:	
Within 8" of Joint:	NO
Remarks:	Intruding Tap
