Profile/Photo Observation Report

Date:	10/16/2021	Weather:		Coding:	PACP 6.0
Pipe Length (ft):		Owner:	Hobart, IN	Pre Clean:	Not Known
P.O.#:	841_1	Surveyor:	M. Pielacha	PSR:	P-104-001-003
Customer:	Hobart, IN	Clean Date:		Shape:	C

Street:	Off 41st Avenue	Flow Control:	Not Controlled
City:	Hobart, IN	Year Renewed:	
Location:	Yard	Tape/Media #:	841
Purpose:	Reversal	Dia/Height:	8"
Use:	Sanitary	Material:	VCP
Drain Area:		Lining:	
Category:	NA		
Comment:			
Location Details:		Direction of Survey:	Downstream
US MH:	M-104-1	DS MH:	M-104-3
		Total Length Surveyed (ft):	.1

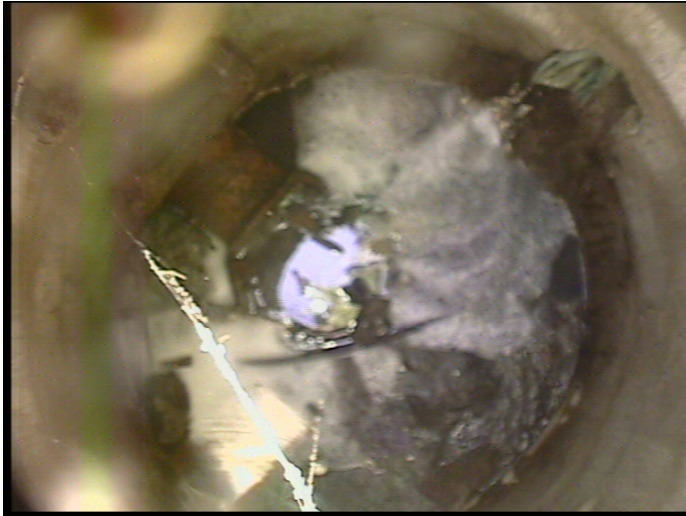
Code: **MWL**
Description: **Water Level**

Distance (ft): **.0**
Structural Grade: **0**
O&M Grade: **0**
Clock Start/From:
Clock To:
1st Value:
2nd Value:
Value Percent: **5.000**
Continuous Index:
Within 8" of Joint: **NO**
Remarks:

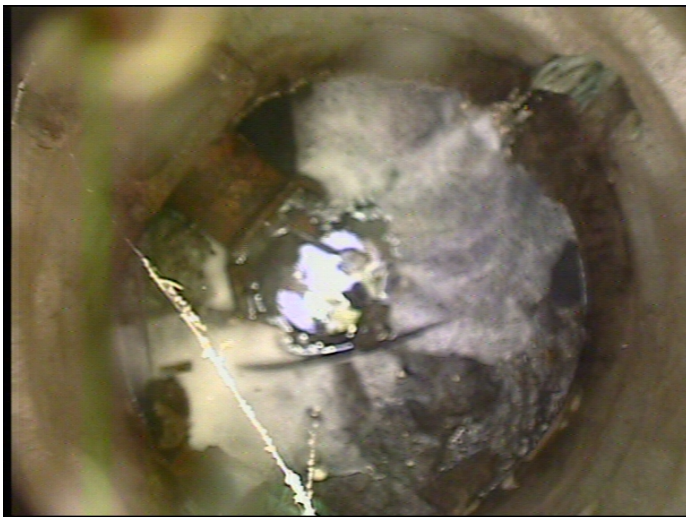
Code: **OBZ**
Description: **Obstacle Other**

Distance (ft): **.0**
Structural Grade: **0**
O&M Grade: **4**
Clock Start/From: **4**
Clock To: **8**
1st Value:
2nd Value:
Value Percent: **25.000**
Continuous Index:
Within 8" of Joint: **NO**
Remarks: **Debris**

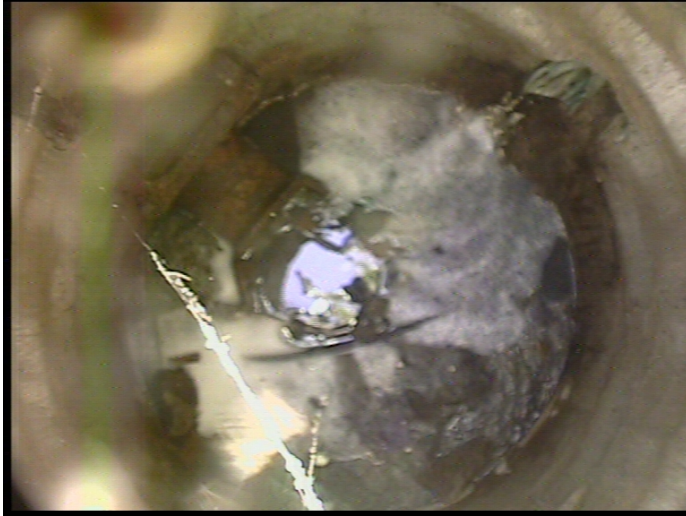
Code:	MSA
Description:	Abandoned Survey
Distance (ft):	.0
Structural Grade:	0
O&M Grade:	0
Clock Start/From:	
Clock To:	
1st Value:	
2nd Value:	
Value Percent:	
Continuous Index:	
Within 8" of Joint:	NO
Remarks:	heavy debris in pipe entrance
