## Profile/Photo Observation Report

Date:	<b>10/16/2021</b>	Weather:		Coding:	<b>PACP 6.0</b>
Pipe Length (ft):		Owner:	<b>Hobart, IN</b>	Pre Clean:	<b>Not Known</b>
P.O.#:	<b>839_1</b>	Surveyor:	<b>M. Pielacha</b>	PSR:	<b>P-104-002-003</b>
Customer:	<b>Hobart, IN</b>	Clean Date:		Shape:	<b>C</b>

Street:	<b>Off 41st Avenue</b>	Flow Control:	
City:	<b>Hobart, IN</b>	Year Renewed:	
Location:	<b>Yard</b>	Tape/Media #:	<b>839</b>
Purpose:	<b>Routine Assessment</b>	Dia/Height:	<b>10"</b>
Use:	<b>Sanitary</b>	Material:	<b>VCP</b>
Drain Area:		Lining:	
Category:	<b>NA</b>		
Comment:			
Location Details:		Direction of Survey:	<b>Upstream</b>
US MH:	<b>M-104-3</b>	DS MH:	<b>M-104-2</b>
		Total Length Surveyed (ft):	<b>3.6</b>

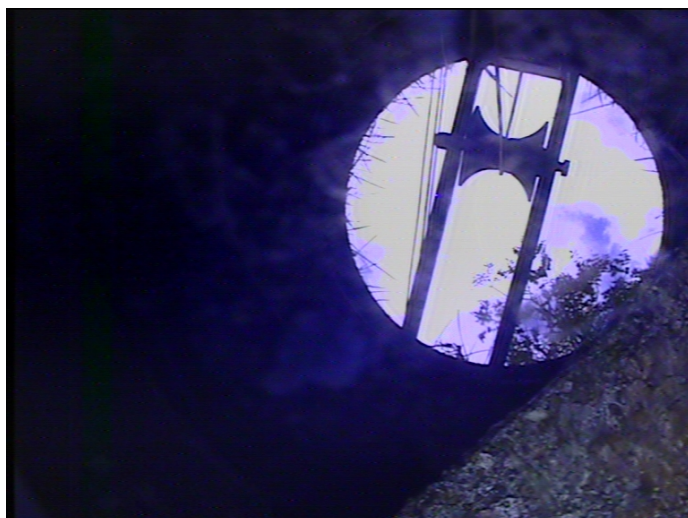
Code: **AMH**  
Description: **Manhole**

Distance (ft): **.0**  
Structural Grade: **0**  
O&M Grade: **0**  
Clock Start/From:  
Clock To:  
1st Value:  
2nd Value:  
Value Percent:  
Continuous Index:  
Within 8" of Joint: **NO**  
Remarks: **M-104-2**

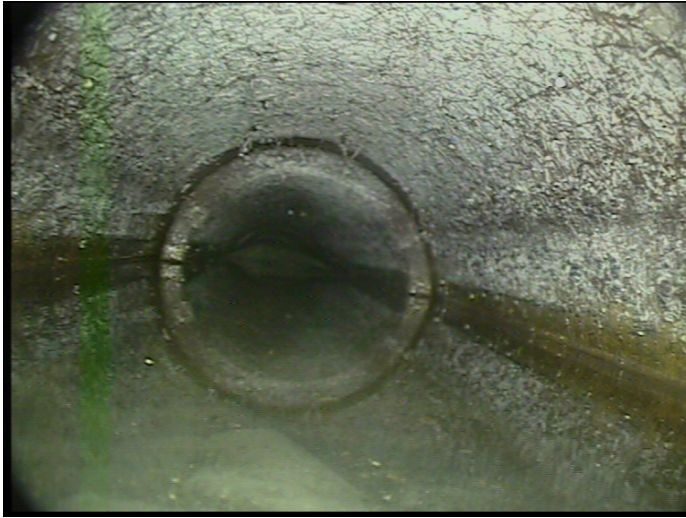
Code: **MWL**  
Description: **Water Level**

Distance (ft): **.0**  
Structural Grade: **0**  
O&M Grade: **0**  
Clock Start/From:  
Clock To:  
1st Value:  
2nd Value:  
Value Percent: **30.000**  
Continuous Index:  
Within 8" of Joint: **NO**  
Remarks:

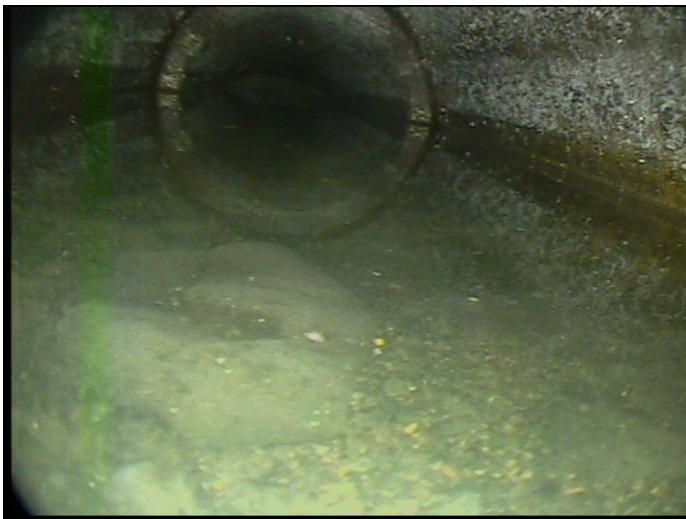
Code: **DSF**  
Description: **Deposits Settled Fine**

Distance (ft): **.0**  
Structural Grade: **0**  
O&M Grade: **3**  
Clock Start/From: **4**  
Clock To: **8**  
1st Value:  
2nd Value:  
Value Percent: **20.000**  
Continuous Index:  
Within 8" of Joint: **NO**  
Remarks:

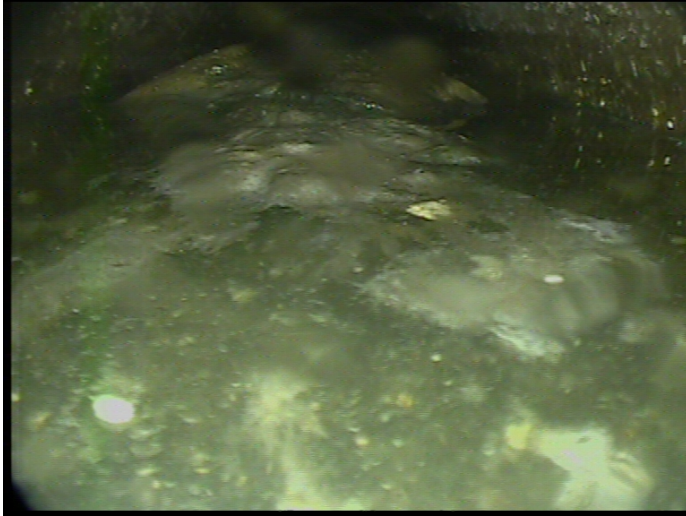
Code: **OBZ**  
Description: **Obstacle Other**

Distance (ft): **3.6**  
Structural Grade: **0**  
O&M Grade: **2**  
Clock Start/From: **6**  
Clock To:  
1st Value:  
2nd Value:  
Value Percent: **10.000**  
Continuous Index:  
Within 8" of Joint: **NO**  
Remarks: **Under water debris**

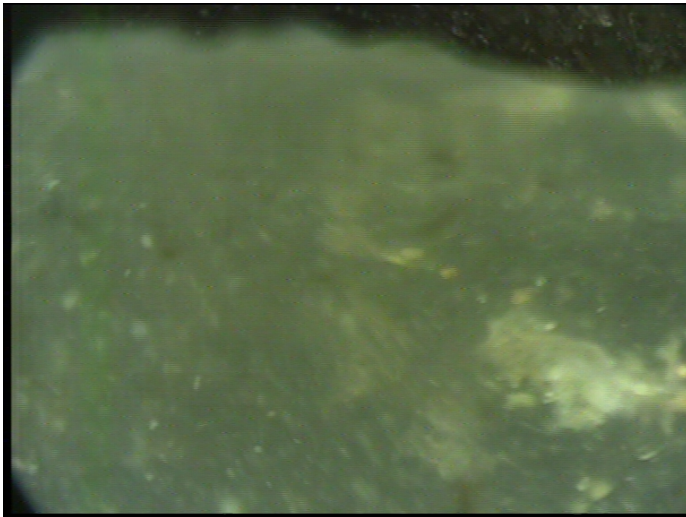
Code: **MSA**  
Description: **Abandoned Survey**

Distance (ft): **3.6**  
Structural Grade: **0**  
O&M Grade: **0**  
Clock Start/From:  
Clock To:  
1st Value:  
2nd Value:  
Value Percent:  
Continuous Index:  
Within 8" of Joint: **NO**  
Remarks: **Under water debris**
