Profile/Photo Observation Report

Date:	10/16/2021	Weather:		Coding:	PACP 6.0
Pipe Length (ft):		Owner:	Hobart, IN	Pre Clean:	Not Known
P.O.#:	836_1	Surveyor:	M. Pielacha	PSR:	P-104-004-008
Customer:	Hobart, IN	Clean Date:		Shape:	C

Street:	Alabama Street	Flow Control:	
City:	Hobart, IN	Year Renewed:	
Location:	Light Highway	Tape/Media #:	836
Purpose:	Routine Assessment	Dia/Height:	10"
Use:	Sanitary	Material:	VCP
Drain Area:		Lining:	
Category:	NA		
Comment:

Location Details:		Direction of Survey:	Downstream
US MH:	M-104-8	DS MH:	M-104-4
		Total Length Surveyed (ft):	110.9

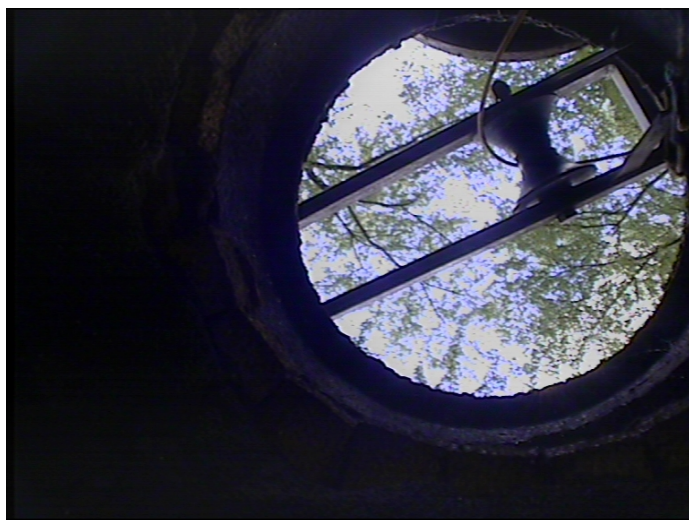
Code: **AMH**
Description: **Manhole**

Distance (ft): **.0**
Structural Grade: **0**
O&M Grade: **0**
Clock Start/From:
Clock To:
1st Value:
2nd Value:
Value Percent:
Continuous Index:
Within 8" of Joint: **NO**
Remarks: **M-104-8**

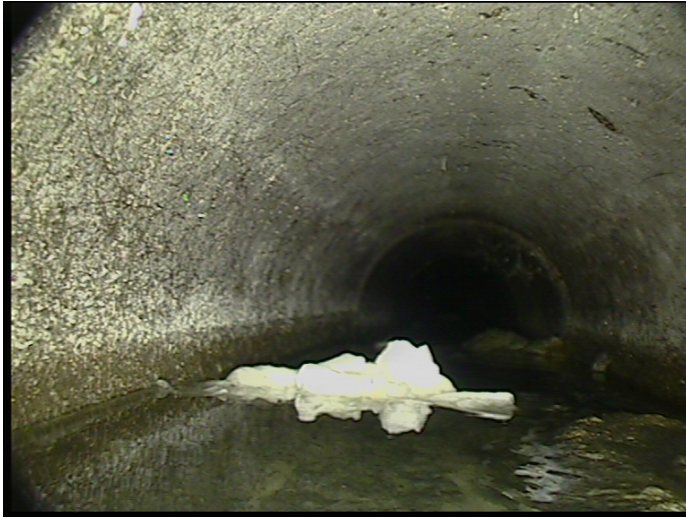
Code: **MWL**
Description: **Water Level**

Distance (ft): **.0**
Structural Grade: **0**
O&M Grade: **0**
Clock Start/From:
Clock To:
1st Value:
2nd Value:
Value Percent: **10.000**
Continuous Index:
Within 8" of Joint: **NO**
Remarks:

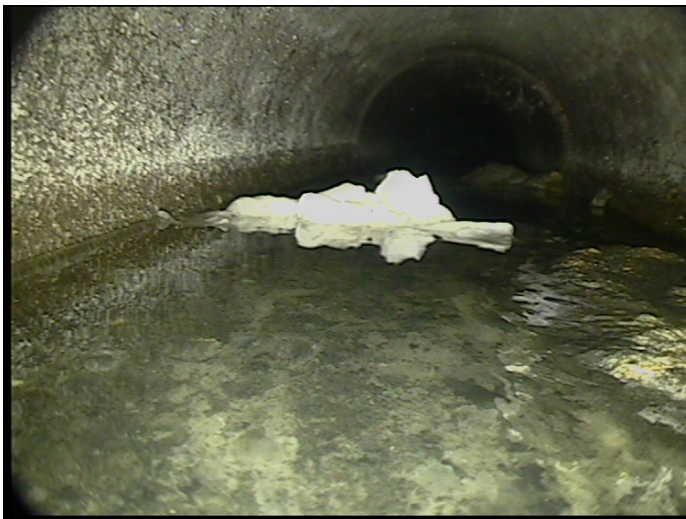
Code: **DSF**
Description: **Deposits Settled Fine**

Distance (ft): **.0**
Structural Grade: **0**
O&M Grade: **3**
Clock Start/From: **4**
Clock To: **8**
1st Value:
2nd Value:
Value Percent: **15.000**
Continuous Index: **S01**
Within 8" of Joint: **YES**
Remarks:

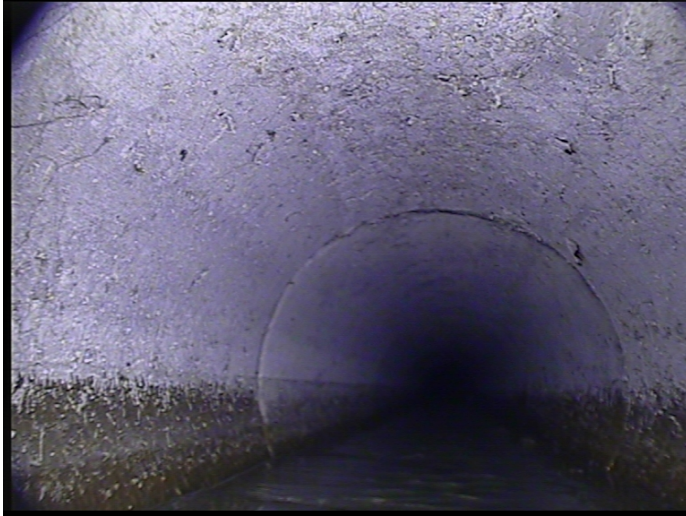
Code:	DSF
Description:	Deposits Settled Fine
Distance (ft):	38.8
Structural Grade:	0
O&M Grade:	3
Clock Start/From:	4
Clock To:	8
1st Value:	
2nd Value:	
Value Percent:	15.000
Continuous Index:	F01
Within 8" of Joint:	NO
Remarks:

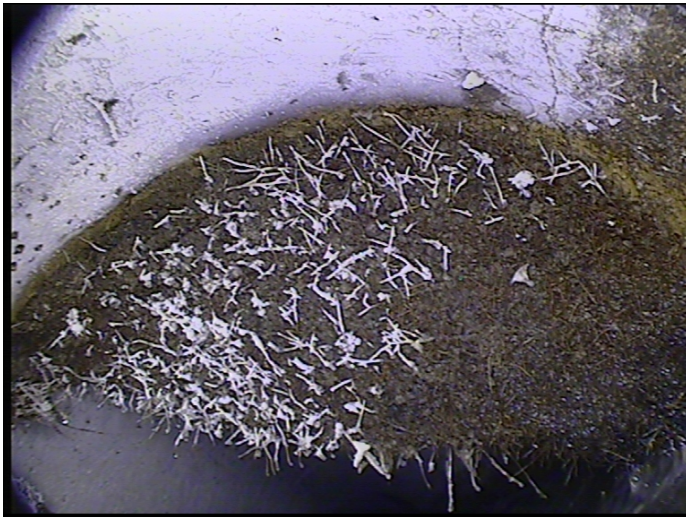
Code:	RMJ
Description:	Roots Medium Joint
Distance (ft):	66.8
Structural Grade:	0
O&M Grade:	3
Clock Start/From:	12
Clock To:	5
1st Value:	
2nd Value:	
Value Percent:	15.000
Continuous Index:	
Within 8" of Joint:	YES
Remarks:

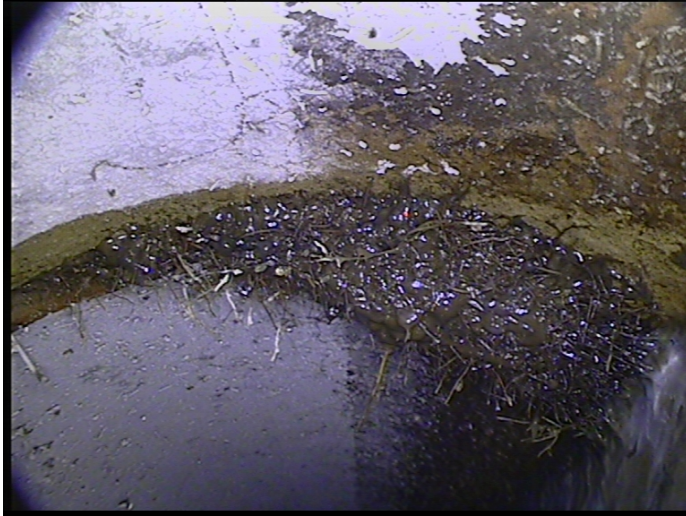
Code: **RMJ**
Description: **Roots Medium Joint**

Distance (ft): **73.0**
Structural Grade: **0**
O&M Grade: **3**
Clock Start/From: **2**
Clock To: **5**
1st Value:
2nd Value:
Value Percent: **5.000**
Continuous Index:
Within 8" of Joint: **YES**
Remarks:

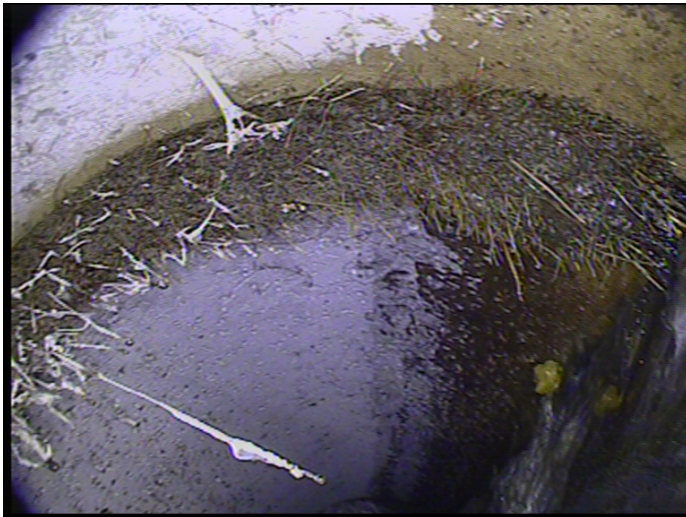
Code: **RMJ**
Description: **Roots Medium Joint**

Distance (ft): **99.9**
Structural Grade: **0**
O&M Grade: **3**
Clock Start/From: **7**
Clock To: **5**
1st Value:
2nd Value:
Value Percent: **5.000**
Continuous Index: **S02**
Within 8" of Joint: **YES**
Remarks:

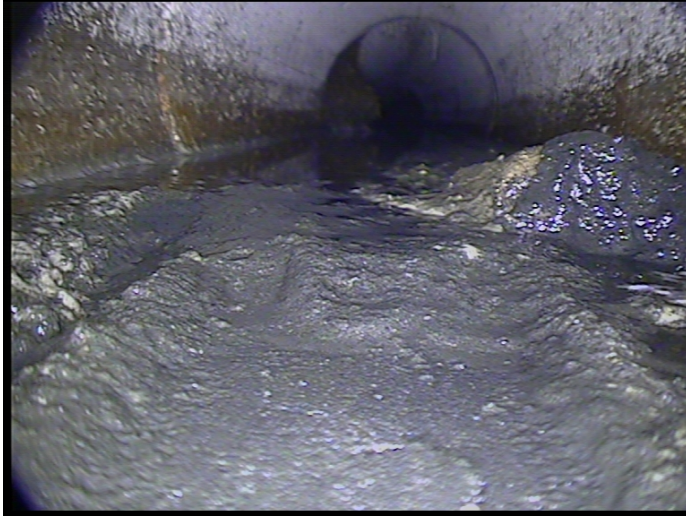
Code:	DSF
Description:	Deposits Settled Fine
Distance (ft):	108.1
Structural Grade:	0
O&M Grade:	3
Clock Start/From:	4
Clock To:	8
1st Value:	
2nd Value:	
Value Percent:	15.000
Continuous Index:	
Within 8" of Joint:	YES
Remarks:

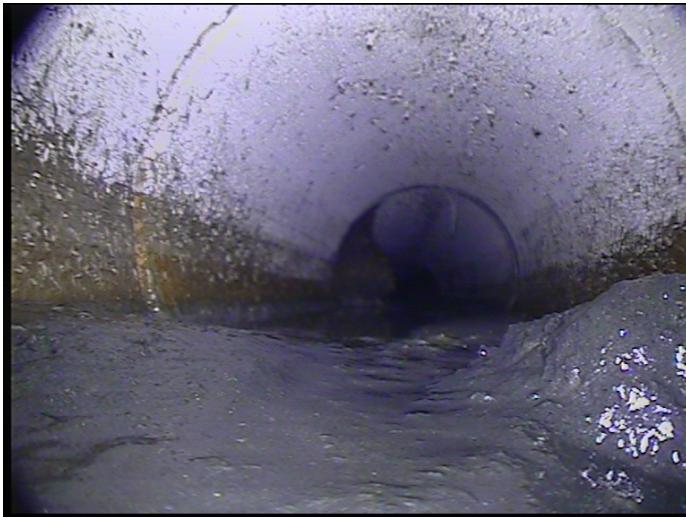
Code:	RMJ
Description:	Roots Medium Joint
Distance (ft):	110.3
Structural Grade:	0
O&M Grade:	3
Clock Start/From:	7
Clock To:	5
1st Value:	
2nd Value:	
Value Percent:	5.000
Continuous Index:	F02
Within 8" of Joint:	YES
Remarks:

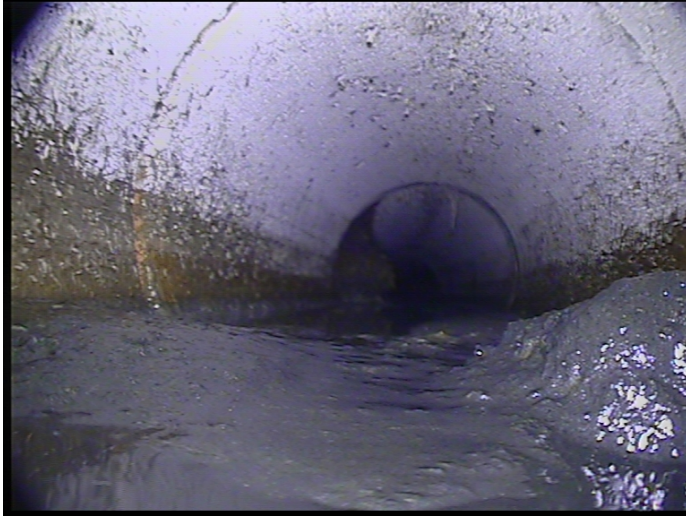
Code:	MSA
Description:	Abandoned Survey
Distance (ft):	110.3
Structural Grade:	0
O&M Grade:	0
Clock Start/From:	
Clock To:	
1st Value:	
2nd Value:	
Value Percent:	
Continuous Index:	
Within 8" of Joint:	NO
Remarks:	deep sediment
