## Profile/Photo Observation Report

Date:	<b>10/16/2021</b>	Weather:		Coding:	<b>PACP 6.0</b>
Pipe Length (ft):		Owner:	<b>Hobart, IN</b>	Pre Clean:	<b>Not Known</b>
P.O.#:	<b>833_1</b>	Surveyor:	<b>M. Pielacha</b>	PSR:	<b>P-104-008-013</b>
Customer:	<b>Hobart, IN</b>	Clean Date:		Shape:	<b>C</b>

Street:	<b>Off 41st Avenue</b>	Flow Control:	
City:	<b>Hobart, IN</b>	Year Renewed:	
Location:	<b>Yard</b>	Tape/Media #:	<b>833</b>
Purpose:	<b>Routine Assessment</b>	Dia/Height:	<b>12"</b>
Use:	<b>Sanitary</b>	Material:	<b>CP</b>
Drain Area:		Lining:	
Category:	<b>NA</b>		
Comment:			
Location Details:		Direction of Survey:	<b>Upstream</b>
US MH:	<b>M-104-8</b>	DS MH:	<b>M-104-13</b>
		Total Length Surveyed (ft):	<b>27.0</b>

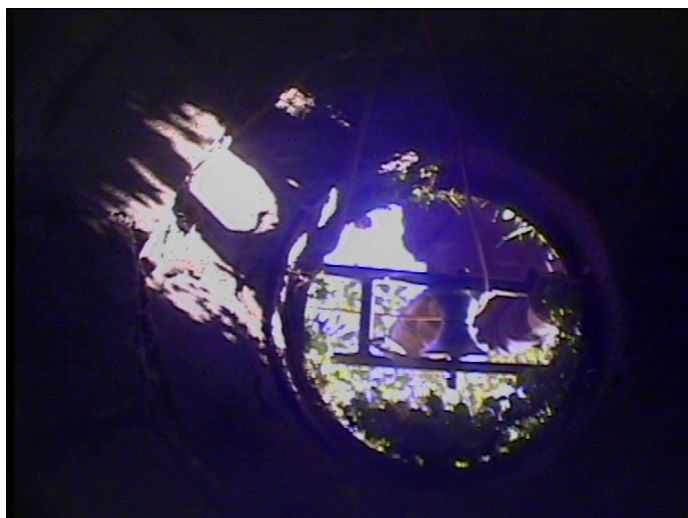
Code: **AMH**  
Description: **Manhole**

Distance (ft): **.0**  
Structural Grade: **0**  
O&M Grade: **0**  
Clock Start/From:  
Clock To:  
1st Value:  
2nd Value:  
Value Percent:  
Continuous Index:  
Within 8" of Joint: **NO**  
Remarks: **M-104-13**

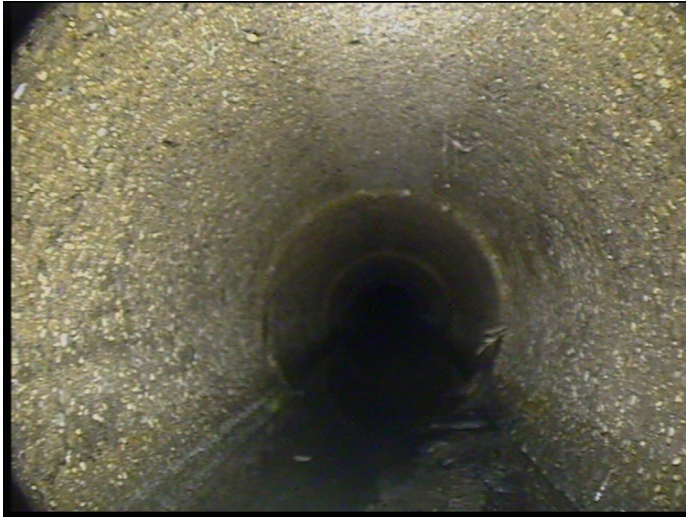
Code: **MWL**  
Description: **Water Level**

Distance (ft): **.0**  
Structural Grade: **0**  
O&M Grade: **0**  
Clock Start/From:  
Clock To:  
1st Value:  
2nd Value:  
Value Percent: **5.000**  
Continuous Index:  
Within 8" of Joint: **NO**  
Remarks:

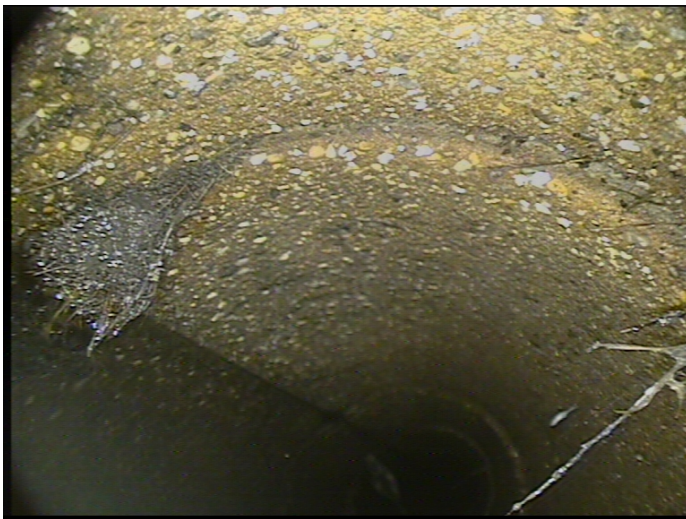
Code: **RFJ**  
Description: **Roots Fine Joint**

Distance (ft): **11.7**  
Structural Grade: **0**  
O&M Grade: **1**  
Clock Start/From: **7**  
Clock To: **5**  
1st Value:  
2nd Value:  
Value Percent:  
Continuous Index:  
Within 8" of Joint: **YES**  
Remarks:

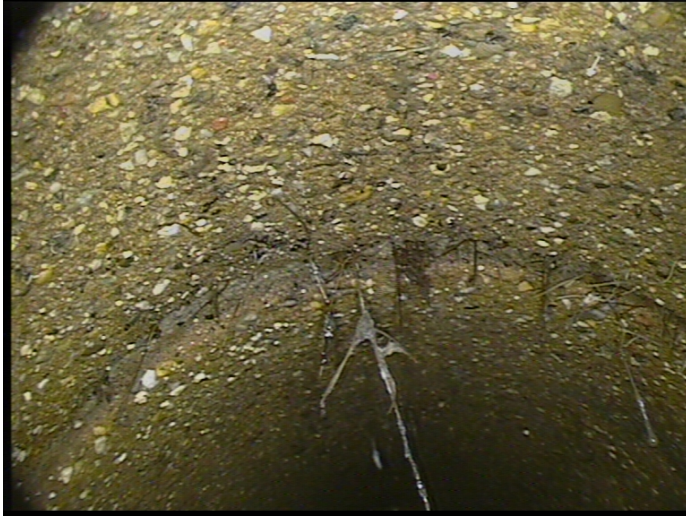
Code: **SAV**  
Description: **Surface Aggregate Visible**

Distance (ft): **11.7**  
Structural Grade: **3**  
O&M Grade: **0**  
Clock Start/From: **7**  
Clock To: **5**  
1st Value:  
2nd Value:  
Value Percent:  
Continuous Index:  
Within 8" of Joint: **YES**  
Remarks:

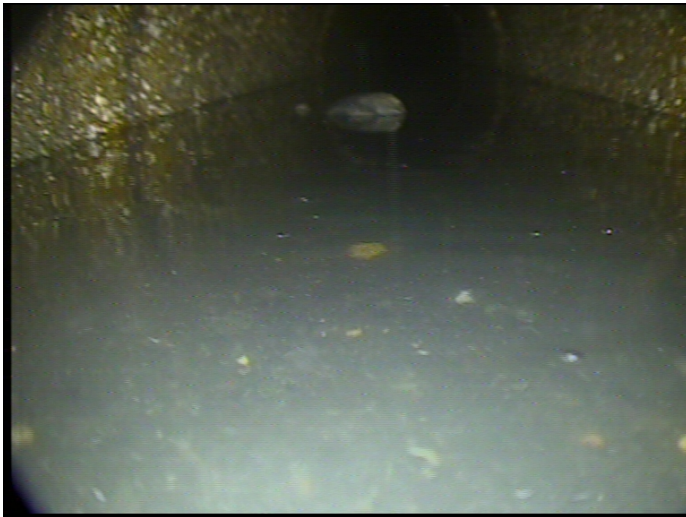
Code: **DSF**  
Description: **Deposits Settled Fine**

Distance (ft): **22.7**  
Structural Grade: **0**  
O&M Grade: **3**  
Clock Start/From: **4**  
Clock To: **8**  
1st Value:  
2nd Value:  
Value Percent: **15.000**  
Continuous Index: **S01**  
Within 8" of Joint: **YES**  
Remarks:

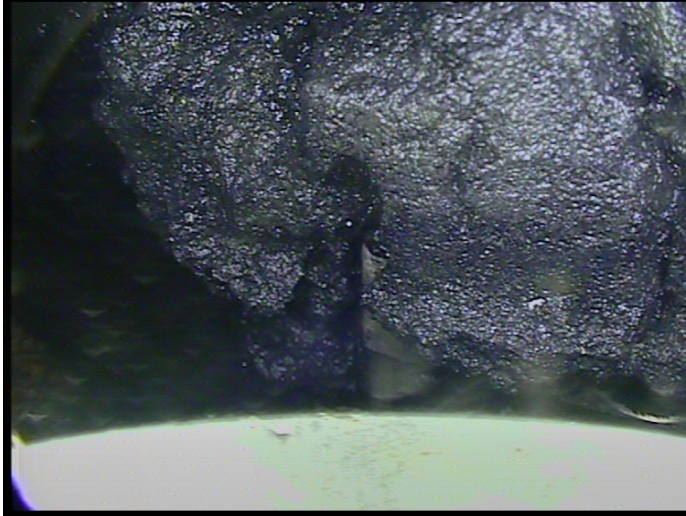
Code: **DSF**  
Description: **Deposits Settled Fine**

Distance (ft): **27.0**  
Structural Grade: **0**  
O&M Grade: **3**  
Clock Start/From: **4**  
Clock To: **8**  
1st Value:  
2nd Value:  
Value Percent: **20.000**  
Continuous Index: **F01**  
Within 8" of Joint: **NO**  
Remarks:

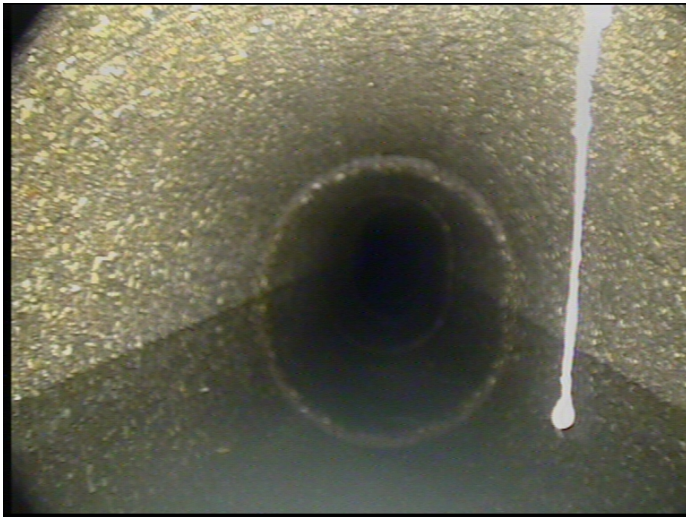
Code: **MSA**  
Description: **Abandoned Survey**

Distance (ft): **27.0**  
Structural Grade: **0**  
O&M Grade: **0**  
Clock Start/From:  
Clock To:  
1st Value:  
2nd Value:  
Value Percent:  
Continuous Index:  
Within 8" of Joint: **NO**  
Remarks: **Deep sediment**
