## Profile/Photo Observation Report

Street:	Off 41st Avenue	Flow Control:	
City:	Hobart, IN	Year Renewed:	
Location:	Yard	Tape/Media #:	830
Purpose:	Routine Assessment	Dia/Height:	8"
Use:	Sanitary	Material:	VCP
Drain Area:		Lining:	
Category:	NA		
Comment:

Location Details:		Direction of Survey:	Upstream
US MH:	M-104-9	DS MH:	M-104-13
		Total Length Surveyed (ft):	45.5

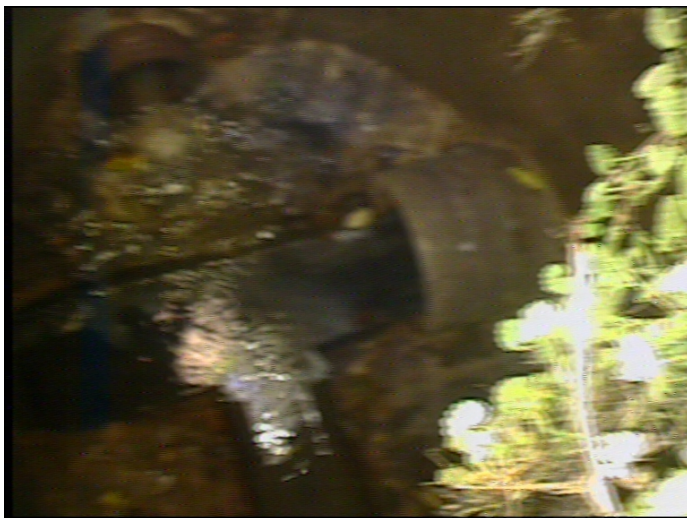
Code:	AMH
Description:	Manhole
Distance (ft):	.0
Structural Grade:	0
O&M Grade:	0
Clock Start/From:	
Clock To:	
1st Value:	
2nd Value:	
Value Percent:	
Continuous Index:	
Within 8" of Joint:	NO
Remarks:	M-104-13

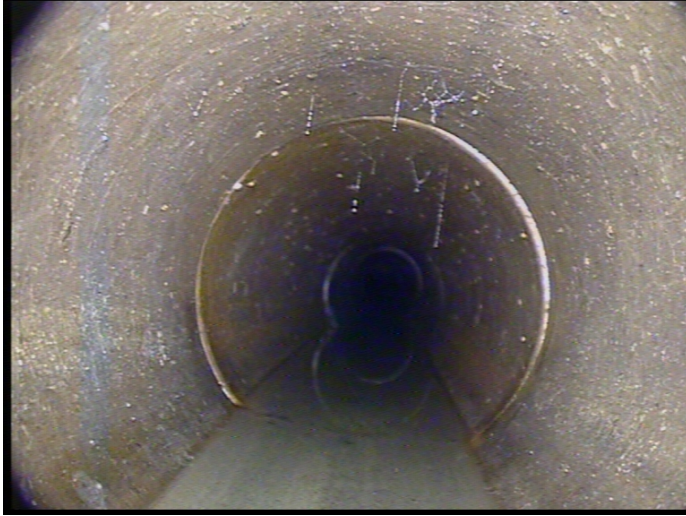
Code: **MWL**  
Description: **Water Level**

Distance (ft): **.0**  
Structural Grade: **0**  
O&M Grade: **0**  
Clock Start/From:  
Clock To:  
1st Value:  
2nd Value:  
Value Percent: **5.000**  
Continuous Index:  
Within 8" of Joint: **NO**  
Remarks:

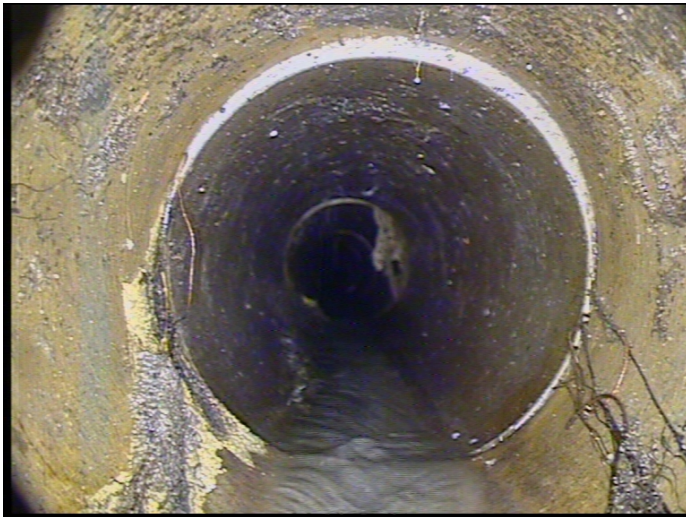
Code: **RFJ**  
Description: **Roots Fine Joint**

Distance (ft): **34.7**  
Structural Grade: **0**  
O&M Grade: **1**  
Clock Start/From: **7**  
Clock To: **5**  
1st Value:  
2nd Value:  
Value Percent:  
Continuous Index: **S01**  
Within 8" of Joint: **YES**  
Remarks:

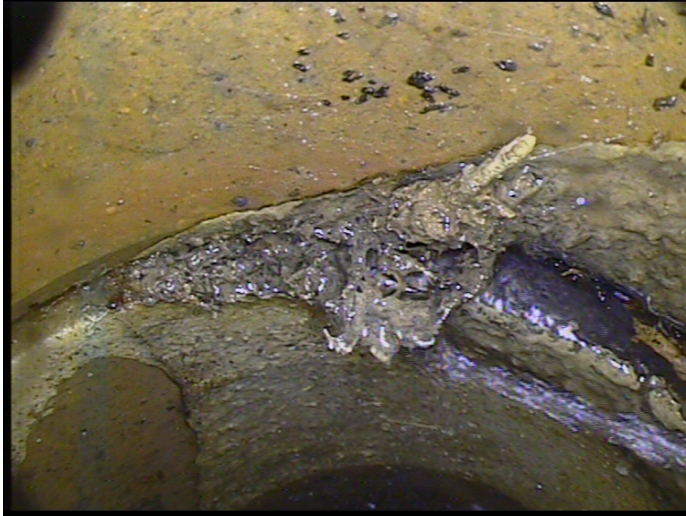
Code: **IR**  
Description: **Infil Runner**

Distance (ft): **42.6**  
Structural Grade: **0**  
O&M Grade: **4**  
Clock Start/From: **2**  
Clock To:  
1st Value:  
2nd Value:  
Value Percent:  
Continuous Index:  
Within 8" of Joint: **YES**  
Remarks:

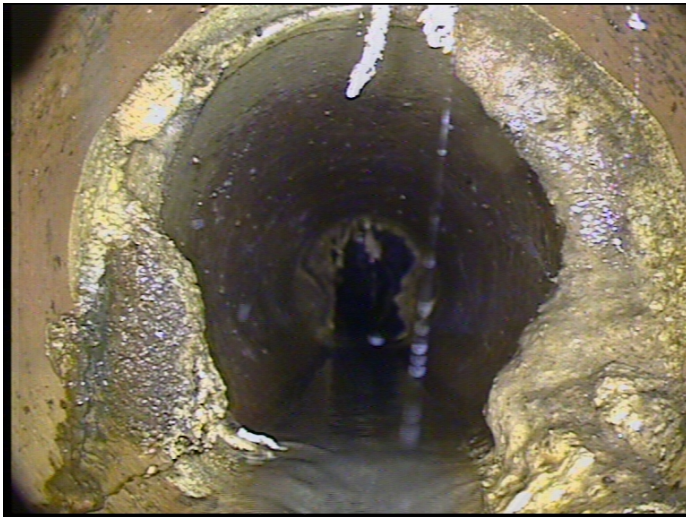
Code: **RFJ**  
Description: **Roots Fine Joint**

Distance (ft): **45.1**  
Structural Grade: **0**  
O&M Grade: **1**  
Clock Start/From: **7**  
Clock To: **5**  
1st Value:  
2nd Value:  
Value Percent:  
Continuous Index: **F01**  
Within 8" of Joint: **YES**  
Remarks:

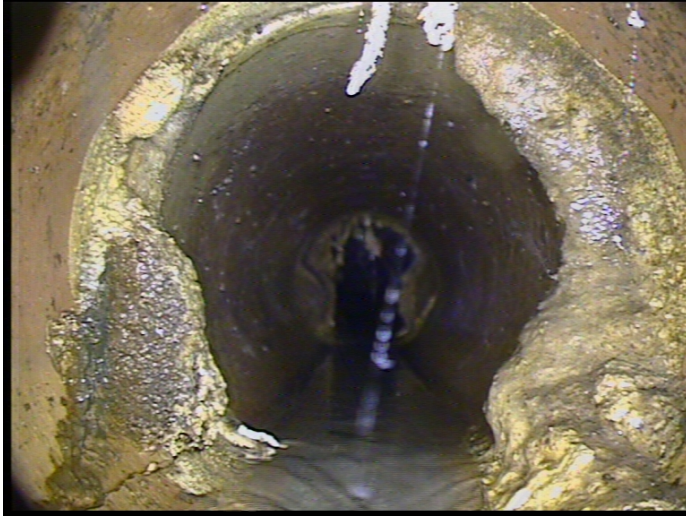
Code:	<b>DAE</b>
Description:	<b>Deposits Attached Encrustation</b>
Distance (ft):	<b>45.1</b>
Structural Grade:	<b>0</b>
O&M Grade:	<b>2</b>
Clock Start/From:	<b>7</b>
Clock To:	<b>5</b>
1st Value:	
2nd Value:	
Value Percent:	<b>10.000</b>
Continuous Index:	
Within 8" of Joint:	<b>NO</b>
Remarks:

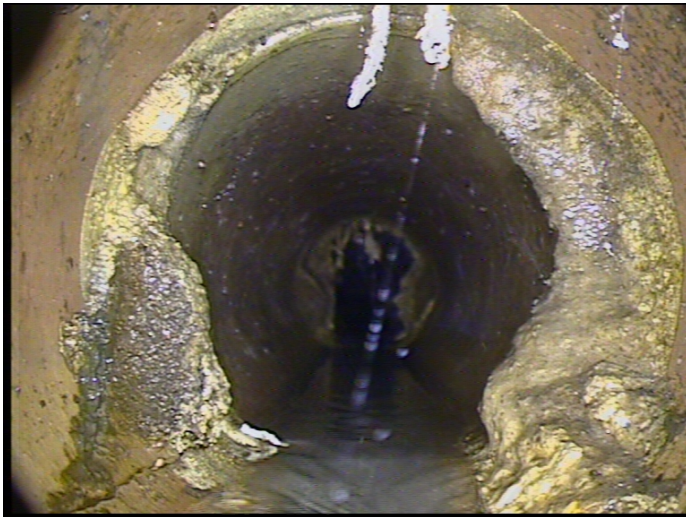
Code:	<b>MSA</b>
Description:	<b>Abandoned Survey</b>
Distance (ft):	<b>45.1</b>
Structural Grade:	<b>0</b>
O&M Grade:	<b>0</b>
Clock Start/From:	
Clock To:	
1st Value:	
2nd Value:	
Value Percent:	
Continuous Index:	
Within 8" of Joint:	<b>NO</b>
Remarks:	<b>Can not pass encrustation</b>
