Profile/Photo Observation Report

Date:	10/16/2021	Weather:		Coding:	PACP 6.0
Pipe Length (ft):		Owner:	Hobart, IN	Pre Clean:	Not Known
P.O.#:	835_1	Surveyor:	M. Pielacha	PSR:	P-104-011-012
Customer:	Hobart, IN	Clean Date:		Shape:	C

Street:	Off 41st Avenue	Flow Control:	
City:	Hobart, IN	Year Renewed:	
Location:	Light Highway	Tape/Media #:	835
Purpose:	Routine Assessment	Dia/Height:	10"
Use:	Sanitary	Material:	VCP
Drain Area:		Lining:	
Category:	NA		
Comment:

Location Details:		Direction of Survey:	Upstream
US MH:	M-104-12	DS MH:	M-104-11
		Total Length Surveyed (ft):	50.0

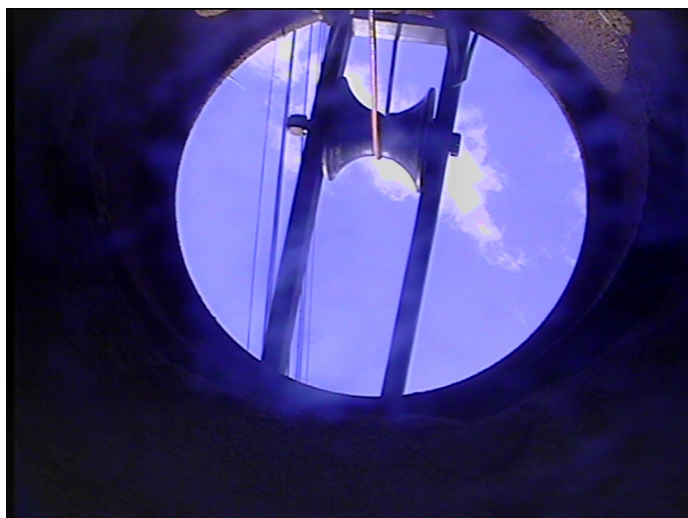
Code: **AMH**
 Description: **Manhole**

Distance (ft): **.0**
 Structural Grade: **0**
 O&M Grade: **0**
 Clock Start/From:
 Clock To:
 1st Value:
 2nd Value:
 Value Percent:
 Continuous Index:
 Within 8" of Joint: **NO**
 Remarks: **M-104-11**

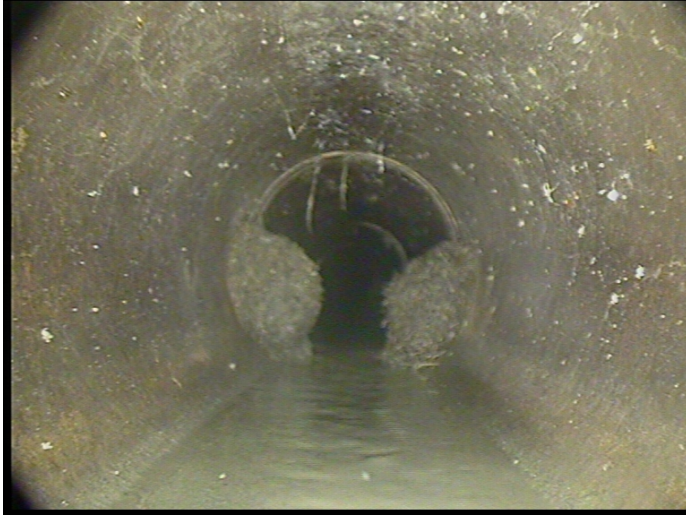
Code: **MWL**
Description: **Water Level**

Distance (ft): **.0**
Structural Grade: **0**
O&M Grade: **0**
Clock Start/From:
Clock To:
1st Value:
2nd Value:
Value Percent: **5.000**
Continuous Index:
Within 8" of Joint: **NO**
Remarks:

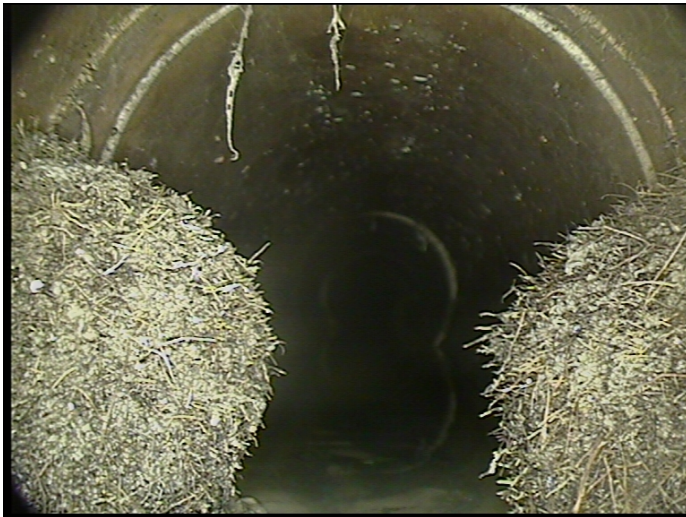
Code: **RMJ**
Description: **Roots Medium Joint**

Distance (ft): **4.0**
Structural Grade: **0**
O&M Grade: **3**
Clock Start/From: **7**
Clock To: **5**
1st Value:
2nd Value:
Value Percent: **20.000**
Continuous Index:
Within 8" of Joint: **YES**
Remarks:

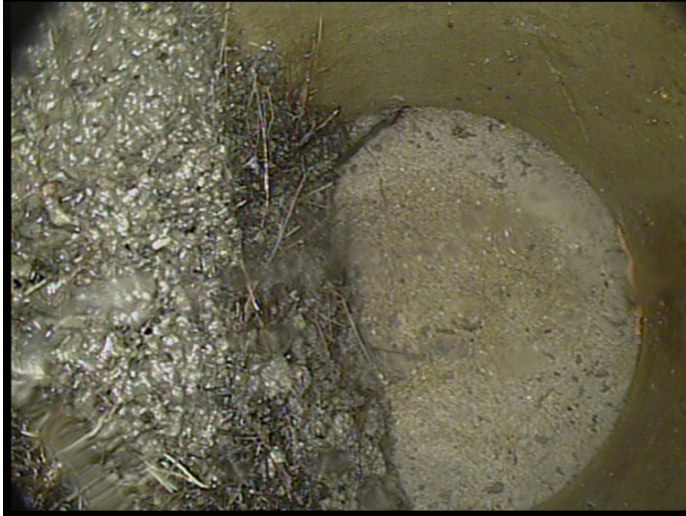
Code: **TFC**
Description: **Tap Factory Capped**

Distance (ft): **11.7**
Structural Grade: **0**
O&M Grade: **0**
Clock Start/From: **9**
Clock To:
1st Value: **4.000**
2nd Value:
Value Percent:
Continuous Index:
Within 8" of Joint: **NO**
Remarks:

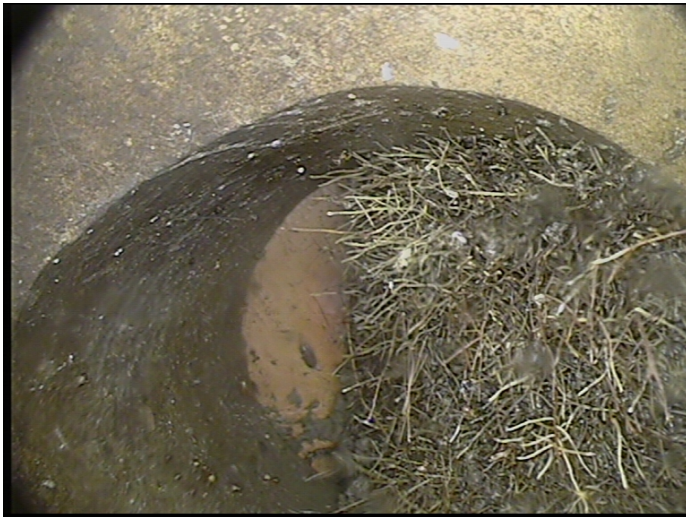
Code: **TFD**
Description: **Tap Factory Defective**

Distance (ft): **13.7**
Structural Grade: **0**
O&M Grade: **2**
Clock Start/From: **4**
Clock To:
1st Value: **4.000**
2nd Value:
Value Percent:
Continuous Index:
Within 8" of Joint: **NO**
Remarks: **roots**

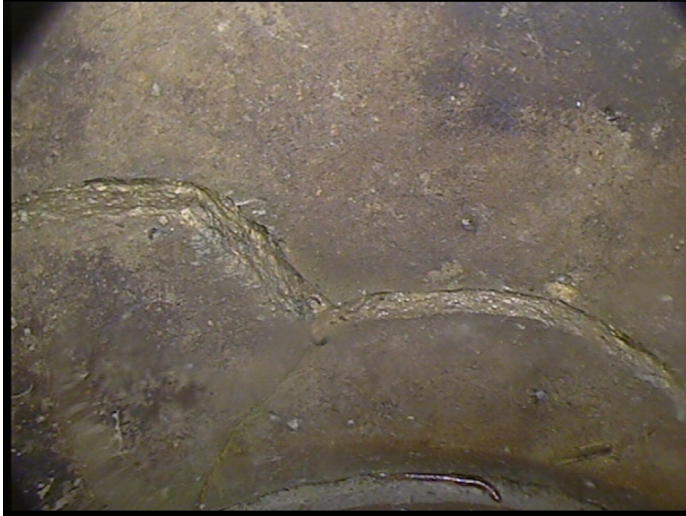
Code: **B**
Description: **Broken**

Distance (ft): **40.6**
Structural Grade: **5**
O&M Grade: **0**
Clock Start/From: **8**
Clock To: **1**
1st Value:
2nd Value:
Value Percent:
Continuous Index:
Within 8" of Joint: **YES**
Remarks:

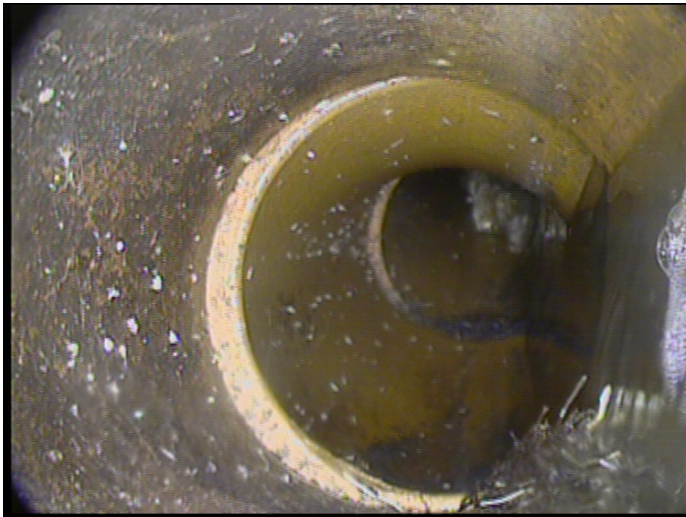
Code: **TF**
Description: **Tap Factory**

Distance (ft): **43.7**
Structural Grade: **0**
O&M Grade: **0**
Clock Start/From: **3**
Clock To:
1st Value: **4.000**
2nd Value:
Value Percent:
Continuous Index:
Within 8" of Joint: **NO**
Remarks:

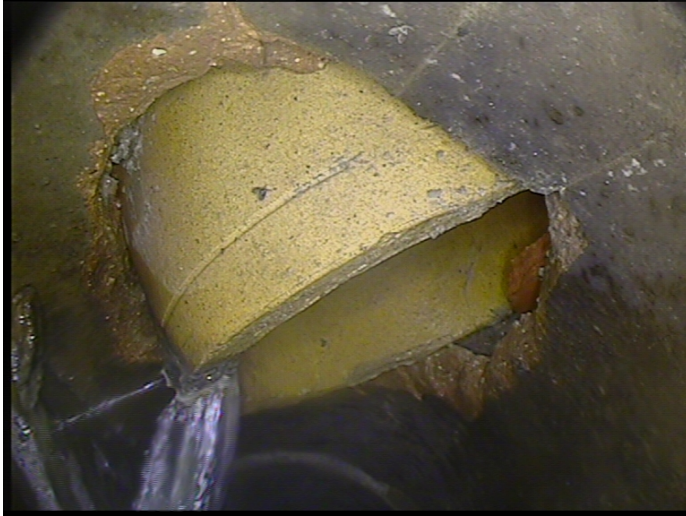
Code:	TBI
Description:	Tap Break-in Intruding
Distance (ft):	46.4
Structural Grade:	0
O&M Grade:	2
Clock Start/From:	10
Clock To:	
1st Value:	4.000
2nd Value:	2.000
Value Percent:	
Continuous Index:	
Within 8" of Joint:	NO
Remarks:

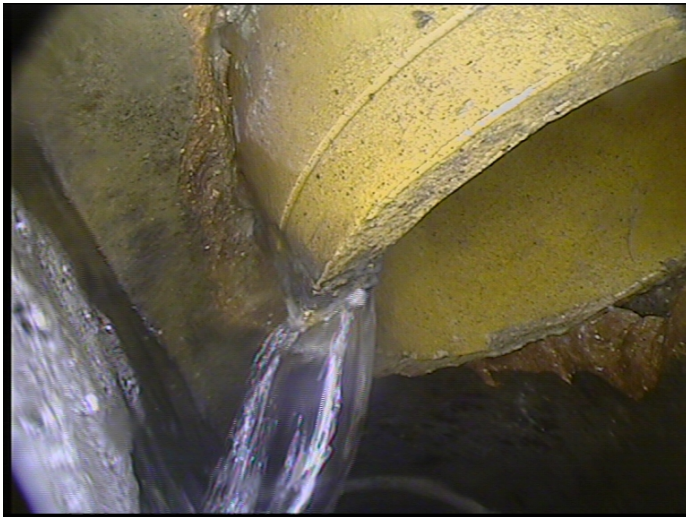
Code:	MSA
Description:	Abandoned Survey
Distance (ft):	50.0
Structural Grade:	0
O&M Grade:	0
Clock Start/From:	
Clock To:	
1st Value:	
2nd Value:	
Value Percent:	
Continuous Index:	
Within 8" of Joint:	NO
Remarks:	Intruding tap
