Profile/Photo Observation Report

Date:	10/16/2021	Weather:		Coding:	PACP 6.0
Pipe Length (ft):		Owner:	Hobart, IN	Pre Clean:	Not Known
P.O.#:	831_1	Surveyor:	M. Pielacha	PSR:	P-104-012-013
Customer:	Hobart, IN	Clean Date:		Shape:	C

Street:	Off 41st Avenue	Flow Control:	
City:	Hobart, IN	Year Renewed:	
Location:	Yard	Tape/Media #:	831
Purpose:	Routine Assessment	Dia/Height:	10"
Use:	Sanitary	Material:	VCP
Drain Area:		Lining:	
Category:	NA		
Comment:

Location Details:		Direction of Survey:	Upstream
US MH:	M-104-13	DS MH:	M-104-12
		Total Length Surveyed (ft):	60.6

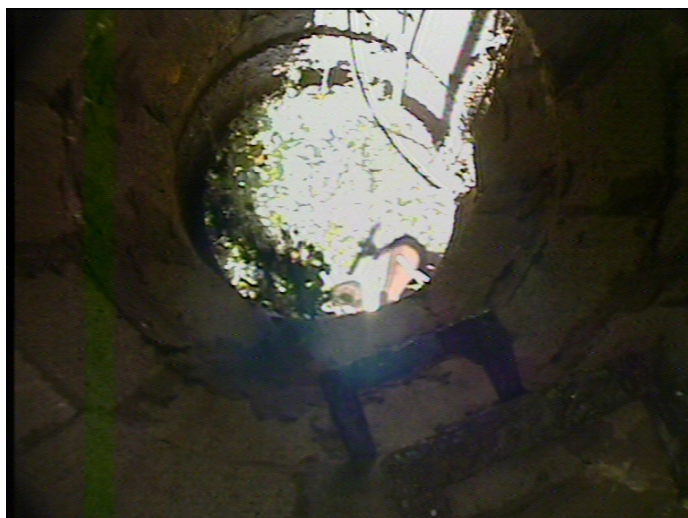
Code: **AMH**
Description: **Manhole**

Distance (ft): **.0**
Structural Grade: **0**
O&M Grade: **0**
Clock Start/From:
Clock To:
1st Value:
2nd Value:
Value Percent:
Continuous Index:
Within 8" of Joint: **NO**
Remarks: **M-104-12**

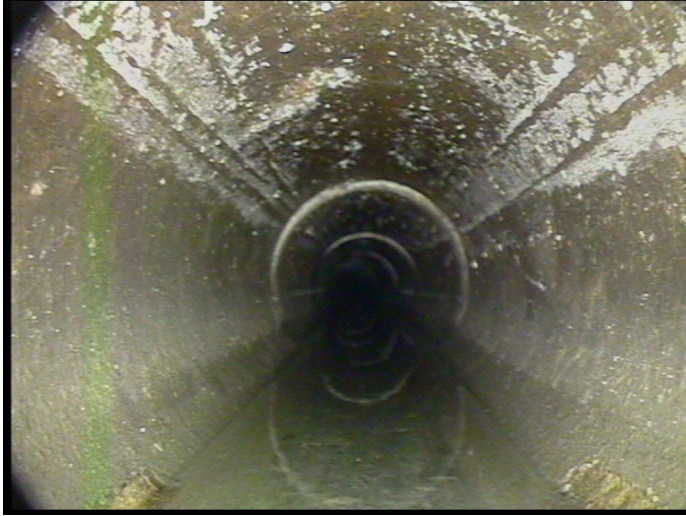
Code: **MWL**
Description: **Water Level**

Distance (ft): **.0**
Structural Grade: **0**
O&M Grade: **0**
Clock Start/From:
Clock To:
1st Value:
2nd Value:
Value Percent: **5.000**
Continuous Index:
Within 8" of Joint: **NO**
Remarks:

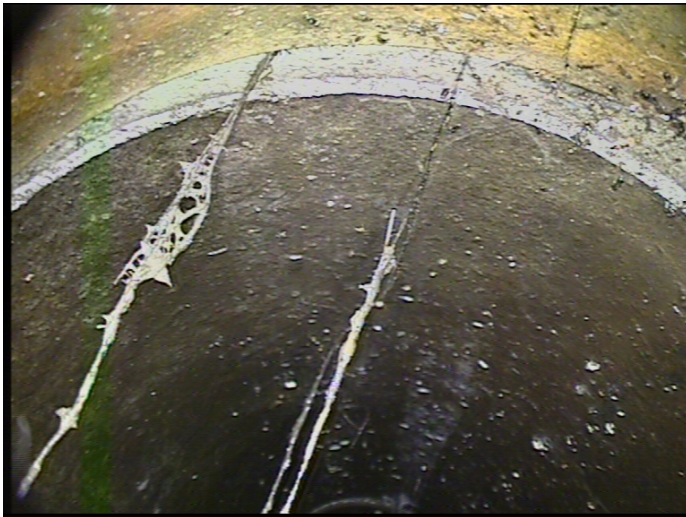
Code: **RFJ**
Description: **Roots Fine Joint**

Distance (ft): **18.6**
Structural Grade: **0**
O&M Grade: **1**
Clock Start/From: **11**
Clock To:
1st Value:
2nd Value:
Value Percent:
Continuous Index: **S01**
Within 8" of Joint: **YES**
Remarks:

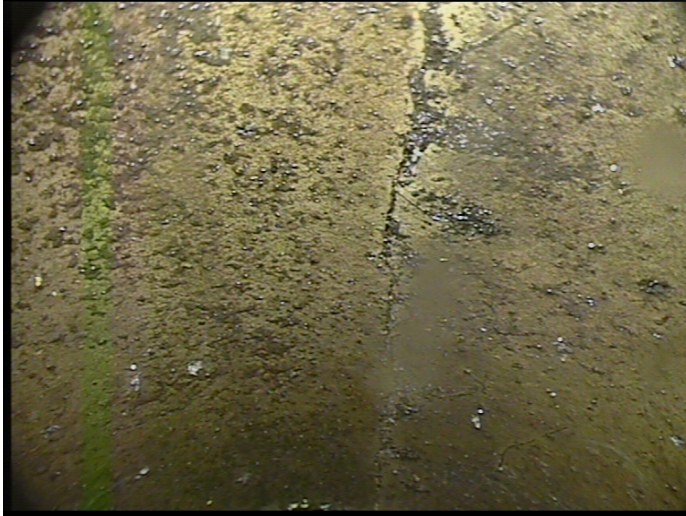
Code:	CL
Description:	Crack Longitudinal
Distance (ft):	45.1
Structural Grade:	2
O&M Grade:	0
Clock Start/From:	12
Clock To:	
1st Value:	
2nd Value:	
Value Percent:	
Continuous Index:	S02
Within 8" of Joint:	YES
Remarks:

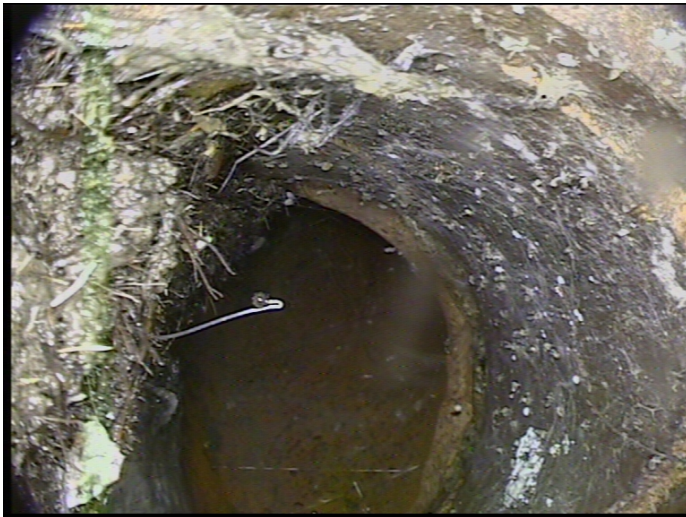
Code:	TBD
Description:	Tap Break-in Defective
Distance (ft):	56.5
Structural Grade:	0
O&M Grade:	3
Clock Start/From:	9
Clock To:	
1st Value:	4.000
2nd Value:	
Value Percent:	
Continuous Index:	
Within 8" of Joint:	NO
Remarks:	roots

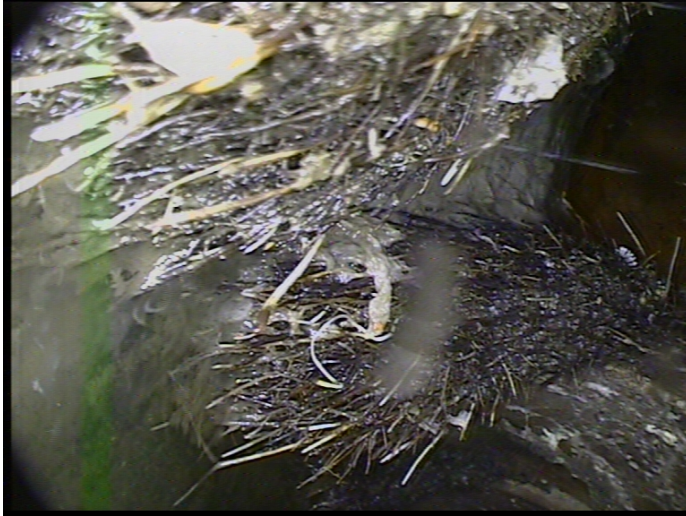
Code:	RML
Description:	Roots Medium Lateral
Distance (ft):	56.5
Structural Grade:	0
O&M Grade:	3
Clock Start/From:	7
Clock To:	9
1st Value:	
2nd Value:	
Value Percent:	10.000
Continuous Index:	
Within 8" of Joint:	NO
Remarks:

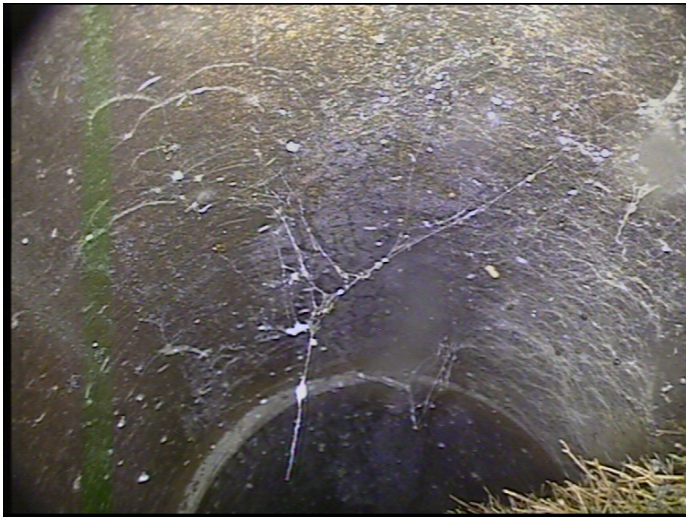
Code:	CL
Description:	Crack Longitudinal
Distance (ft):	60.3
Structural Grade:	2
O&M Grade:	0
Clock Start/From:	12
Clock To:	
1st Value:	
2nd Value:	
Value Percent:	
Continuous Index:	F02
Within 8" of Joint:	NO
Remarks:

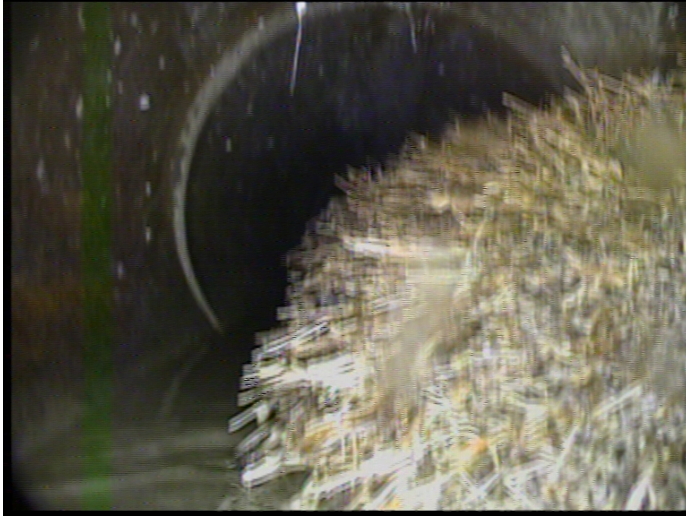
Code:	RFJ
Description:	Roots Fine Joint
Distance (ft):	60.3
Structural Grade:	0
O&M Grade:	1
Clock Start/From:	11
Clock To:	
1st Value:	
2nd Value:	
Value Percent:	
Continuous Index:	F01
Within 8" of Joint:	YES
Remarks:

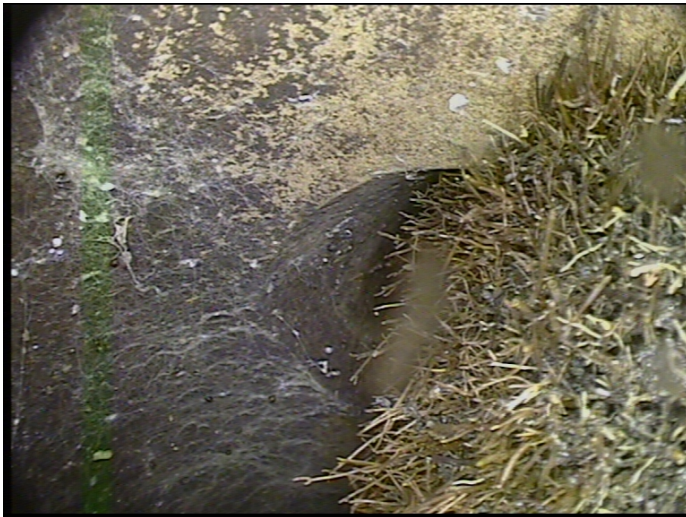
Code:	TFD
Description:	Tap Factory Defective
Distance (ft):	60.6
Structural Grade:	0
O&M Grade:	2
Clock Start/From:	4
Clock To:	
1st Value:	4.000
2nd Value:	
Value Percent:	
Continuous Index:	
Within 8" of Joint:	NO
Remarks:	roots

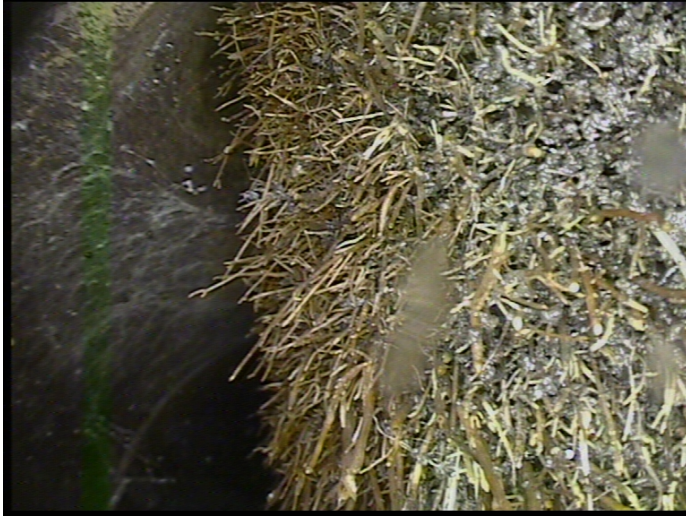
Code:	RML
Description:	Roots Medium Lateral
Distance (ft):	60.6
Structural Grade:	0
O&M Grade:	3
Clock Start/From:	3
Clock To:	6
1st Value:	
2nd Value:	
Value Percent:	25.000
Continuous Index:	
Within 8" of Joint:	NO
Remarks:

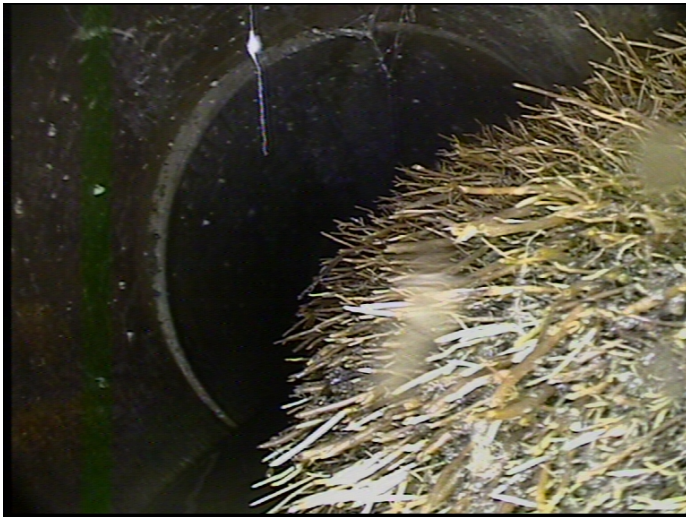
Code:	MSA
Description:	Abandoned Survey
Distance (ft):	60.6
Structural Grade:	0
O&M Grade:	0
Clock Start/From:	
Clock To:	
1st Value:	
2nd Value:	
Value Percent:	
Continuous Index:	
Within 8" of Joint:	NO
Remarks:	Can not pass roots.
