## Profile/Photo Observation Report

Street:	<b>Off 41st Avenue</b>	Flow Control:	
City:	<b>Hobart, IN</b>	Year Renewed:	
Location:	<b>Yard</b>	Tape/Media #:	<b>834</b>
Purpose:	<b>Reversal</b>	Dia/Height:	<b>12"</b>
Use:	<b>Sanitary</b>	Material:	<b>VCP</b>
Drain Area:		Lining:	
Category:	<b>NA</b>		
Comment:

Location Details:		Direction of Survey:	<b>Downstream</b>
US MH:	<b>M-104-13</b>	DS MH:	<b>M-104-12</b>
		Total Length Surveyed (ft):	<b>86.9</b>

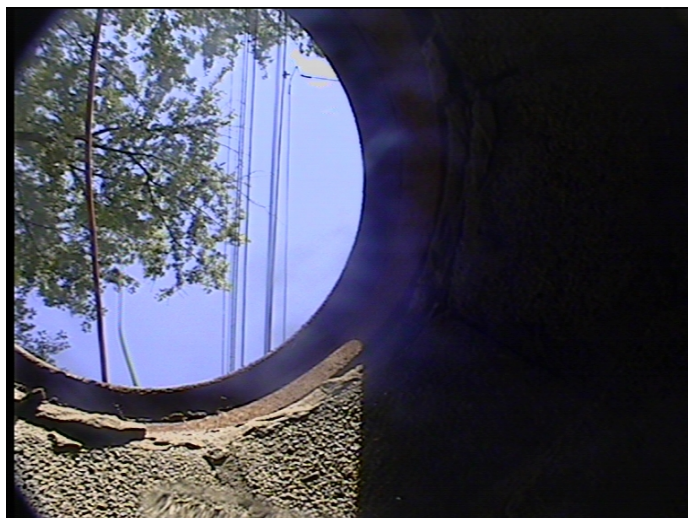
Code: **AMH**  
Description: **Manhole**

Distance (ft): **.0**  
Structural Grade: **0**  
O&M Grade: **0**  
Clock Start/From:  
Clock To:  
1st Value:  
2nd Value:  
Value Percent:  
Continuous Index:  
Within 8" of Joint: **NO**  
Remarks: **M-104-13**

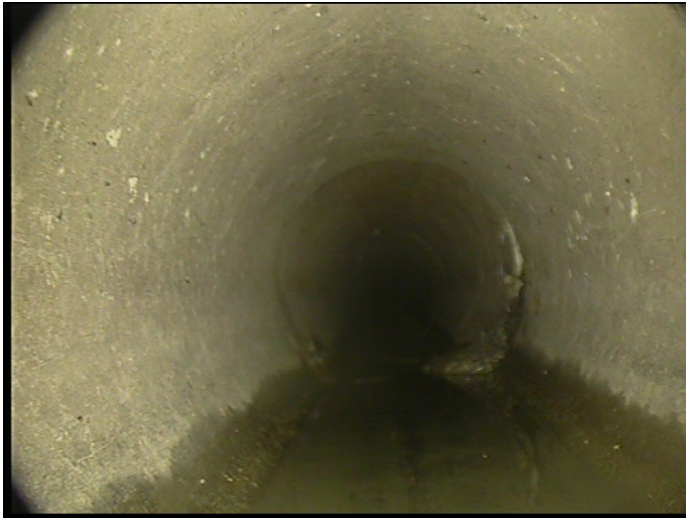
Code: **MWL**  
Description: **Water Level**

Distance (ft): **.0**  
Structural Grade: **0**  
O&M Grade: **0**  
Clock Start/From:  
Clock To:  
1st Value:  
2nd Value:  
Value Percent: **5.000**  
Continuous Index:  
Within 8" of Joint: **NO**  
Remarks:

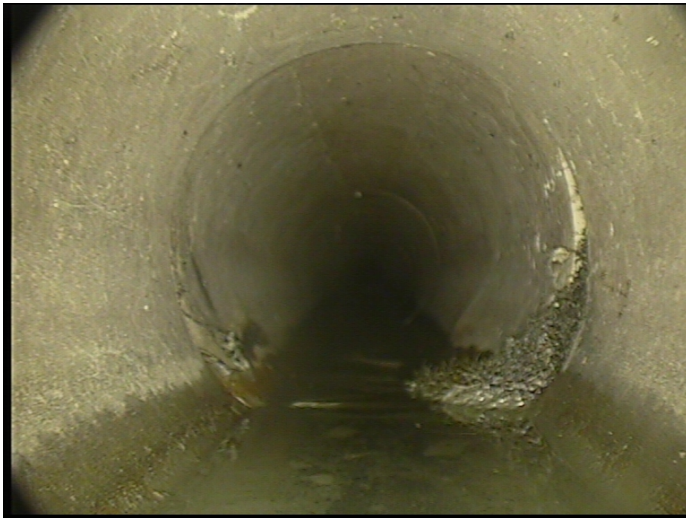
Code: **RFJ**  
Description: **Roots Fine Joint**

Distance (ft): **2.6**  
Structural Grade: **0**  
O&M Grade: **1**  
Clock Start/From: **7**  
Clock To: **5**  
1st Value:  
2nd Value:  
Value Percent:  
Continuous Index: **S01**  
Within 8" of Joint: **YES**  
Remarks:

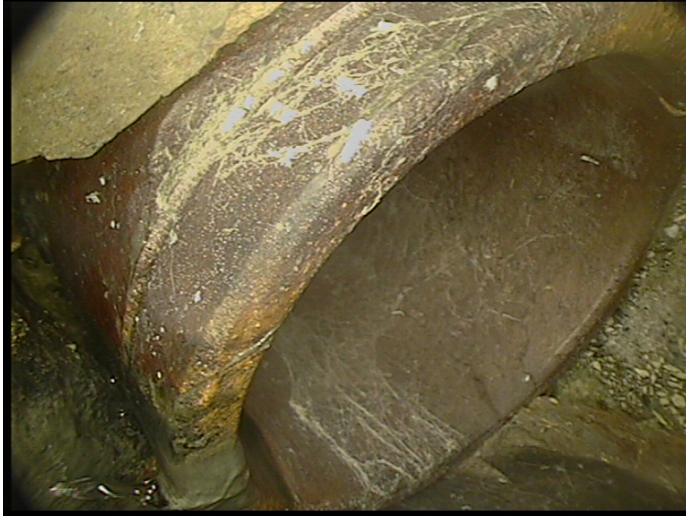
Code:	<b>TBA</b>
Description:	<b>Tap Break-in Active</b>
Distance (ft):	<b>16.3</b>
Structural Grade:	<b>0</b>
O&M Grade:	<b>0</b>
Clock Start/From:	<b>9</b>
Clock To:	
1st Value:	<b>4.000</b>
2nd Value:	
Value Percent:	
Continuous Index:	
Within 8" of Joint:	<b>NO</b>
Remarks:

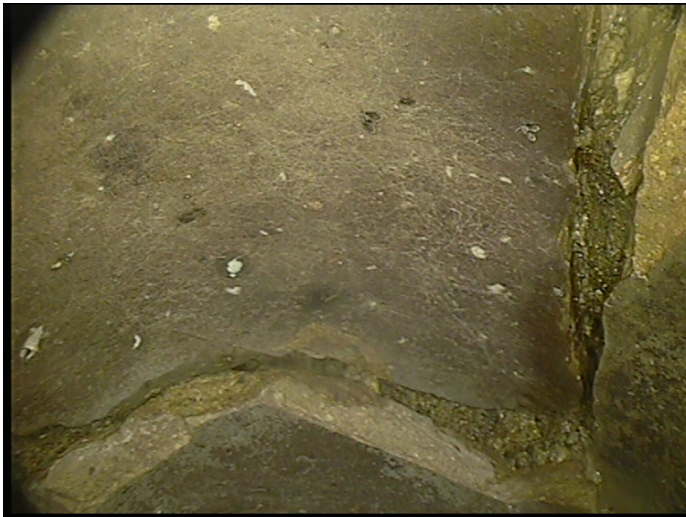
Code:	<b>B</b>
Description:	<b>Broken</b>
Distance (ft):	<b>16.4</b>
Structural Grade:	<b>5</b>
O&M Grade:	<b>0</b>
Clock Start/From:	<b>12</b>
Clock To:	<b>4</b>
1st Value:	
2nd Value:	
Value Percent:	
Continuous Index:	
Within 8" of Joint:	<b>YES</b>
Remarks:

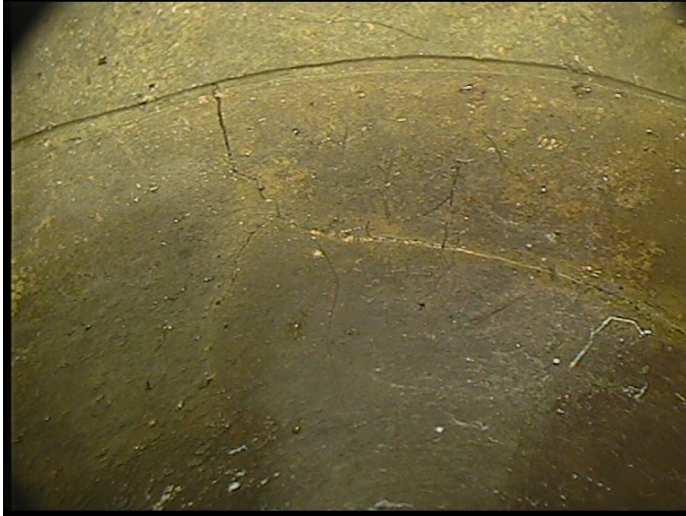
Code:	<b>CM</b>
Description:	<b>Crack Multiple</b>
Distance (ft):	<b>25.3</b>
Structural Grade:	<b>3</b>
O&M Grade:	<b>0</b>
Clock Start/From:	<b>10</b>
Clock To:	<b>12</b>
1st Value:	
2nd Value:	
Value Percent:	
Continuous Index:	
Within 8" of Joint:	<b>YES</b>
Remarks:

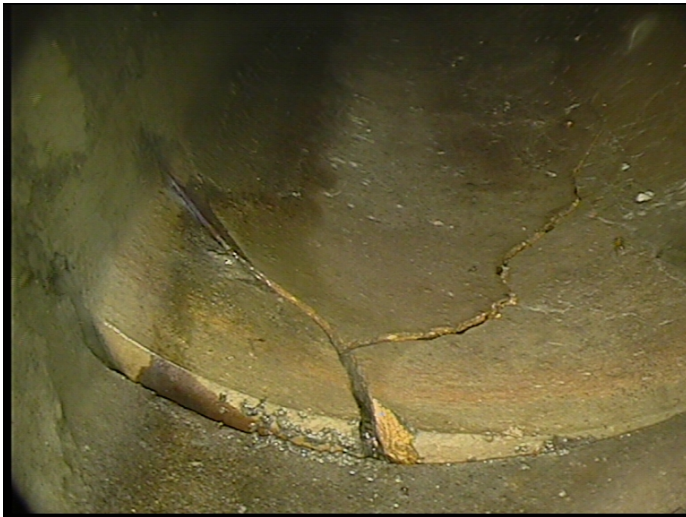
Code:	<b>FM</b>
Description:	<b>Fracture Multiple</b>
Distance (ft):	<b>33.5</b>
Structural Grade:	<b>4</b>
O&M Grade:	<b>0</b>
Clock Start/From:	<b>2</b>
Clock To:	<b>5</b>
1st Value:	
2nd Value:	
Value Percent:	
Continuous Index:	
Within 8" of Joint:	<b>YES</b>
Remarks:

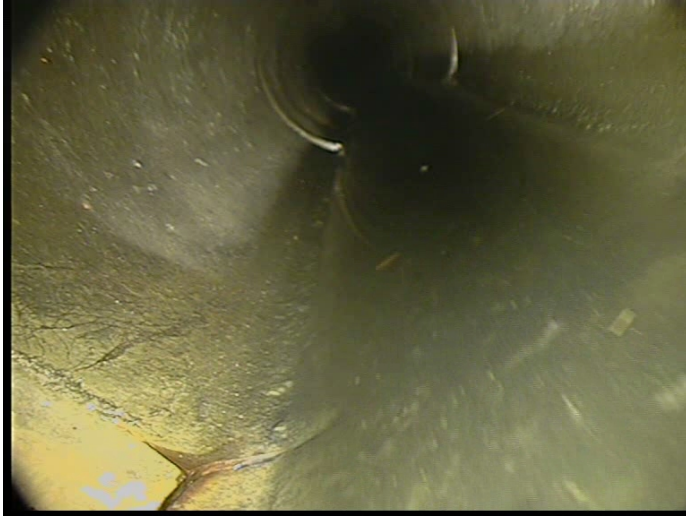
Code: **FM**  
Description: **Fracture Multiple**

Distance (ft): **33.5**  
Structural Grade: **4**  
O&M Grade: **0**  
Clock Start/From: **7**  
Clock To: **8**  
1st Value:  
2nd Value:  
Value Percent:  
Continuous Index:  
Within 8" of Joint: **YES**  
Remarks:

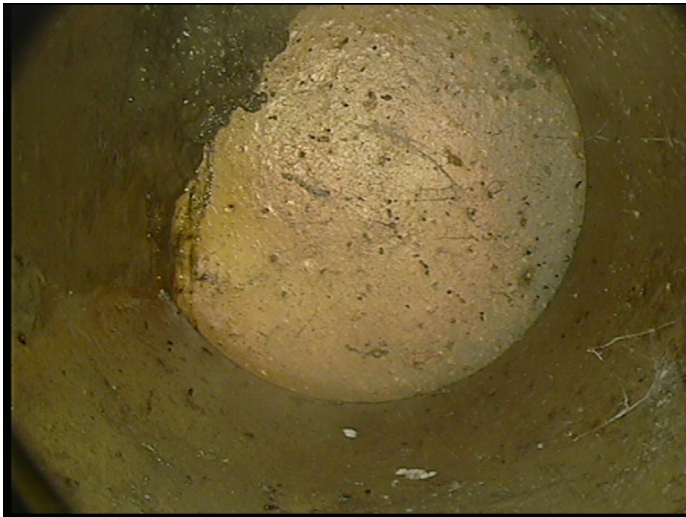
Code: **TFC**  
Description: **Tap Factory Capped**

Distance (ft): **38.0**  
Structural Grade: **0**  
O&M Grade: **0**  
Clock Start/From: **9**  
Clock To:  
1st Value: **4.000**  
2nd Value:  
Value Percent:  
Continuous Index:  
Within 8" of Joint: **NO**  
Remarks:

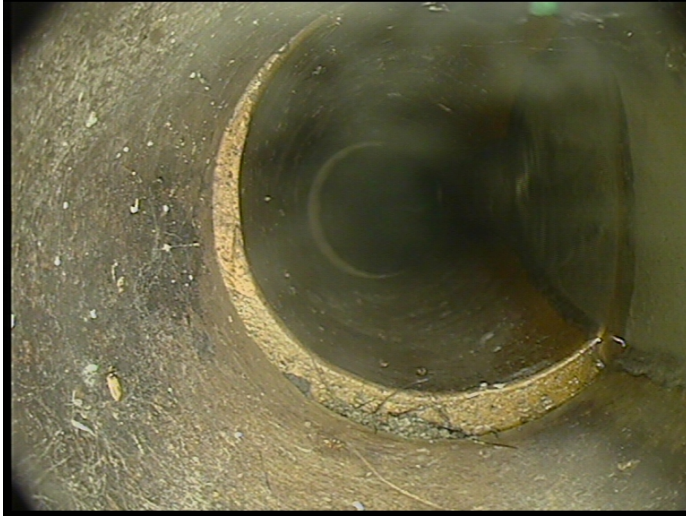
Code: **TFA**  
Description: **Tap Factory Active**

Distance (ft): **40.8**  
Structural Grade: **0**  
O&M Grade: **0**  
Clock Start/From: **3**  
Clock To:  
1st Value: **4.000**  
2nd Value:  
Value Percent:  
Continuous Index:  
Within 8" of Joint: **NO**  
Remarks:

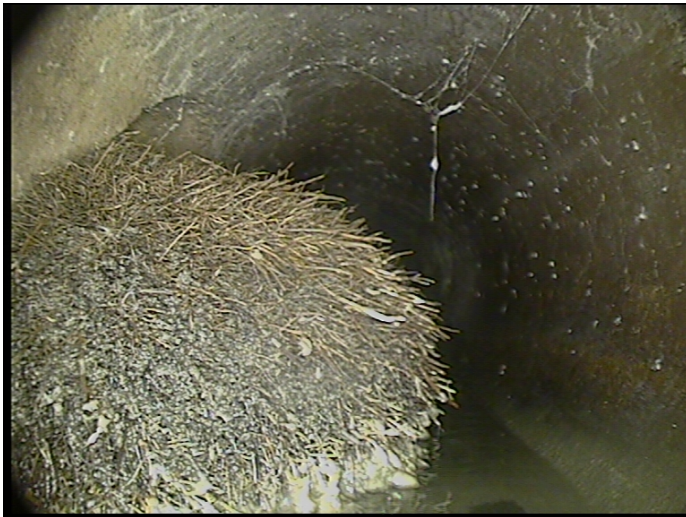
Code: **RFJ**  
Description: **Roots Fine Joint**

Distance (ft): **86.7**  
Structural Grade: **0**  
O&M Grade: **1**  
Clock Start/From: **7**  
Clock To: **5**  
1st Value:  
2nd Value:  
Value Percent:  
Continuous Index: **F01**  
Within 8" of Joint: **YES**  
Remarks:

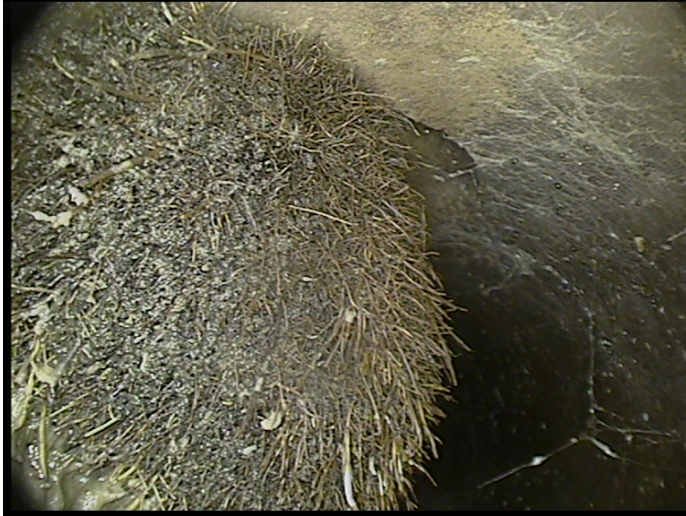
Code: **TFD**  
Description: **Tap Factory Defective**

Distance (ft): **86.9**  
Structural Grade: **0**  
O&M Grade: **2**  
Clock Start/From: **9**  
Clock To:  
1st Value: **4.000**  
2nd Value:  
Value Percent:  
Continuous Index:  
Within 8" of Joint: **NO**  
Remarks: **roots**

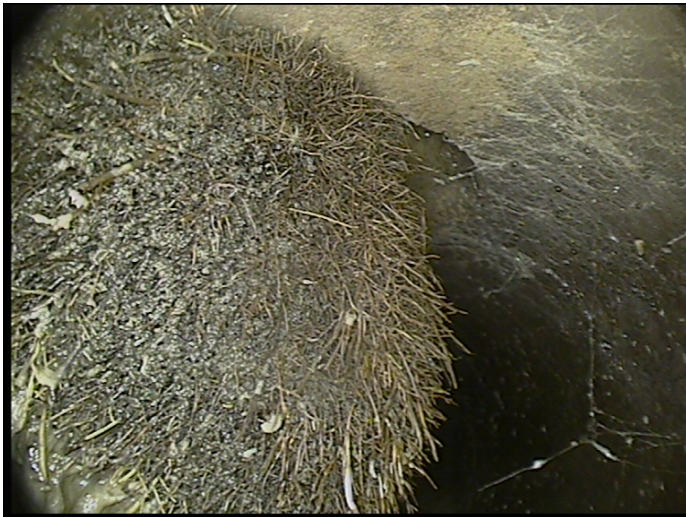
Code: **RML**  
Description: **Roots Medium Lateral**

Distance (ft): **86.9**  
Structural Grade: **0**  
O&M Grade: **3**  
Clock Start/From: **7**  
Clock To: **9**  
1st Value:  
2nd Value:  
Value Percent: **20.000**  
Continuous Index:  
Within 8" of Joint: **NO**  
Remarks:

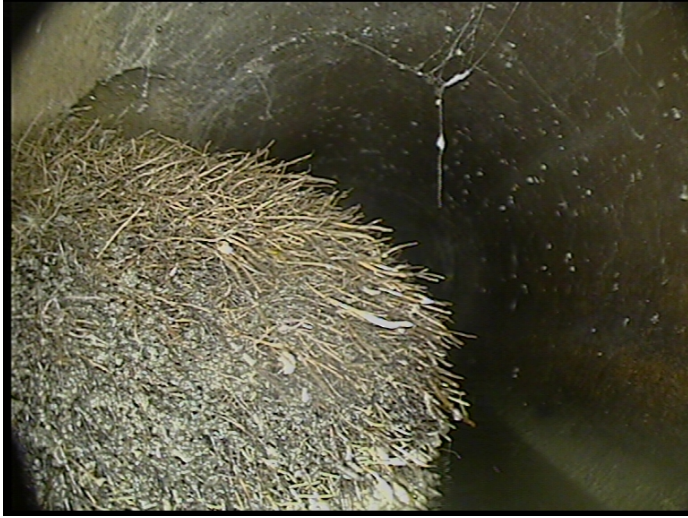
Code:	<b>MSA</b>
Description:	<b>Abandoned Survey</b>
Distance (ft):	<b>86.9</b>
Structural Grade:	<b>0</b>
O&M Grade:	<b>0</b>
Clock Start/From:	
Clock To:	
1st Value:	
2nd Value:	
Value Percent:	
Continuous Index:	
Within 8" of Joint:	<b>NO</b>
Remarks:	<b>reverse Complete</b>
