## Profile/Photo Observation Report

Date:	<b>10/16/2021</b>	Weather:		Coding:	<b>PACP 6.0</b>
Pipe Length (ft):		Owner:	<b>Hobart, IN</b>	Pre Clean:	<b>Not Known</b>
P.O.#:	<b>832_1</b>	Surveyor:	<b>M. Pielacha</b>	PSR:	<b>P-104-013-014</b>
Customer:	<b>Hobart, IN</b>	Clean Date:		Shape:	<b>C</b>

Street:	<b>Off 41st Avenue</b>	Flow Control:	
City:	<b>Hobart, IN</b>	Year Renewed:	
Location:	<b>Yard</b>	Tape/Media #:	<b>832</b>
Purpose:	<b>Routine Assessment</b>	Dia/Height:	<b>12"</b>
Use:	<b>Sanitary</b>	Material:	<b>CP</b>
Drain Area:		Lining:	
Category:	<b>NA</b>		
Comment:			
Location Details:		Direction of Survey:	<b>Downstream</b>
US MH:	<b>M-104-14</b>	DS MH:	<b>M-104-13</b>
		Total Length Surveyed (ft):	<b>10.3</b>

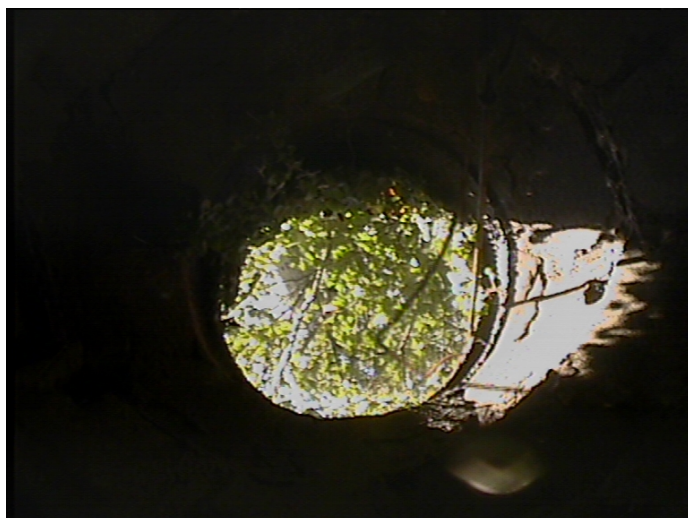
Code: **AMH**  
Description: **Manhole**

Distance (ft): **.0**  
Structural Grade: **0**  
O&M Grade: **0**  
Clock Start/From:  
Clock To:  
1st Value:  
2nd Value:  
Value Percent:  
Continuous Index:  
Within 8" of Joint: **NO**  
Remarks: **M-104-14**

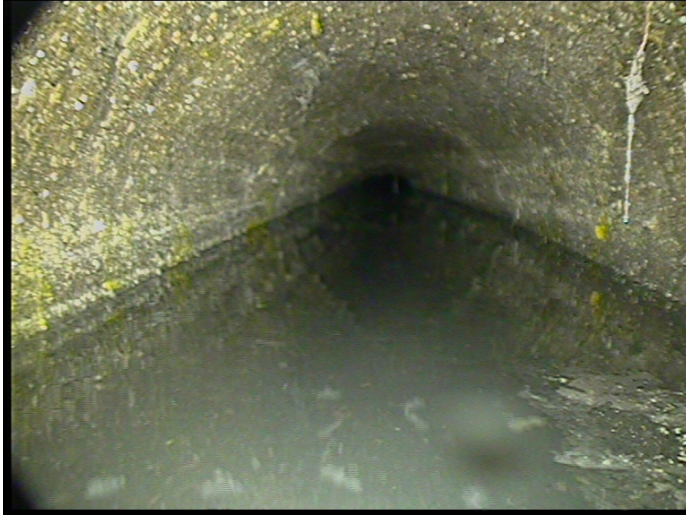
Code: **MWL**  
Description: **Water Level**

Distance (ft): **.0**  
Structural Grade: **0**  
O&M Grade: **0**  
Clock Start/From:  
Clock To:  
1st Value:  
2nd Value:  
Value Percent: **30.000**  
Continuous Index:  
Within 8" of Joint: **NO**  
Remarks:

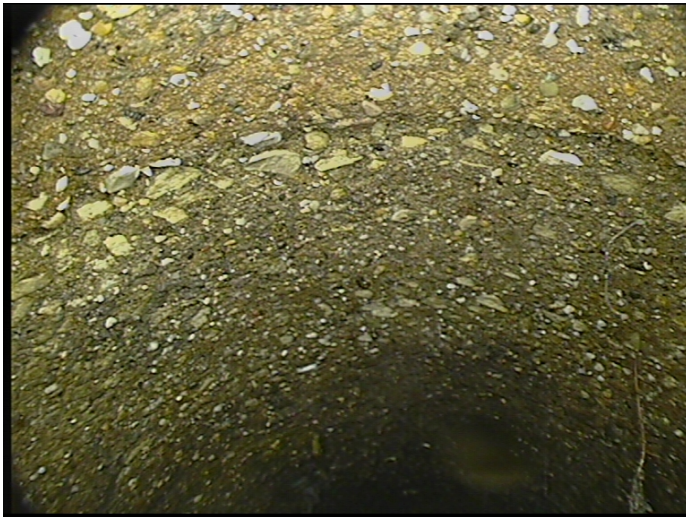
Code: **SAV**  
Description: **Surface Aggregate Visible**

Distance (ft): **.0**  
Structural Grade: **3**  
O&M Grade: **0**  
Clock Start/From: **8**  
Clock To: **4**  
1st Value:  
2nd Value:  
Value Percent:  
Continuous Index: **S01**  
Within 8" of Joint: **YES**  
Remarks:

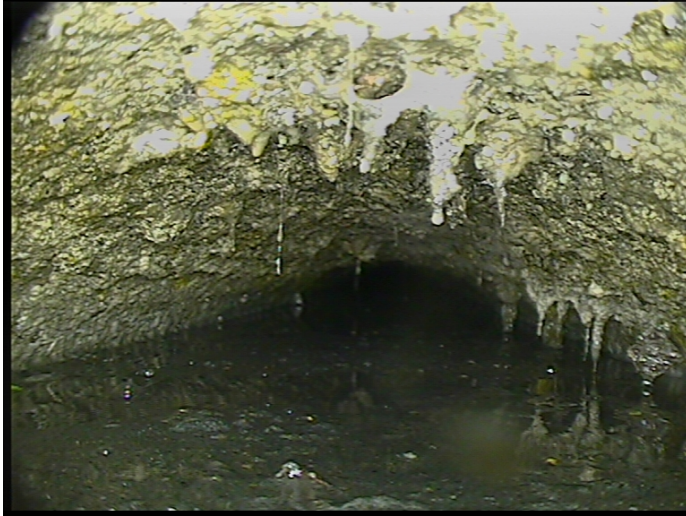
Code: **SAV**  
Description: **Surface Aggregate Visible**

Distance (ft): **9.5**  
Structural Grade: **3**  
O&M Grade: **0**  
Clock Start/From: **8**  
Clock To: **4**  
1st Value:  
2nd Value:  
Value Percent:  
Continuous Index: **F01**  
Within 8" of Joint: **NO**  
Remarks:

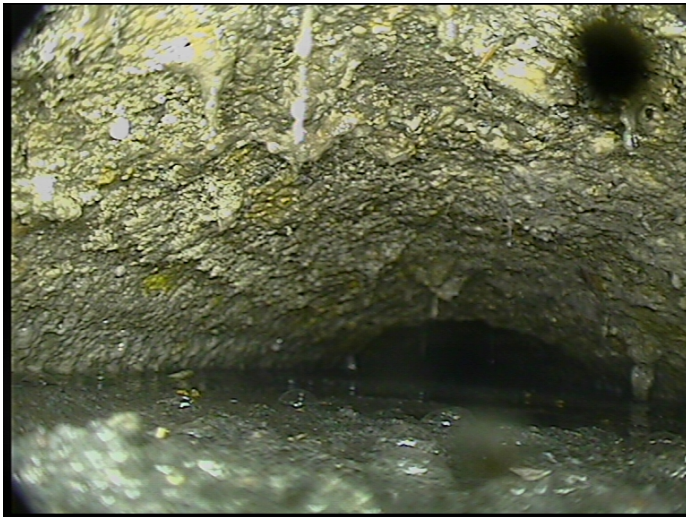
Code: **DSF**  
Description: **Deposits Settled Fine**

Distance (ft): **10.3**  
Structural Grade: **0**  
O&M Grade: **3**  
Clock Start/From: **4**  
Clock To: **8**  
1st Value:  
2nd Value:  
Value Percent: **15.000**  
Continuous Index:  
Within 8" of Joint: **NO**  
Remarks:

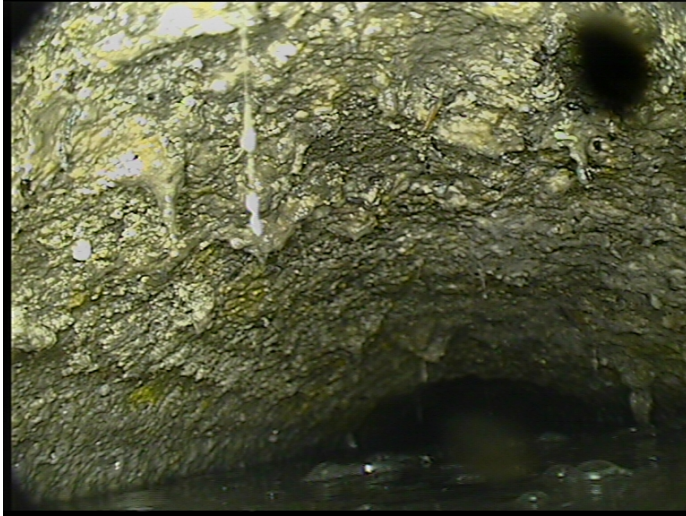
Code: **DAGS**  
Description: **Deposits Attached Grease**

Distance (ft): **10.3**  
Structural Grade: **0**  
O&M Grade: **2**  
Clock Start/From: **9**  
Clock To: **3**  
1st Value:  
2nd Value:  
Value Percent: **5.000**  
Continuous Index:  
Within 8" of Joint: **NO**  
Remarks:

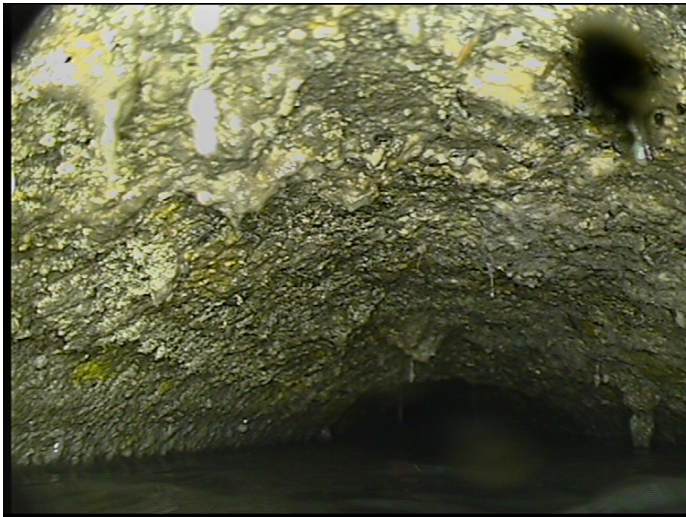
Code: **MSA**  
Description: **Abandoned Survey**

Distance (ft): **10.3**  
Structural Grade: **0**  
O&M Grade: **0**  
Clock Start/From:  
Clock To:  
1st Value:  
2nd Value:  
Value Percent:  
Continuous Index:  
Within 8" of Joint: **NO**  
Remarks: **Under water debris/ grease**
