## Profile/Photo Observation Report

Date:	10/17/2021	Weather:		Coding:	PACP 6.0
Pipe Length (ft):		Owner:	Hobart, IN	Pre Clean:	Not Known
P.O.#:	849_1	Surveyor:	M. Pielacha	PSR:	P-105-001-002
Customer:	Hobart, IN	Clean Date:		Shape:	C

Street:	East Home Avenue	Flow Control:	
City:	Hobart, IN	Year Renewed:	
Location:	Woods	Tape/Media #:	849
Purpose:	Routine Assessment	Dia/Height:	8"
Use:	Sanitary	Material:	PVC
Drain Area:		Lining:	
Category:	NA		
Comment:

Location Details:		Direction of Survey:	Upstream
US MH:	M-105-1	DS MH:	M-105-2
		Total Length Surveyed (ft):	40.9

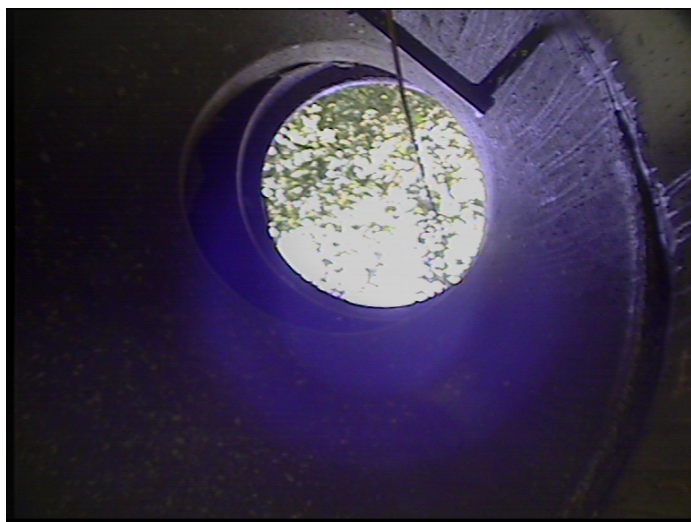
Code: **AMH**  
 Description: **Manhole**

Distance (ft): **.0**  
 Structural Grade: **0**  
 O&M Grade: **0**  
 Clock Start/From:  
 Clock To:  
 1st Value:  
 2nd Value:  
 Value Percent:  
 Continuous Index:  
 Within 8" of Joint: **NO**  
 Remarks: **M-105-2**

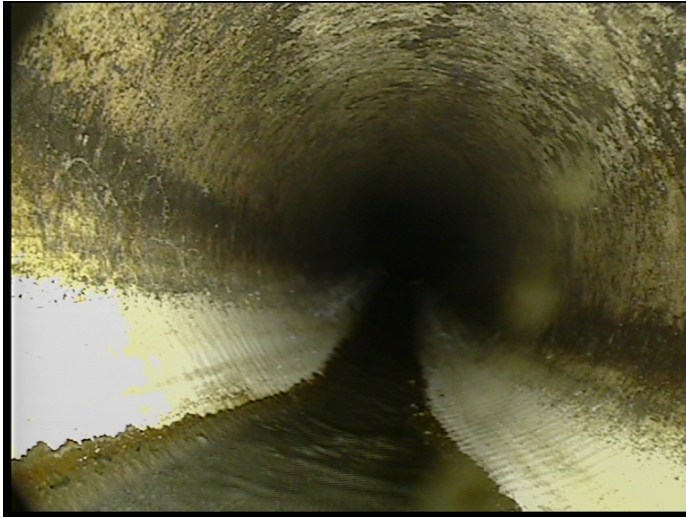
Code:	<b>MWL</b>
Description:	<b>Water Level</b>
Distance (ft):	<b>.0</b>
Structural Grade:	<b>0</b>
O&M Grade:	<b>0</b>
Clock Start/From:	
Clock To:	
1st Value:	
2nd Value:	
Value Percent:	<b>5.000</b>
Continuous Index:	
Within 8" of Joint:	<b>NO</b>
Remarks:

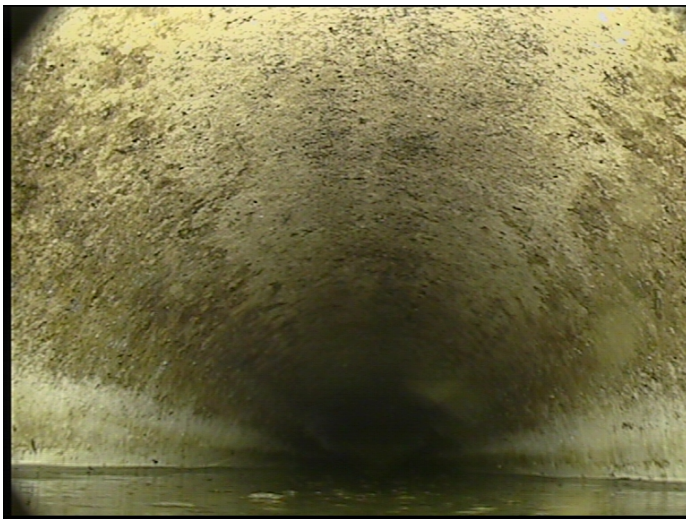
Code:	<b>MWL</b>
Description:	<b>Water Level</b>
Distance (ft):	<b>29.3</b>
Structural Grade:	<b>0</b>
O&M Grade:	<b>0</b>
Clock Start/From:	
Clock To:	
1st Value:	
2nd Value:	
Value Percent:	<b>35.000</b>
Continuous Index:	
Within 8" of Joint:	<b>NO</b>
Remarks:

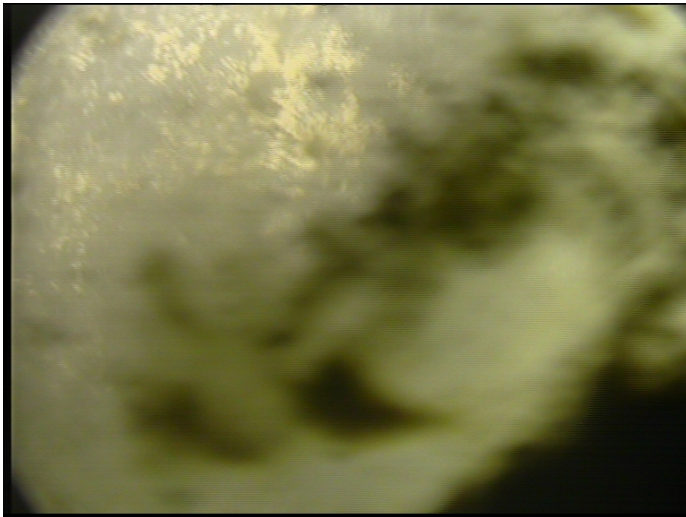
Code: **MGO**  
Description: **General Observation**

Distance (ft): **40.9**  
Structural Grade: **0**  
O&M Grade: **0**  
Clock Start/From:  
Clock To:  
1st Value:  
2nd Value:  
Value Percent:  
Continuous Index:  
Within 8" of Joint: **NO**  
Remarks: **Under water debris**

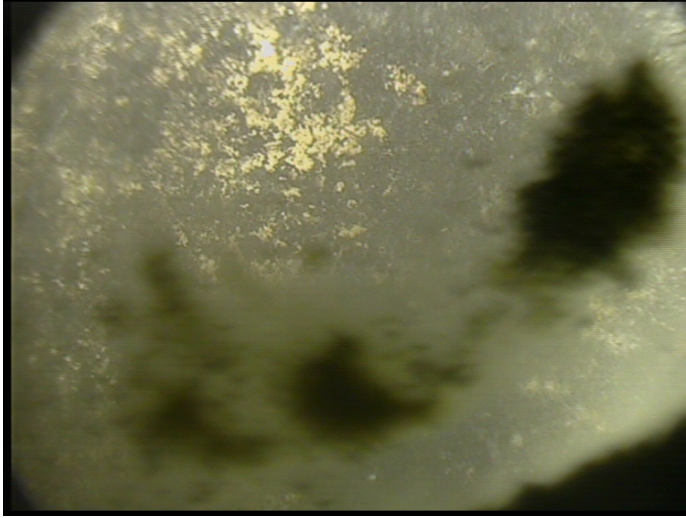
Code: **MSA**  
Description: **Abandoned Survey**

Distance (ft): **40.9**  
Structural Grade: **0**  
O&M Grade: **0**  
Clock Start/From:  
Clock To:  
1st Value:  
2nd Value:  
Value Percent:  
Continuous Index:  
Within 8" of Joint: **NO**  
Remarks: **Under water debris**

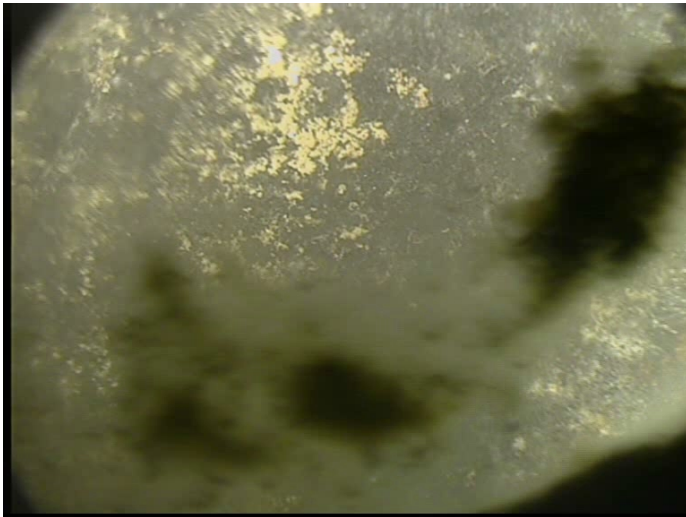
Code: **MCU**  
Description: **Camera Underwater**

Distance (ft): **40.9**  
Structural Grade: **0**  
O&M Grade: **4**  
Clock Start/From:  
Clock To:  
1st Value:  
2nd Value:  
Value Percent:  
Continuous Index: **F01**  
Within 8" of Joint: **NO**  
Remarks:
