Profile/Photo Observation Report

Date:	10/17/2021	Weather:		Coding:	PACP 6.0
Pipe Length (ft):		Owner:	Hobart, IN	Pre Clean:	Not Known
P.O.#:	850_1	Surveyor:	M. Pielacha	PSR:	P-105-002-003
Customer:	Hobart, IN	Clean Date:		Shape:	C

Street:	Off 49th Avenue	Flow Control:	
City:	Hobart, IN	Year Renewed:	
Location:	Woods	Tape/Media #:	850
Purpose:	Routine Assessment	Dia/Height:	8"
Use:	Sanitary	Material:	PVC
Drain Area:		Lining:	
Category:	NA		
Comment:

Location Details:		Direction of Survey:	Downstream
US MH:	M-105-2	DS MH:	M-105-3
		Total Length Surveyed (ft):	15.3

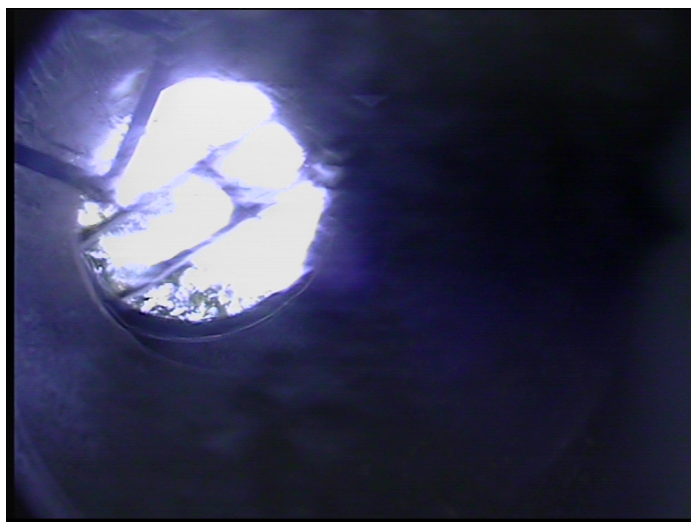
Code: **AMH**
Description: **Manhole**

Distance (ft): **.0**
Structural Grade: **0**
O&M Grade: **0**
Clock Start/From:
Clock To:
1st Value:
2nd Value:
Value Percent:
Continuous Index:
Within 8" of Joint: **NO**
Remarks: **M-105-2**

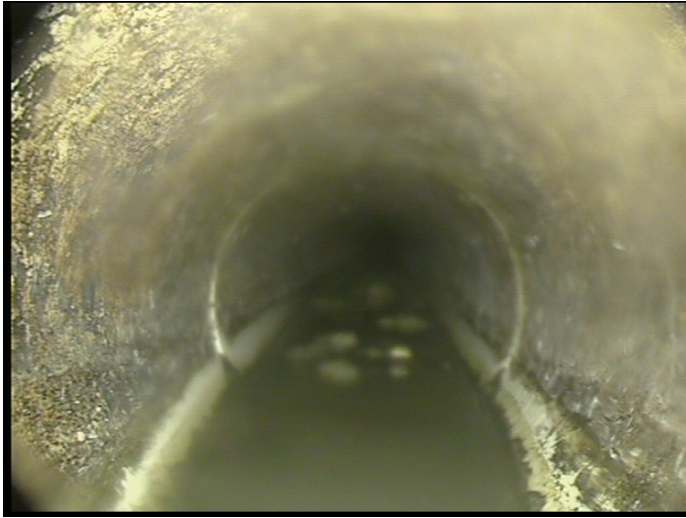
Code: **MWL**
Description: **Water Level**

Distance (ft): **.0**
Structural Grade: **0**
O&M Grade: **0**
Clock Start/From:
Clock To:
1st Value:
2nd Value:
Value Percent: **5.000**
Continuous Index:
Within 8" of Joint: **NO**
Remarks:

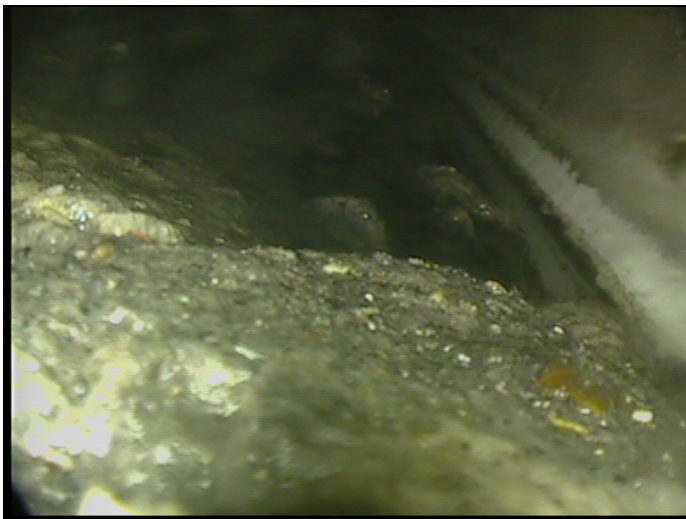
Code: **OBR**
Description: **Obstacle Rocks**

Distance (ft): **15.3**
Structural Grade: **0**
O&M Grade: **3**
Clock Start/From: **4**
Clock To: **8**
1st Value:
2nd Value:
Value Percent: **15.000**
Continuous Index:
Within 8" of Joint: **NO**
Remarks:

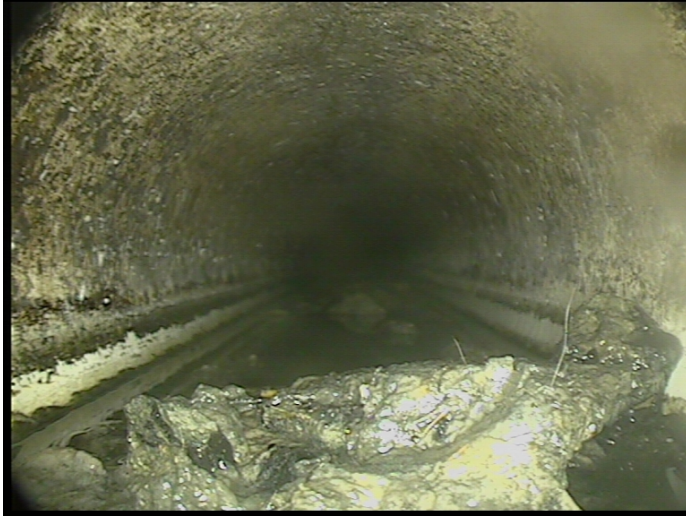
Code:	MSA
Description:	Abandoned Survey
Distance (ft):	15.3
Structural Grade:	0
O&M Grade:	0
Clock Start/From:	
Clock To:	
1st Value:	
2nd Value:	
Value Percent:	
Continuous Index:	
Within 8" of Joint:	NO
Remarks:	rocks
