## Profile/Photo Observation Report

Date:	10/17/2021	Weather:		Coding:	PACP 6.0
Pipe Length (ft):		Owner:	Hobart, IN	Pre Clean:	Not Known
P.O.#:	852_2	Surveyor:	M. Pielacha	PSR:	P-105-002-003
Customer:	Hobart, IN	Clean Date:		Shape:	C

Street:	Off 49th Avenue	Flow Control:	Not Controlled
City:	Hobart, IN	Year Renewed:	
Location:	Easement/Right of Way	Tape/Media #:	852
Purpose:	Routine Assessment	Dia/Height:	8"
Use:	Sanitary	Material:	PVC
Drain Area:		Lining:	
Category:	NA		
Comment:			
Location Details:		Direction of Survey:	Upstream
US MH:	M-105-2	DS MH:	M-105-3
		Total Length Surveyed (ft):	.1

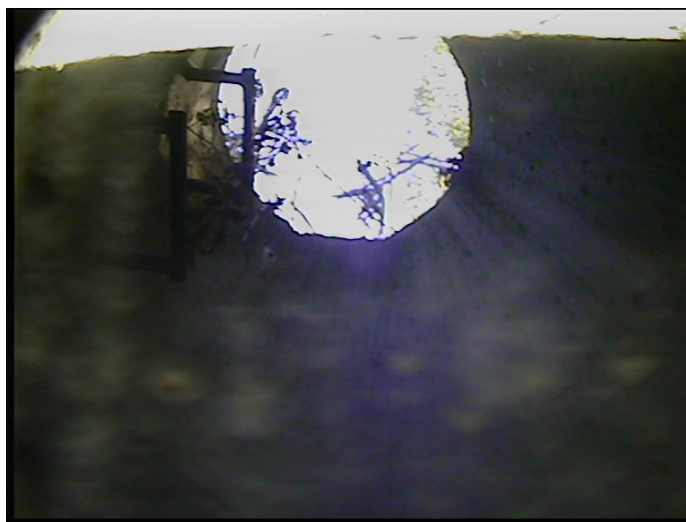
Code: **AMH**  
Description: **Manhole**

Distance (ft): **.0**  
Structural Grade: **0**  
O&M Grade: **0**  
Clock Start/From:  
Clock To:  
1st Value:  
2nd Value:  
Value Percent:  
Continuous Index:  
Within 8" of Joint: **NO**  
Remarks: **M-105-3**

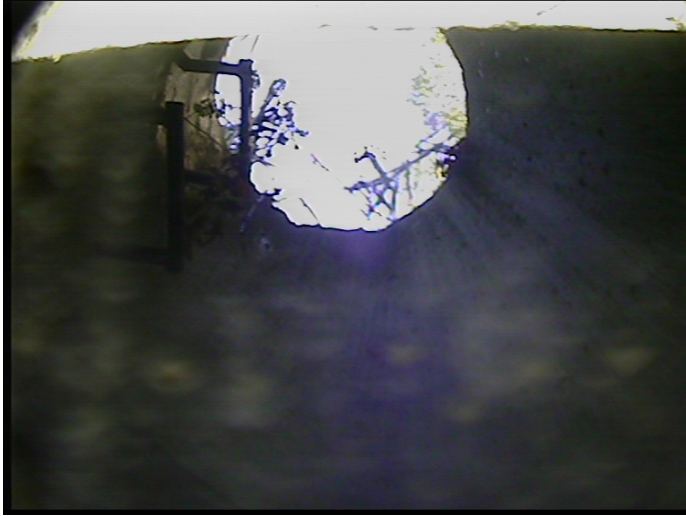
Code:	<b>MGO</b>
Description:	<b>General Observation</b>
Distance (ft):	<b>.0</b>
Structural Grade:	<b>0</b>
O&M Grade:	<b>0</b>
Clock Start/From:	
Clock To:	
1st Value:	
2nd Value:	
Value Percent:	
Continuous Index:	
Within 8" of Joint:	<b>NO</b>
Remarks:	<b>Manhole lid appears to have fallen in</b>

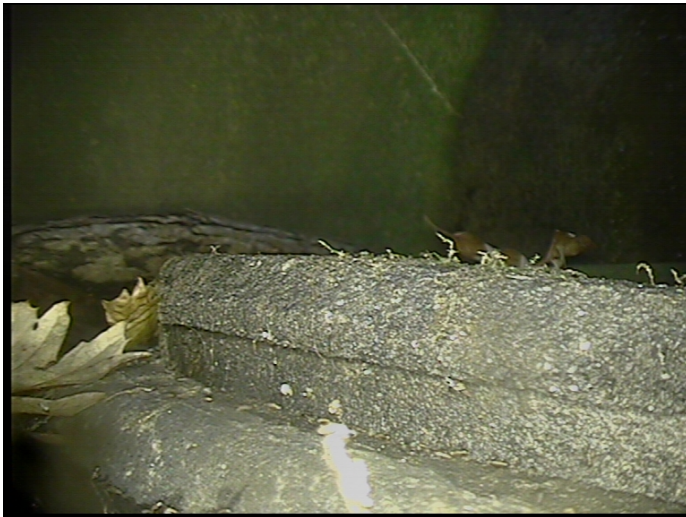
Code:	<b>MWL</b>
Description:	<b>Water Level</b>
Distance (ft):	<b>.0</b>
Structural Grade:	<b>0</b>
O&M Grade:	<b>0</b>
Clock Start/From:	
Clock To:	
1st Value:	
2nd Value:	
Value Percent:	<b>5.000</b>
Continuous Index:	
Within 8" of Joint:	<b>NO</b>
Remarks:

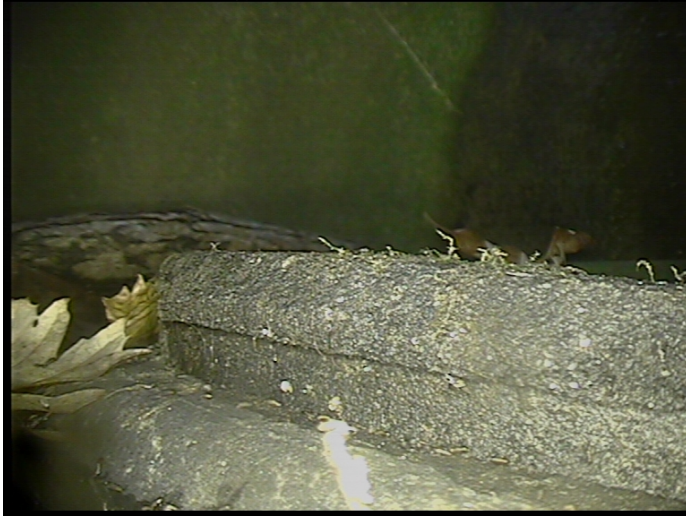
Code: **OBZ**  
Description: **Obstacle Other**

Distance (ft): **.0**  
Structural Grade: **0**  
O&M Grade: **5**  
Clock Start/From: **7**  
Clock To: **5**  
1st Value:  
2nd Value:  
Value Percent: **80.000**  
Continuous Index:  
Within 8" of Joint: **NO**  
Remarks: **Debris**

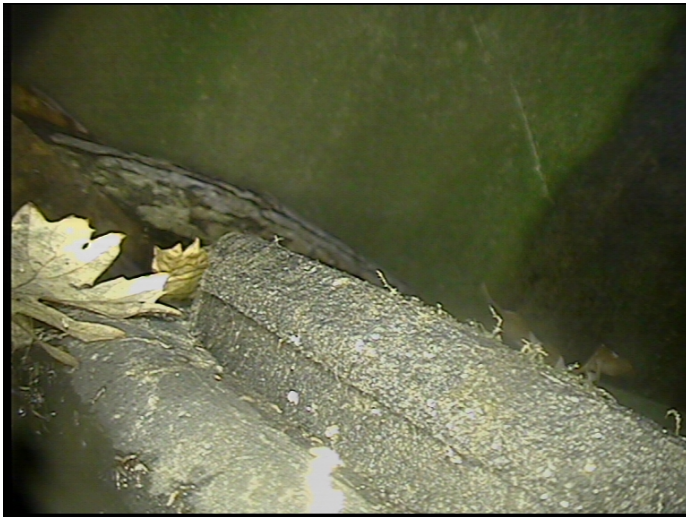
Code: **MSA**  
Description: **Abandoned Survey**

Distance (ft): **.0**  
Structural Grade: **0**  
O&M Grade: **0**  
Clock Start/From:  
Clock To:  
1st Value:  
2nd Value:  
Value Percent:  
Continuous Index:  
Within 8" of Joint: **NO**  
Remarks: **Manhole full of debris**
