Profile/Photo Observation Report

| P.O.#: | 852_1 | Surveyor: | M. Pielacha | PSR: | P-105-003-004 |

| Street: | Off 49th Avenue | Flow Control: | |

| US MH: | M-105-3 | DS MH: | M-105-4 |

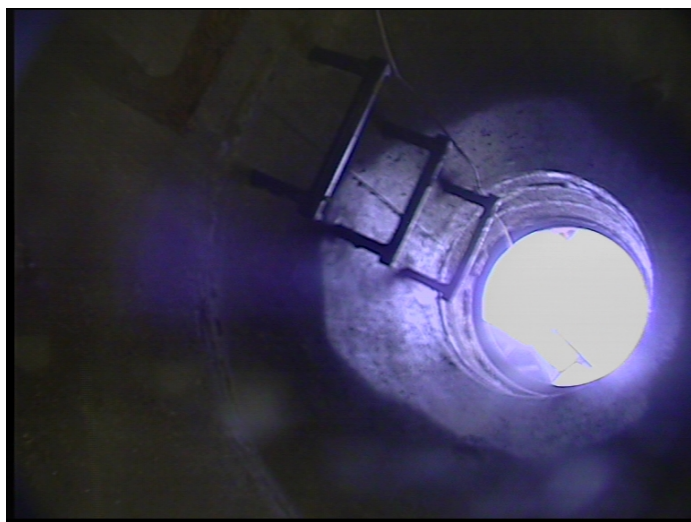
Code: **AMH**
Description: **Manhole**

Distance (ft): **.0**
Structural Grade: **0**
O&M Grade: **0**
Clock Start/From:
Clock To:
1st Value:
2nd Value:
Value Percent:
Continuous Index:
Within 8" of Joint: **NO**
Remarks: **M-105-4**

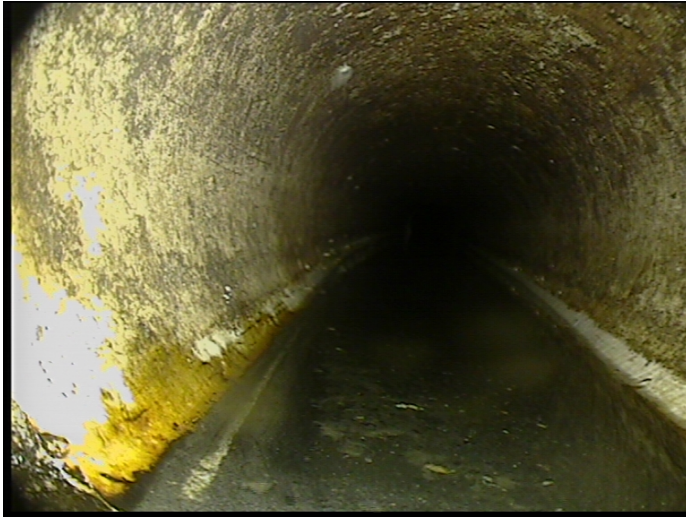
| Code: | MWL |
| Description: | Water Level |
| Distance (ft): | .0 |
| Value Percent: | 5.000 |

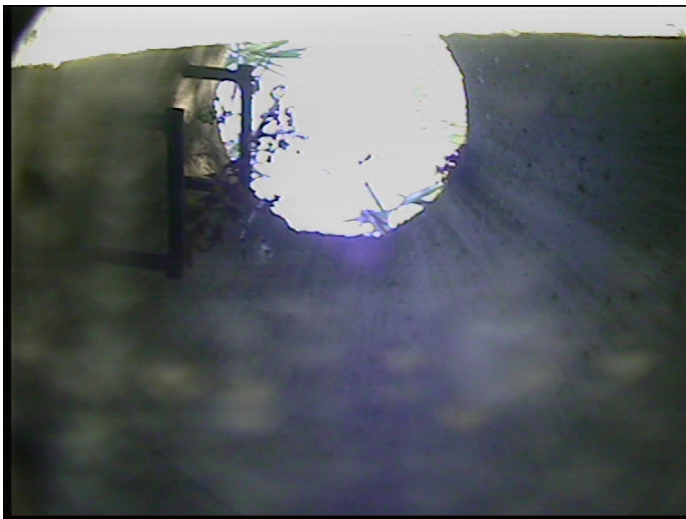
| Code: | AMH |
| Description: | Manhole |
| Distance (ft): | 168.5 |
| Remarks: | M-105-3 |
