Profile/Photo Observation Report

Date:	10/17/2021	Weather:		Coding:	PACP 6.0
Pipe Length (ft):		Owner:	Hobart, IN	Pre Clean:	Not Known
P.O.#:	853_1	Surveyor:	M. Pielacha	PSR:	P-105-004-005
Customer:	Hobart, IN	Clean Date:		Shape:	C

US MH: **M-105-4** DS MH: **M-105-5** Total Length Surveyed (ft): **14.7**

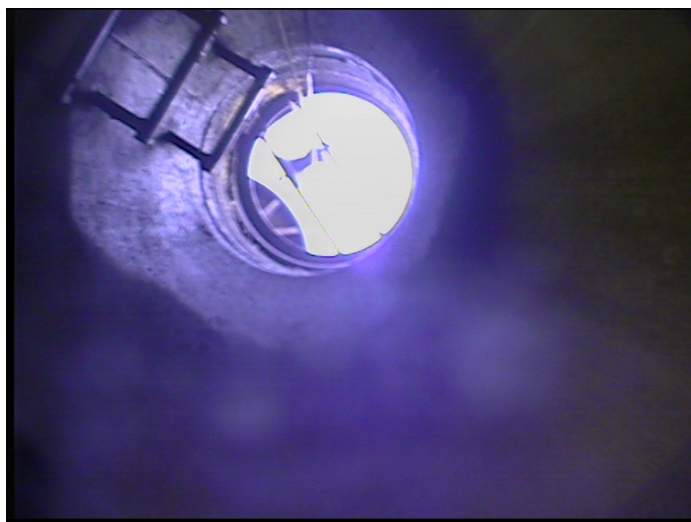
Code: **AMH**
Description: **Manhole**

Distance (ft): **.0**
Structural Grade: **0**
O&M Grade: **0**
Clock Start/From:
Clock To:
1st Value:
2nd Value:
Value Percent:
Continuous Index:
Within 8" of Joint: **NO**
Remarks: **M-105-4**

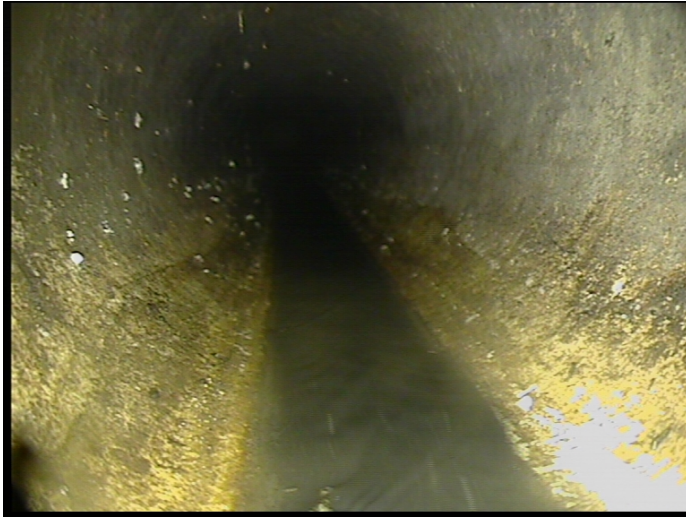
Code: **MWL**
Description: **Water Level**

Distance (ft): **.0**
Structural Grade: **0**
O&M Grade: **0**
Clock Start/From:
Clock To:
1st Value:
2nd Value:
Value Percent: **5.000**
Continuous Index:
Within 8" of Joint: **NO**
Remarks:

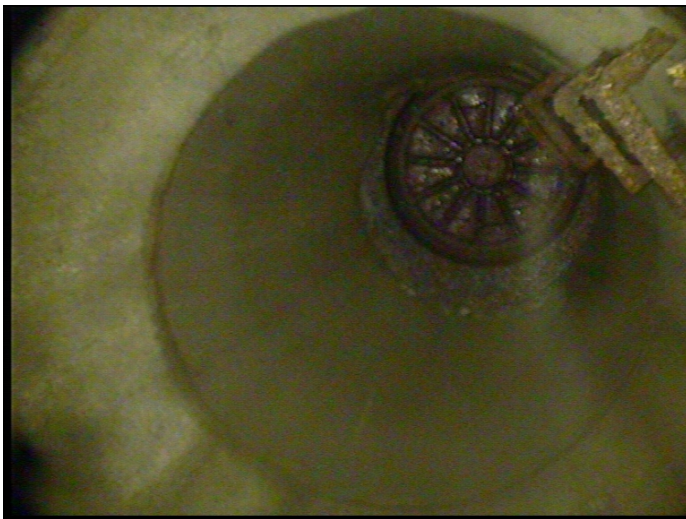
Code: **AMH**
Description: **Manhole**

Distance (ft): **14.7**
Structural Grade: **0**
O&M Grade: **0**
Clock Start/From:
Clock To:
1st Value:
2nd Value:
Value Percent:
Continuous Index:
Within 8" of Joint: **NO**
Remarks: **M-105-5**
